Recommendations to Industry Arising from Investigation of Fractured Plate Girders and Associated Studies at the Transbay Transit Center, San Francisco

February 14, 2020

Introduction

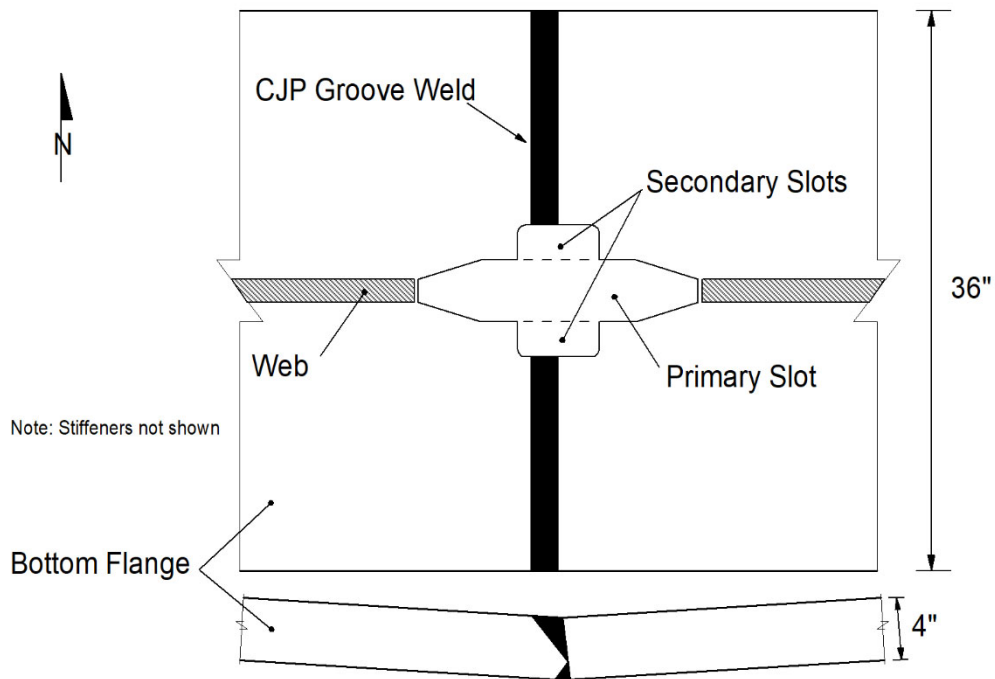
Figure 7 – Schematic Representation of the Bottom Flange near Midspan of TPG3 Girders

Figure 7 also schematically shows the CJP groove weld in the bottom flange. Based on the detailing of this CJP groove weld, the volume of the weld was somewhat offset towards the west end of the secondary slots.

To the understanding of the PRP, the secondary slots were added to avoid terminating the CJP groove weld at the face of the hanger connection plate, where the hanger connection plate might serve as an “end dam” for the weld, with the potential for weld discontinuities at this location. The secondary slots were therefore presumably added to allow sound termination of the CJP groove weld.

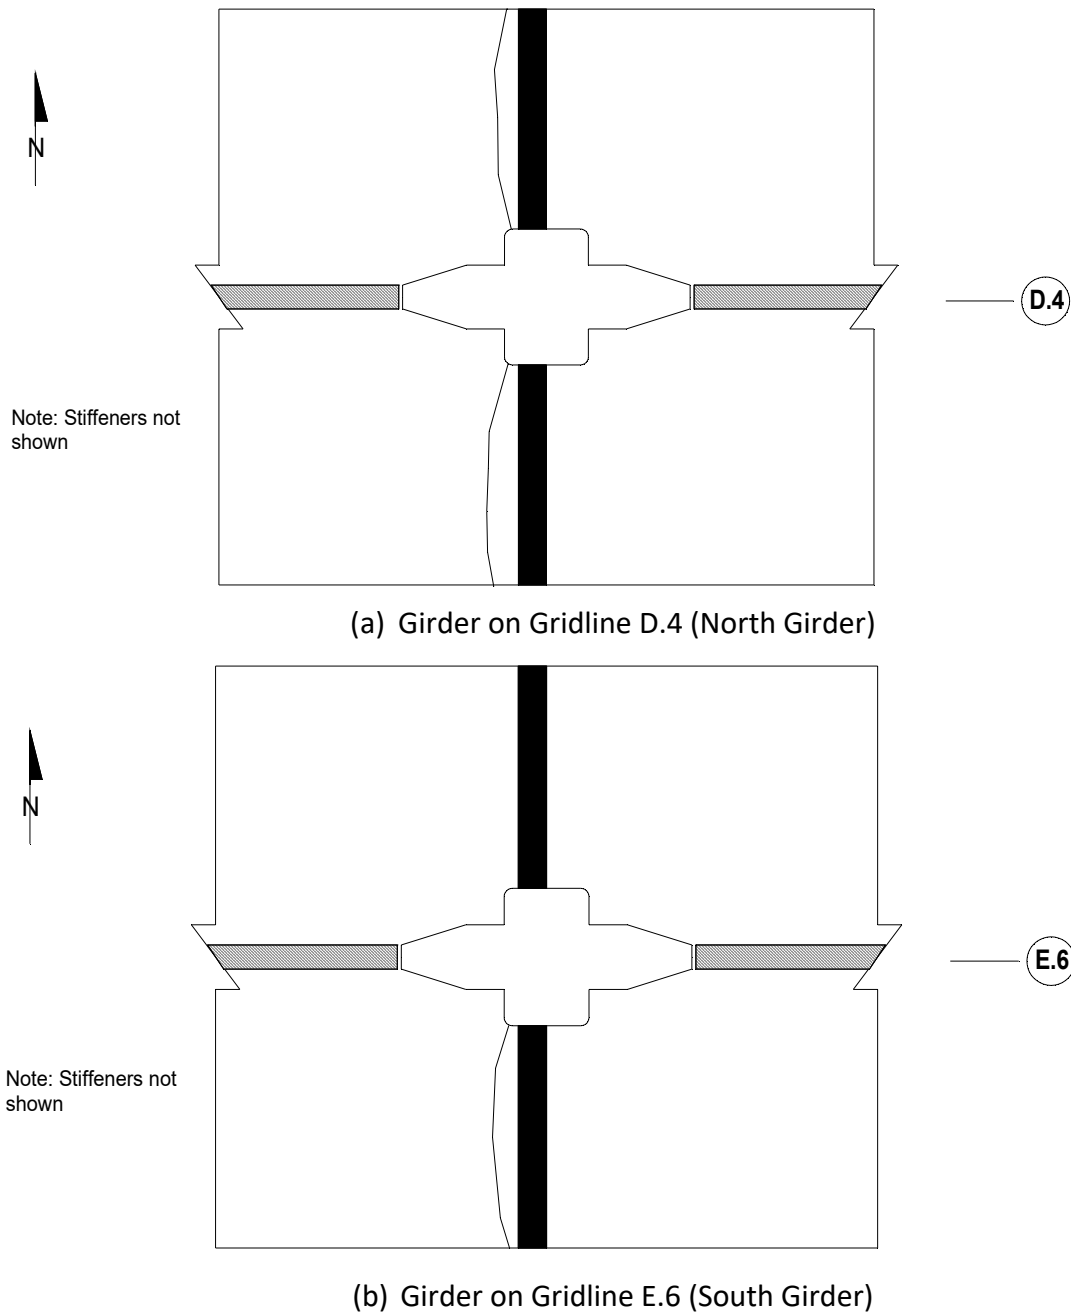
Figure 8 shows a simplified schematic representation of the fracture locations for the TPG3 girders along gridlines D.4 and E.6. For the girder on gridline D.4, fractures extended essentially over the full width of the flange. For the girder on gridline E.6, a fracture extended over half the width of the flange. In the descriptions that follow, the TPG3 girder on gridline D.4 is also referred to as the *North Girder*, and the TPG3 girder on gridline E.6 is also referred to as the *South Girder*.

Figure 8 – Schematic Representation of Fracture Locations in Bottom Flanges of TPG3 Girders at Fremont Street (view looking down at upper side of bottom flanges)

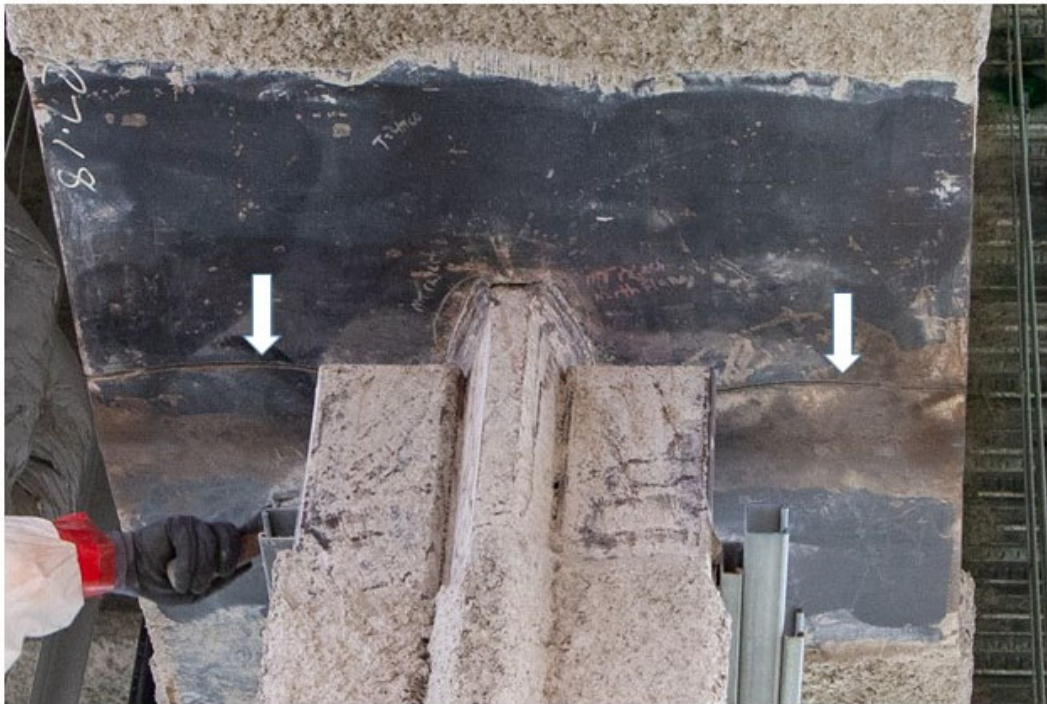
Figures 9 through 15 are photos of the fractures. Arrows have been added to the photos to highlight the fracture locations. The lines drawn on the girders in Figures 11 and 15 denote cut locations for removal of portions of the girders for subsequent examination and material testing. Figure 16 is a photo of the north half of the South Girder, where no fracture occurred. Figure 17 is a photo of a portion of the north half of the North Girder after removal. Figure 18 is a photo of the fracture surface in the south half of the South Girder.

Figure 9 – North Girder - View Looking East (Photo: TJPA)

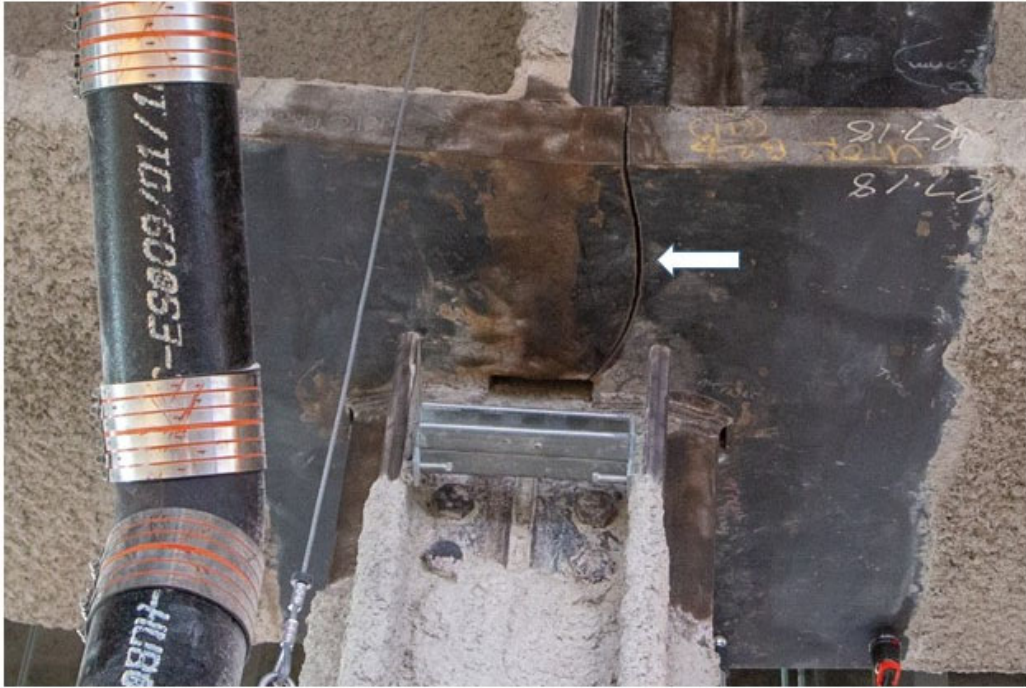
Figure 10 – North Girder – North Half - View Looking South (Photo: TJPA)

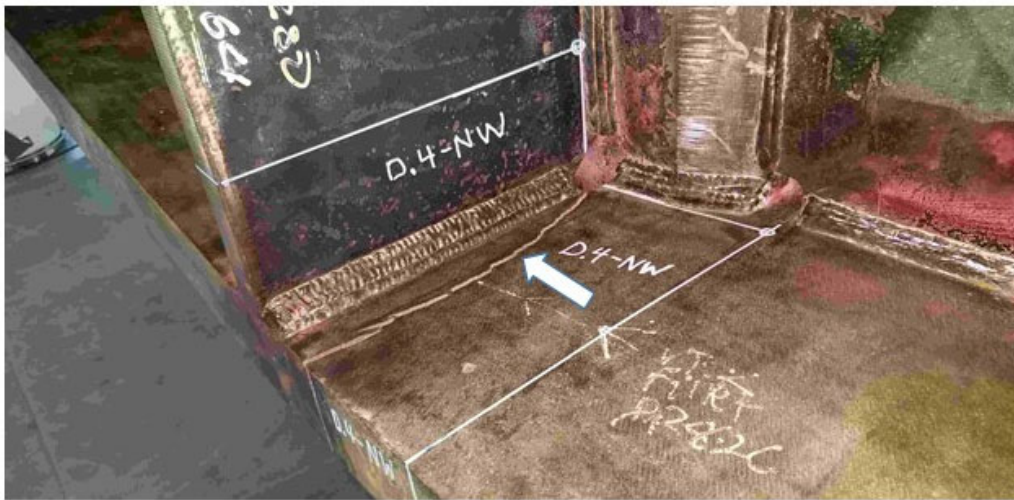
Figure 11 – North Girder – North Half – View Looking Southeast (Photo: TJPA)

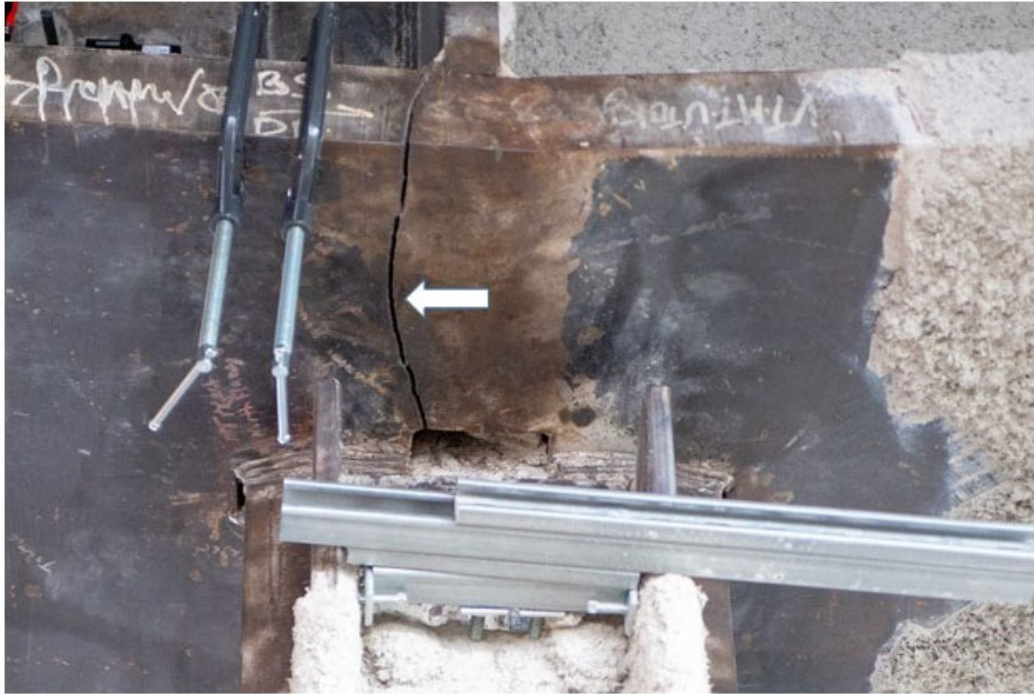
Figure 12 – North Girder – South Half - View Looking North (Photo: TJPA)

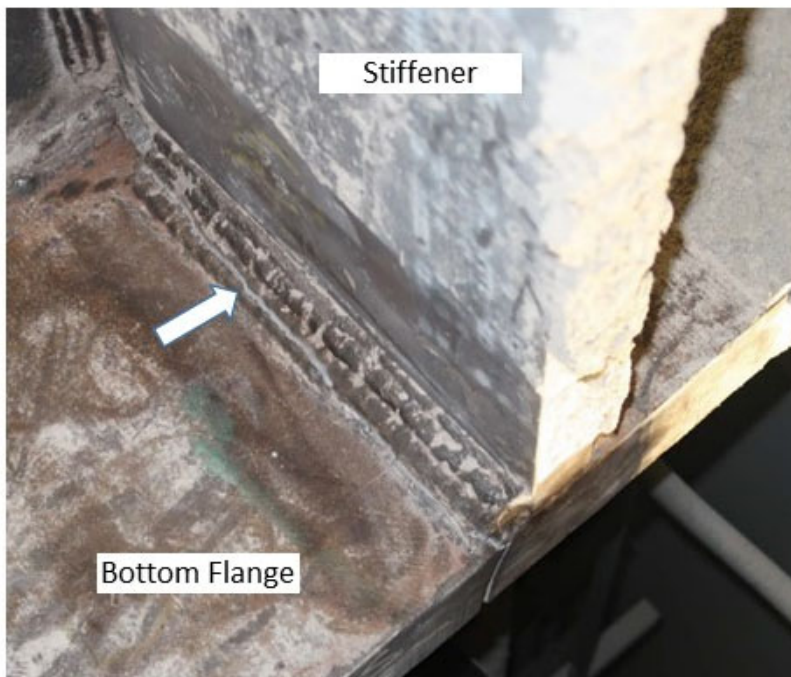
Figure 13 – North Girder – South Half - View Looking Northeast (Photo: TJPA)

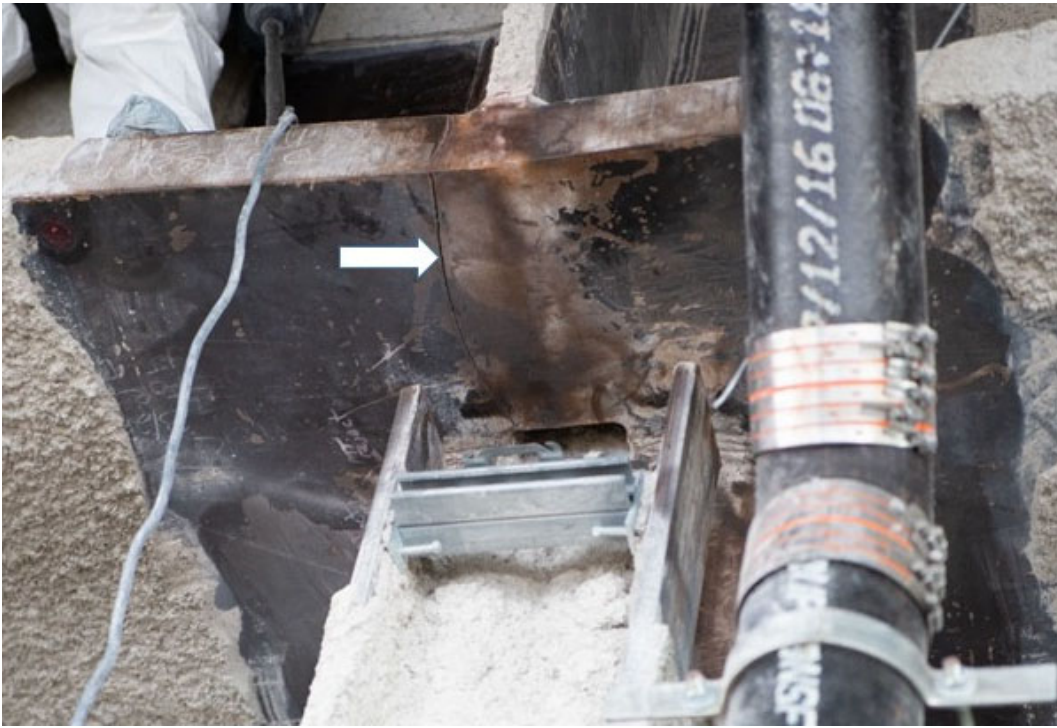
Figure 14 – South Girder – South Half - View Looking North (Photo: TJPA)

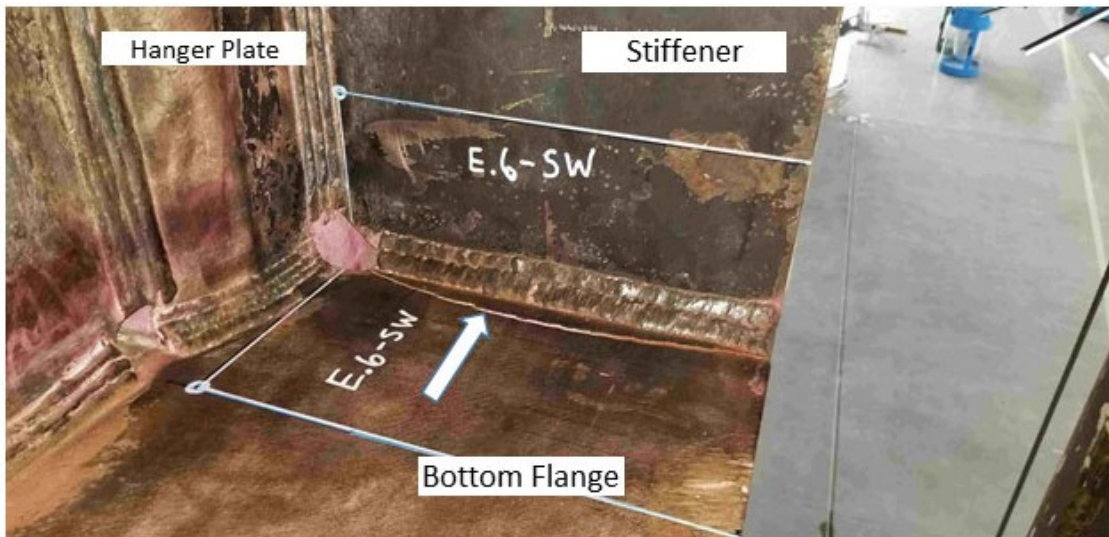
Figure 15 – South Girder – South Half - View Looking East (Photo: TJPA)

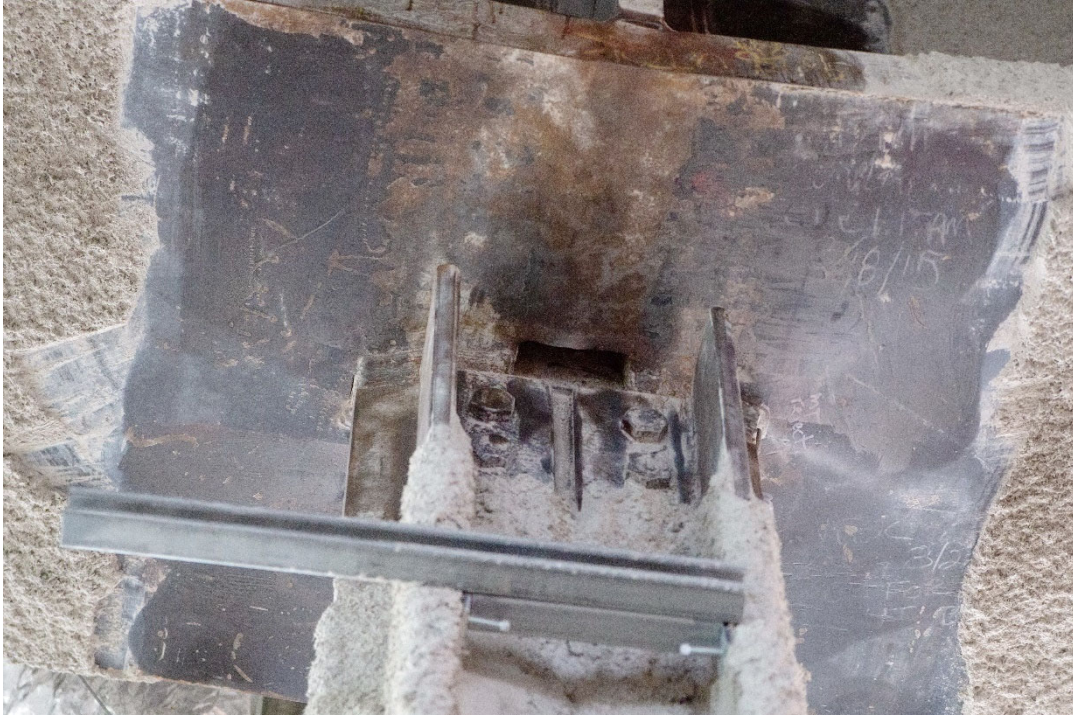
Figure 16 – South Girder – North Half - View Looking South – No Fracture (Photo: TJPA)

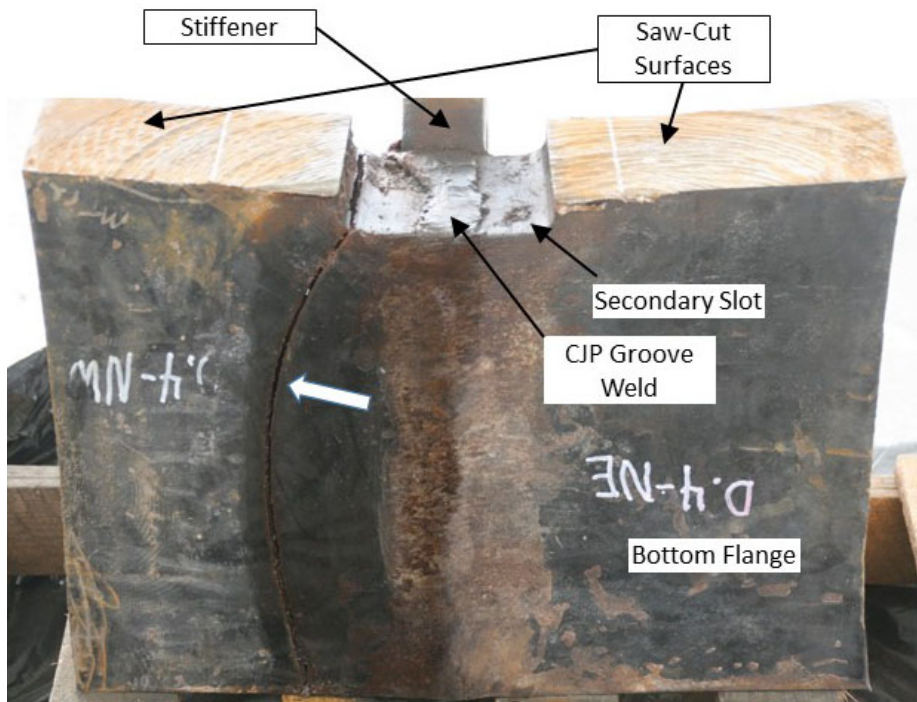
Figure 17 – North Girder – North Half Flange – After Removal (Photo: R. Shaw)

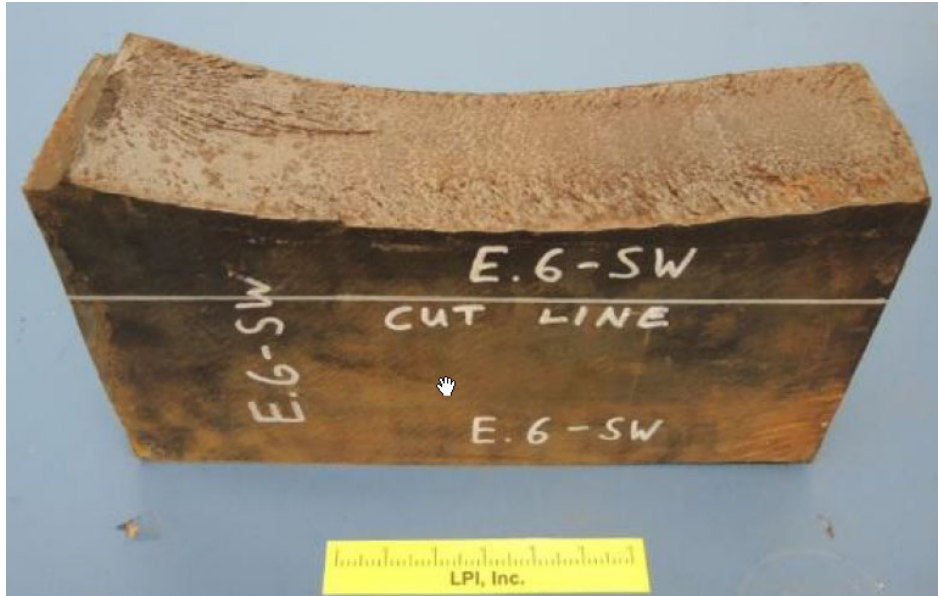
Figure 18 – Fracture Surface – South Half of South Girder (Photo: LPI Report)

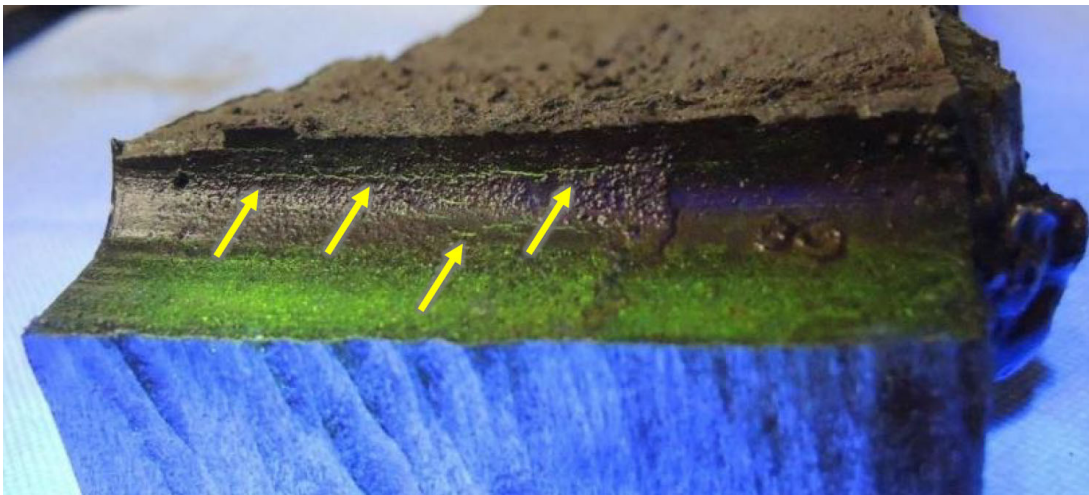
- Thermal cutting of the secondary slots in the girder bottom flange produced microcracks in the radii of the reentrant corners of the secondary slots at mid-thickness of the bottom flange plate near the bottom flange CJP groove weld. Figure 19 is a photo from the LPI Report showing the microcracks. The thermal cutting process resulted in microcracks in a thin layer of hard martensitic material on the surface of the secondary slot. The depth of the martensitic layer and the depth of the microcracks were on the order of several hundredths of an inch.

Figure 19 – Microcracks on Radius of Reentrant Corner of Secondary Slot on South Half of North Girder – Crack Visibility Enhanced by Florescent Magnetic Particle Testing (Photo: LPI Report)

- That AISC 360 and AWS D1.1 re-evaluate whether the requirement to grind to “bright metal” is adequate to ensure removal of hard surface layers and microcracks on thermally cut surfaces in thick materials at locations of stress concentration, such as reentrant corners.

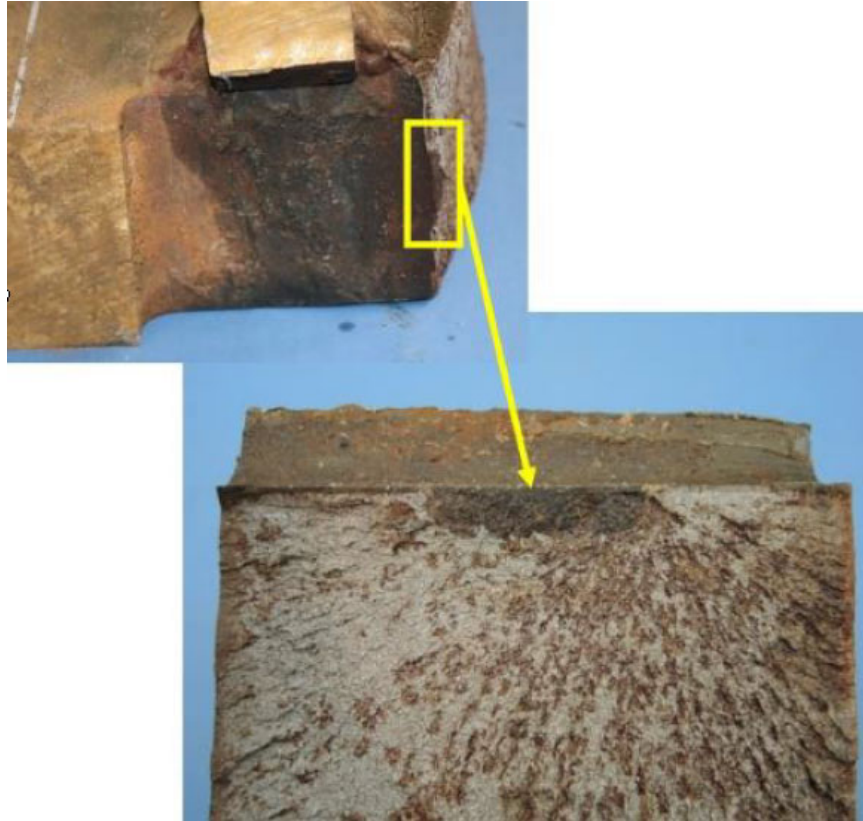
- Some of the microcracks in the reentrant corners later became larger “pop-in” cracks at the mid-thickness of the girder’s bottom flange plate, with a depth on the order of 3/8-in. Pop-in cracks were observed in the north half of the North Girder and the south half of the South Girder but were not observed in the south half of the North Girder. Figure 20 is a photo from the LPI report highlighting the location of the pop-in crack at mid-depth of the flange for the south half of the South Girder. This pop-in crack is also visible on the fracture surface in Figure 18. These pop-in cracks likely occurred due to tensile stresses generated by weld area shrinkage from production of the complete joint penetration groove weld in the bottom flange. The formation of the pop-in cracks was likely facilitated by the very close proximity of the secondary slot reentrant corners to the CJP groove weld on the west end of

Figure 20 – Pop-in Crack (covered by dark oxide) near Mid-depth of Bottom Flange at South Half of South Girder (Photo: LPI Report)

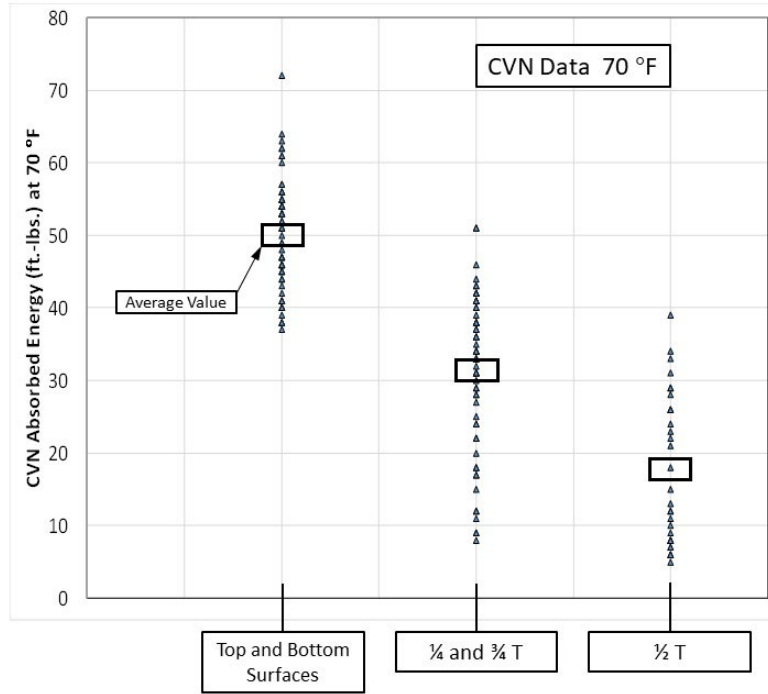
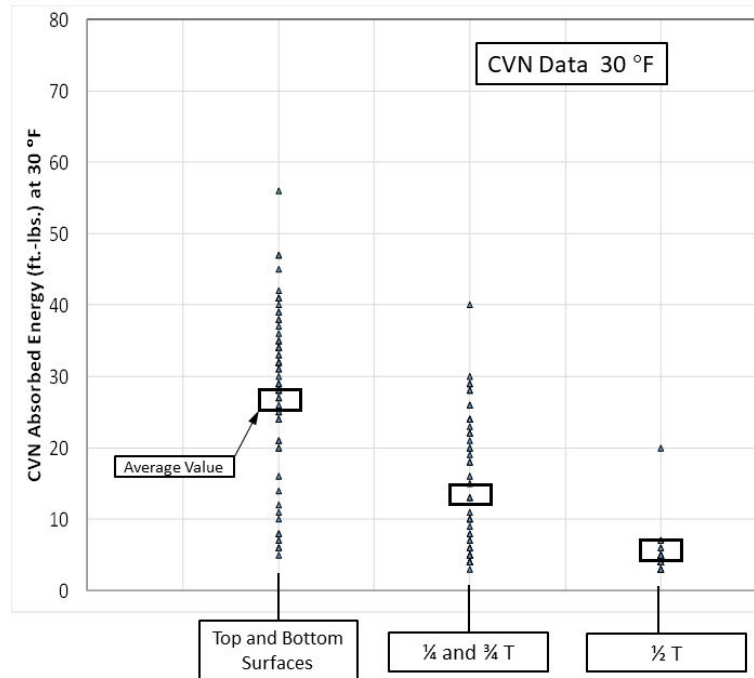
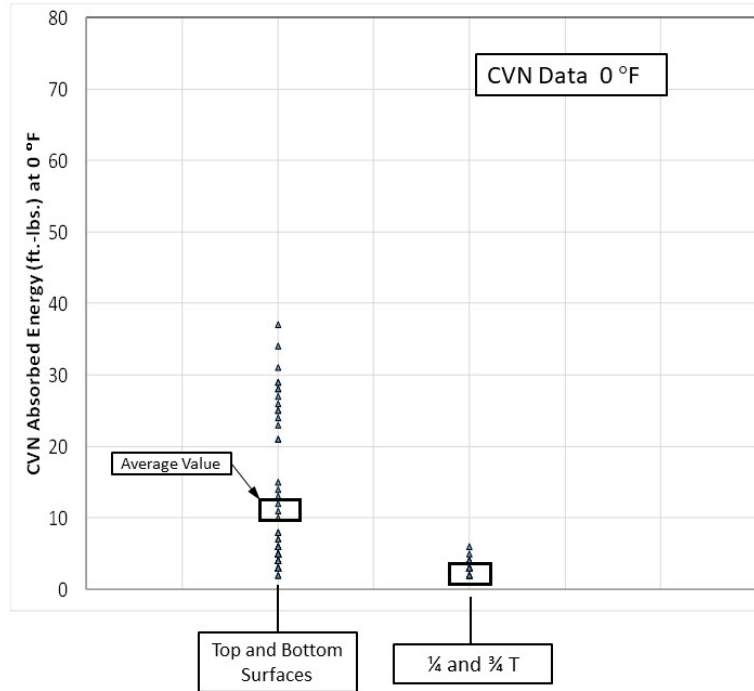
Figure 21 – CVN Data for Steel Samples Removed from Fremont Street Girders
Test Temperature = 70 °F (Data from LPI Report)

Figure 22 – CVN Data for Steel Samples Removed from Fremont Street Girders
Test Temperature = 30 °F (Data from LPI Report)

Figure 23 – CVN Data for Steel Samples Removed from Fremont Street Girders
 Test Temperature = 0 °F (Data from LPI Report)

Further, the CVN testing conducted by LPI showed a large variability in the measured CVN values. For example, the CVN values for mid-thickness samples taken from the Fremont Street girders ranged from 5 ft-lbs to 39 ft-lbs at 70 °F. This large variability calls into question whether three samples are adequate to properly assess CVN impact energy.

- That AISC 360 re-evaluate the standard quarter-thickness sampling location for CVN testing, considering the very low mid-thickness CVN values found in the fractured flanges of the TTC girders. Serious consideration should be given to changing the required sampling location to mid-thickness for details that may be susceptible to brittle fracture. This is analogous to the AISC requirement for special CVN testing of the core area of jumbo rolled sections;
- That AISC 360 re-evaluate the required number of CVN samples. The large variability in the measured CVN values seen in the TTC girders suggests that three samples may not be adequate to provide a statistically meaningful result; and
- That AISC 360 provide guidance on establishing CVN test temperatures for structures exposed to ambient temperatures, either during construction and/or during the service life of the structure.
