LPI, Inc. Consulting Engineers

*Advanced Analysis & Fitness for Service
Failure & Materials Evaluation
Nondestructive Engineering*

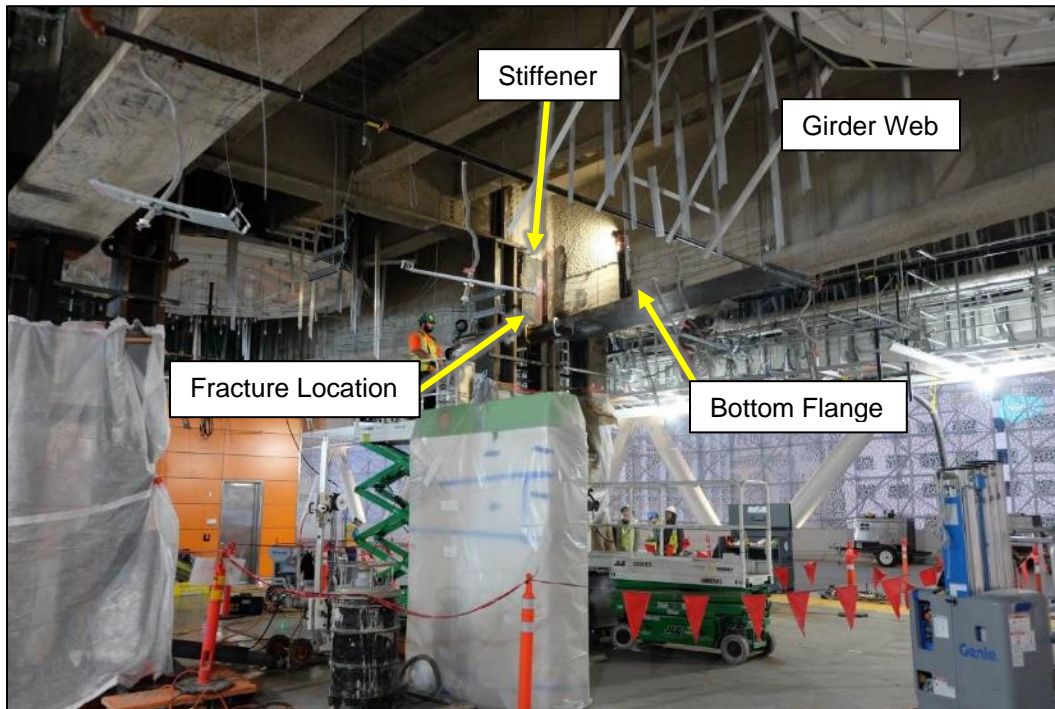
Fig. 1. Fractured girders above Fremont Street

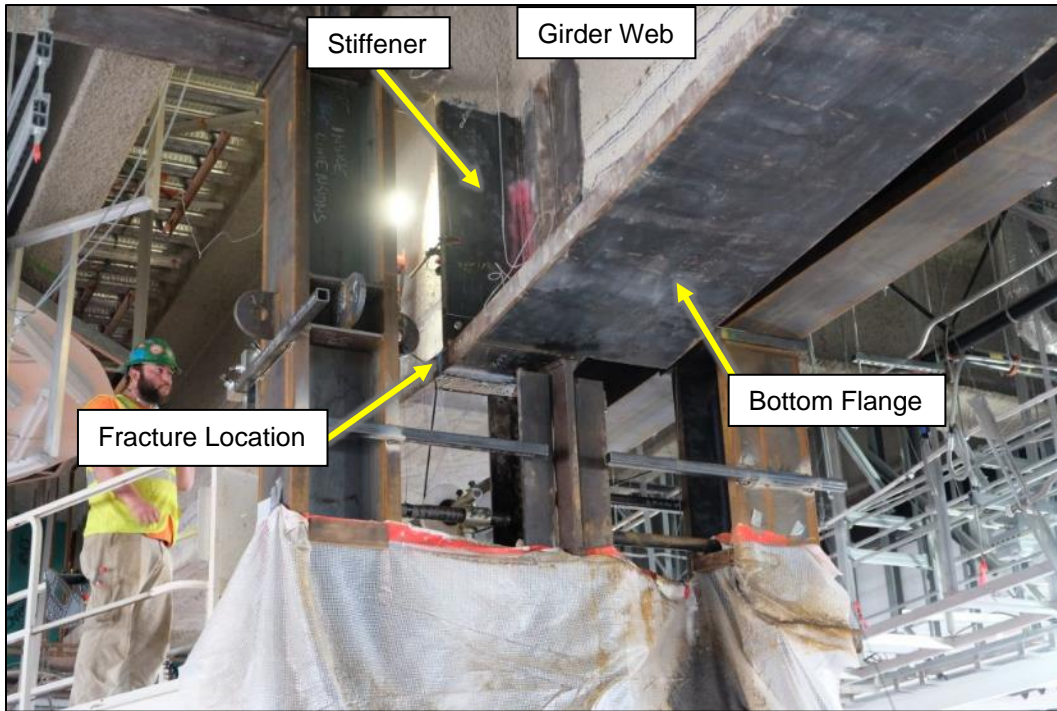
Fig. 2. North side girder flange fracture location above Fremont Street.

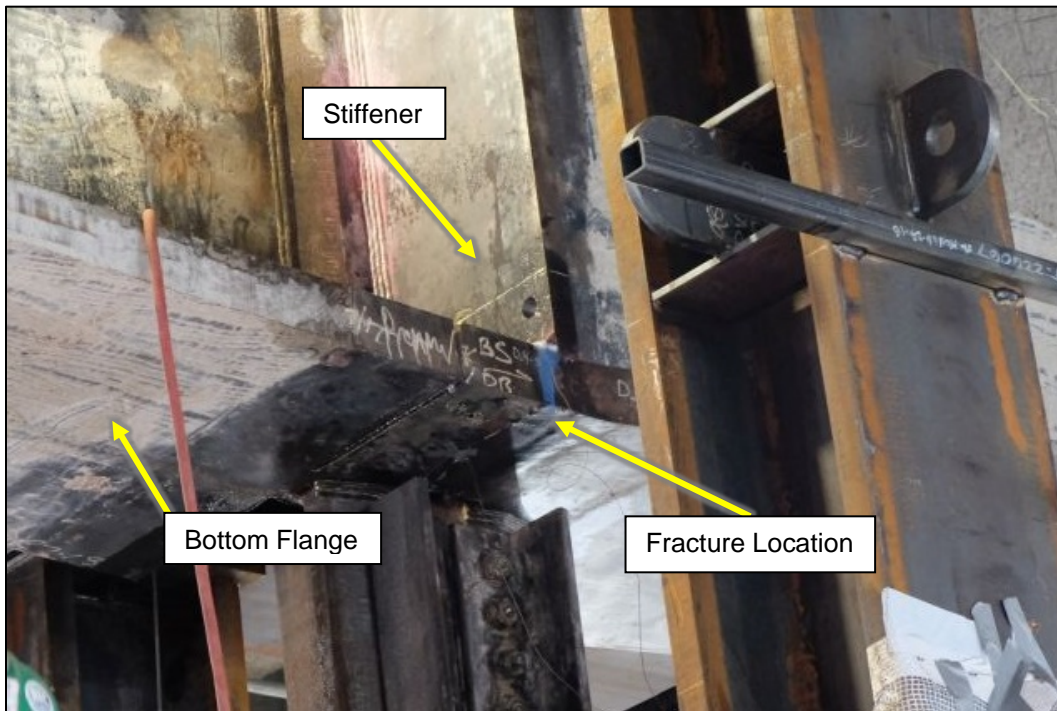
Fig. 3. Typical location of north side girder fracture, where the fracture was protected with silicone prior to flange sample removal.

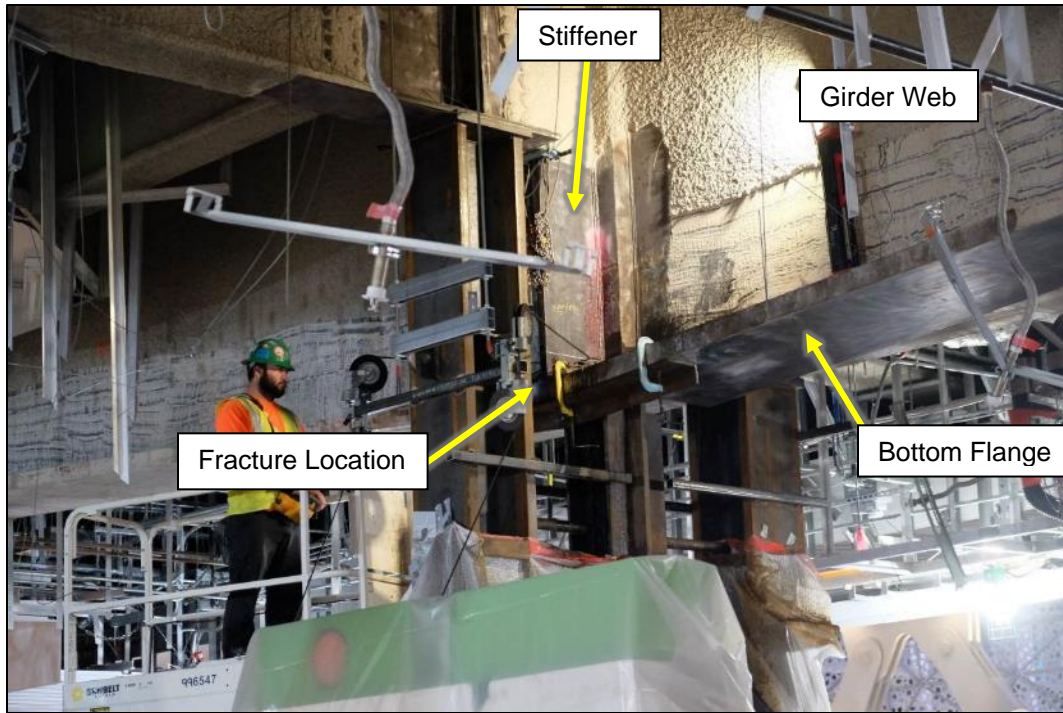
Fig. 4. Flange sample removal of the north side girder by wire cutting.

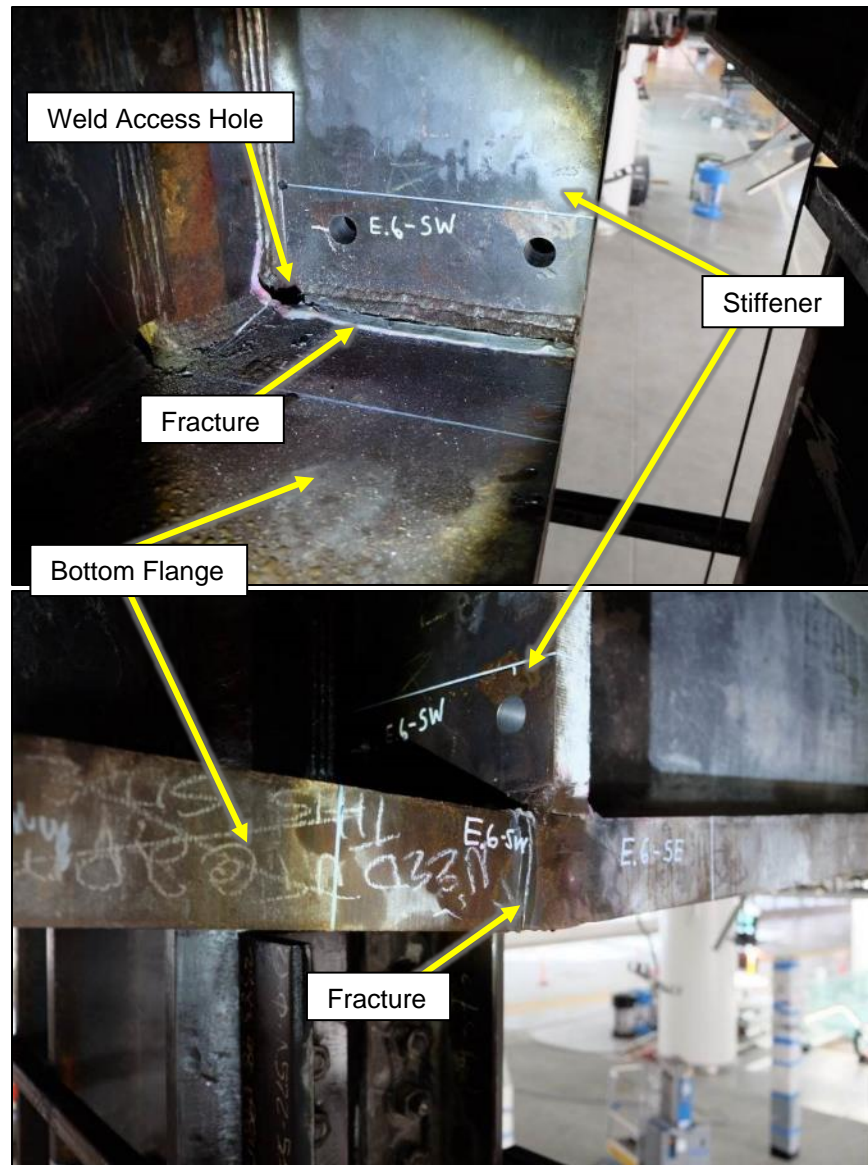
Fig. 5. South side girder fracture, where the fracture was protected with silicone prior to flange sample removal.

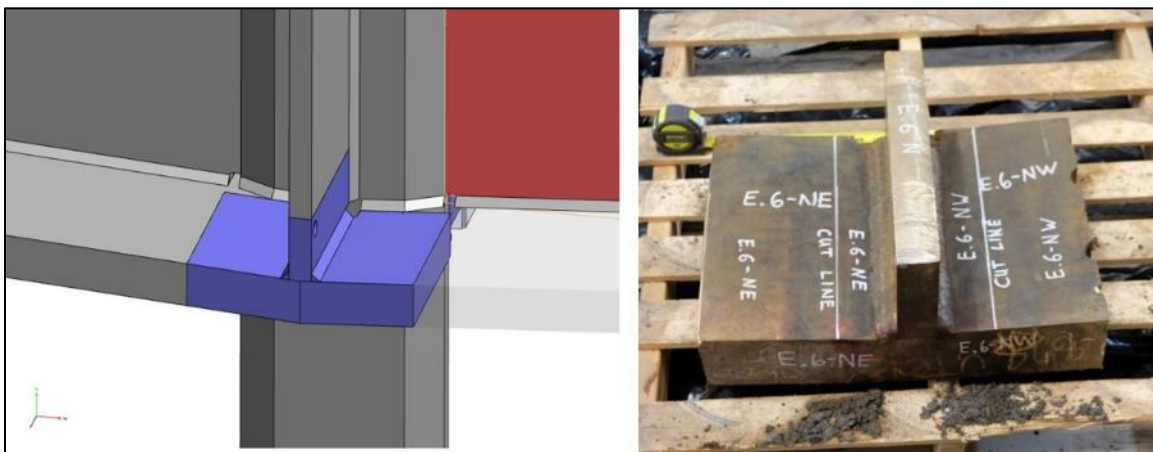
Fig. 6. Girder model (left) showing girder sample geometry and location. Typical girder sample after removal (right).

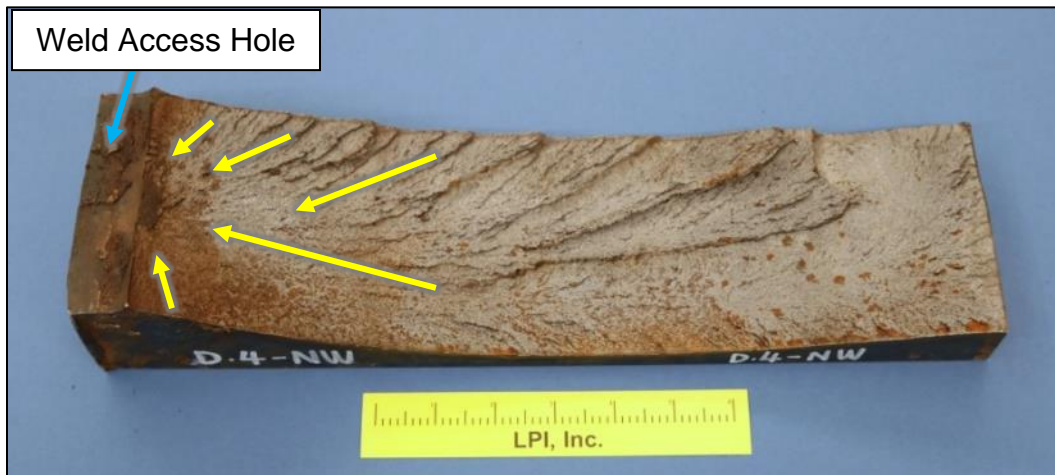
Fig. 9. Chevron marks (yellow arrows) on the fracture surface of girder sample D.4-NW reveal the fracture origin to be adjacent to the weld access hole.

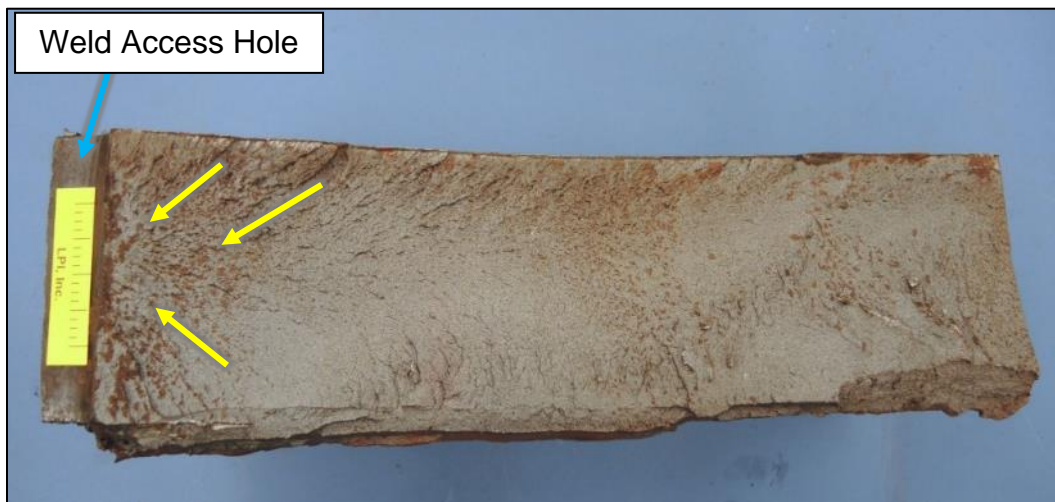
Fig. 10. Chevron marks (yellow arrows) on the fracture surface of girder sample D.4-SW pointing towards the origin at the edge of the weld access hole.

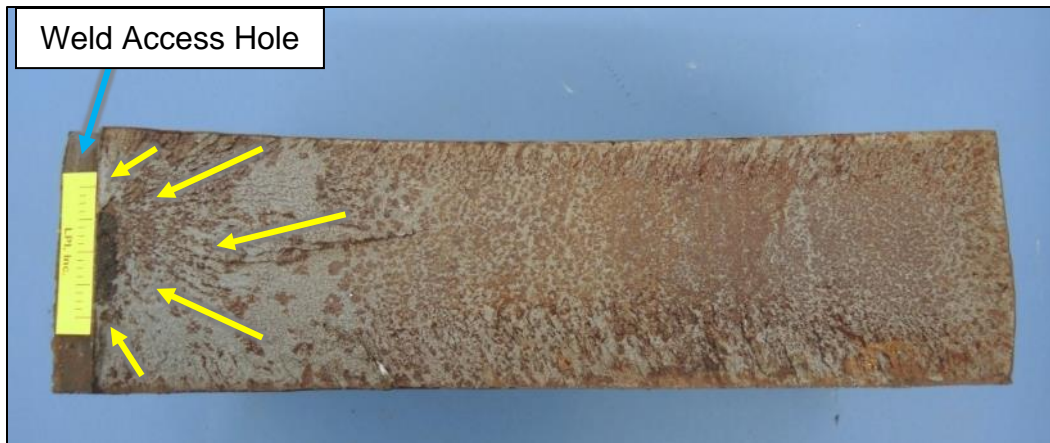
Fig. 11. Chevron marks (yellow arrows) on the fracture surface of girder sample E.6-SW pointing towards the origin at the edge of the weld access hole.

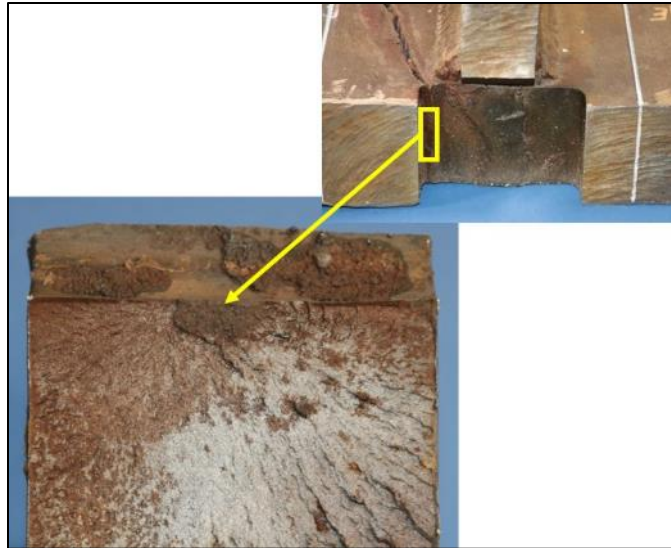
Fig. 12. Dark oxide covered elliptical pop-in crack fracture origin at the weld access hole (top) of girder sample D.4-NW.

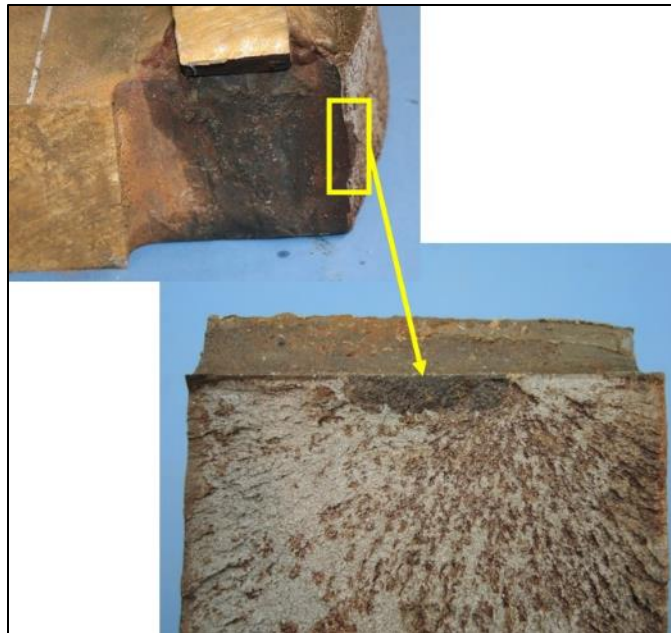
Fig. 13. Dark oxide covered elliptical pop-in crack fracture origin at the weld access hole (top) of girder sample E.6-SW.

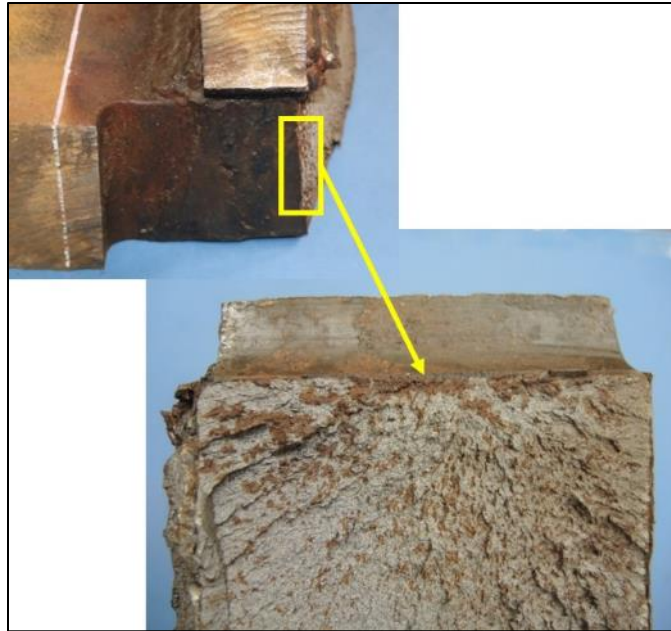
Fig. 14. Dark oxide covered narrow band microcrack fracture origin at the weld access hole (top) of girder sample D.4-SW.

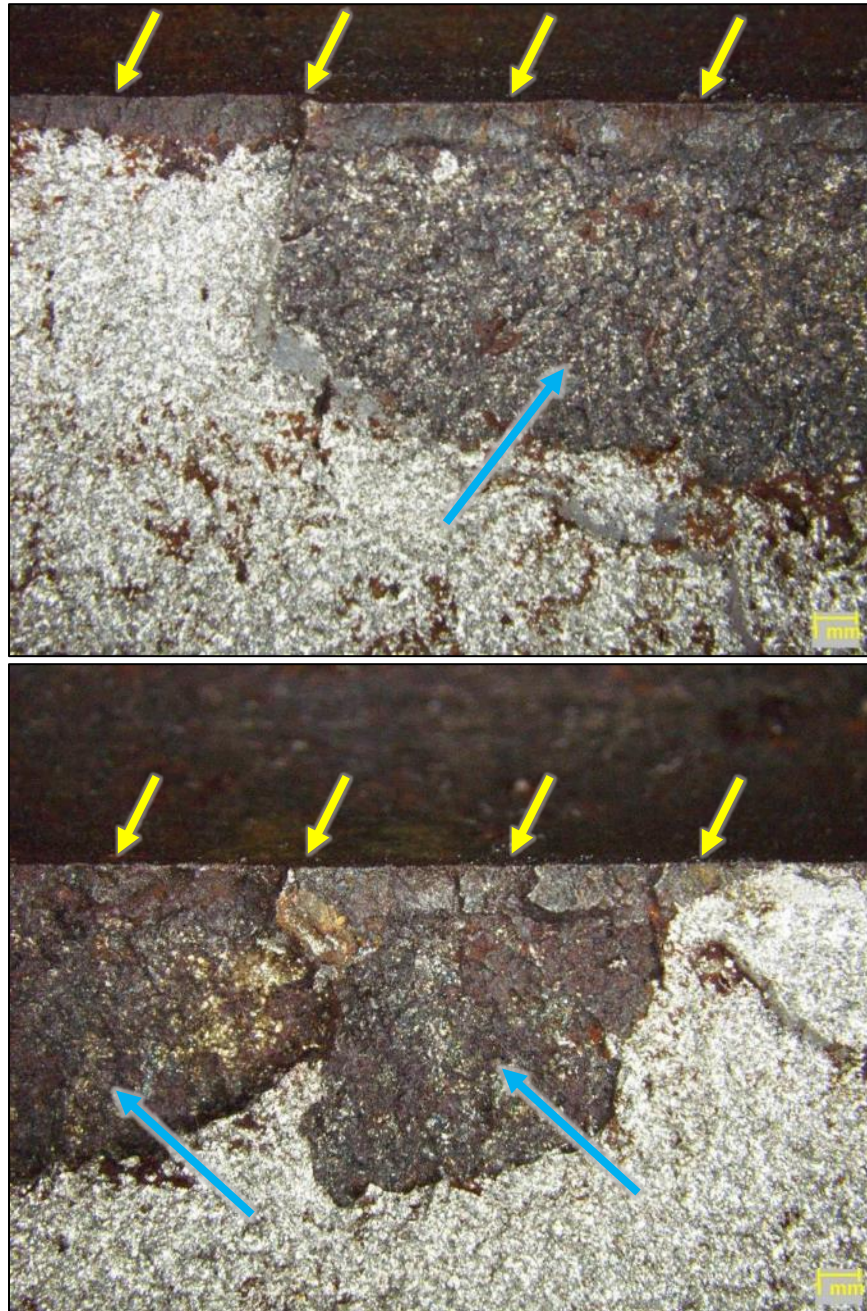
Fig. 15. Origin of D.4-NW exhibited narrow band microcracks (yellow arrows) at the edge to the weld access hole with a tenacious dark oxide layer. The elliptical crack (blue arrows) “popped-in” from the microcracks and exhibited a dark oxide layer that was partially removed after cleaning.

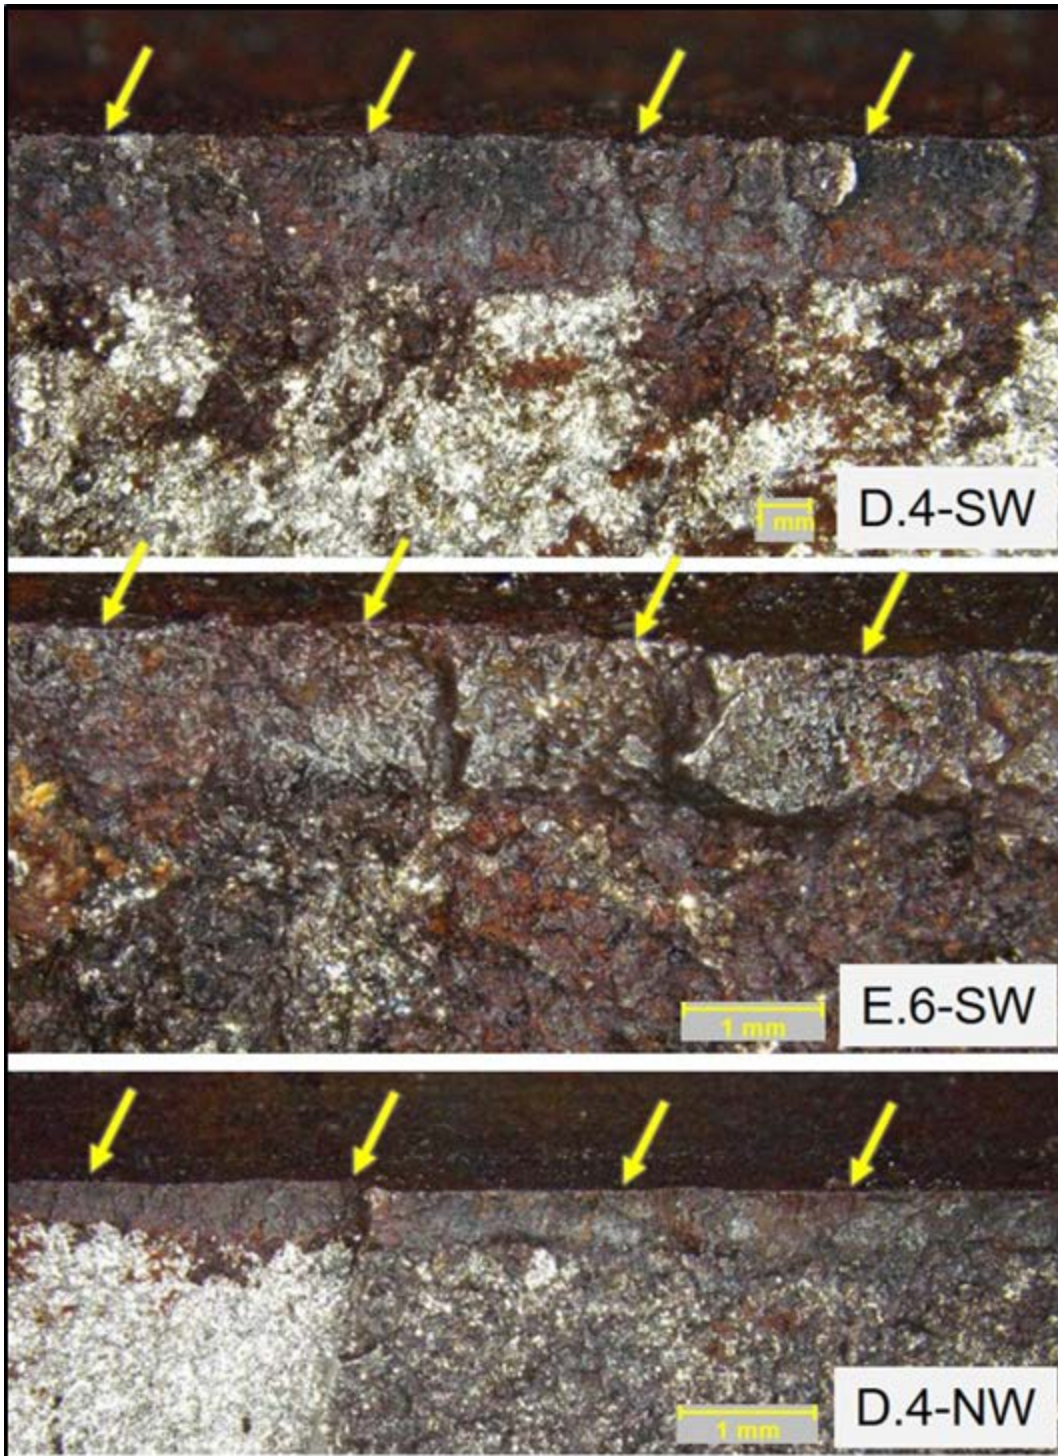
Fig. 16. Fracture origins of samples D.4-SW (top), E.6-SW (center) and D.4-NW (bottom) showing microcracks that initiated during thermal cutting of the access holes.

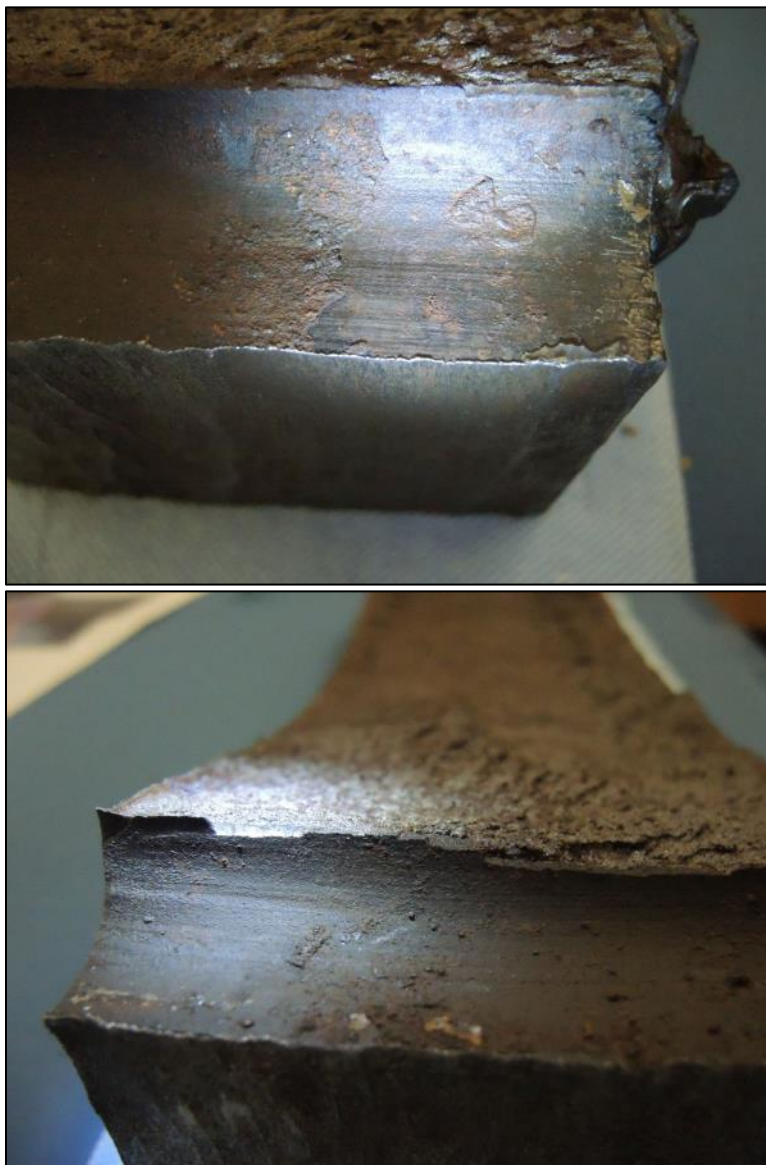
Fig. 17. Weld access hole surfaces in samples D.4-SW (top) and E.6-SW (bottom).

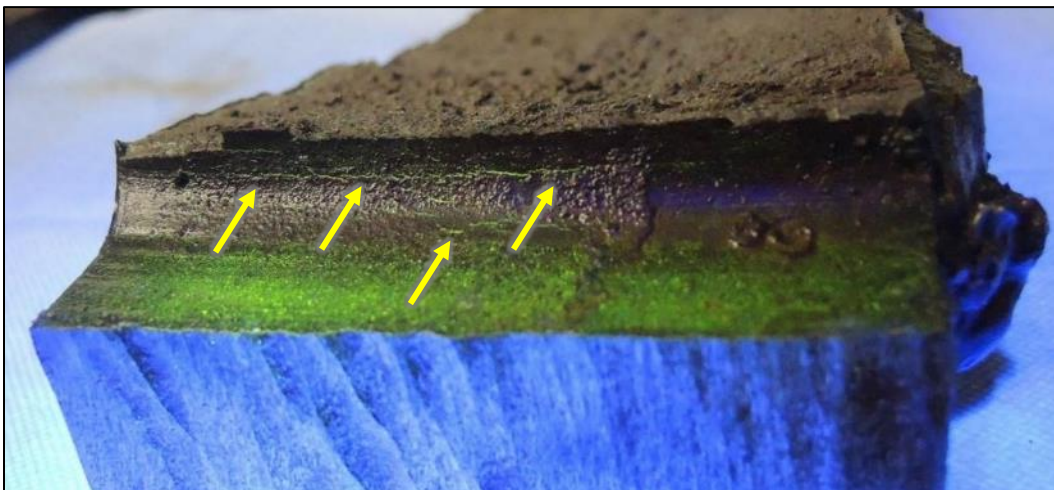
Fig. 18. Cracking in the radius of the thermally cut access hole surface of sample D.4-SW, as identified by fluorescent magnetic particle testing.

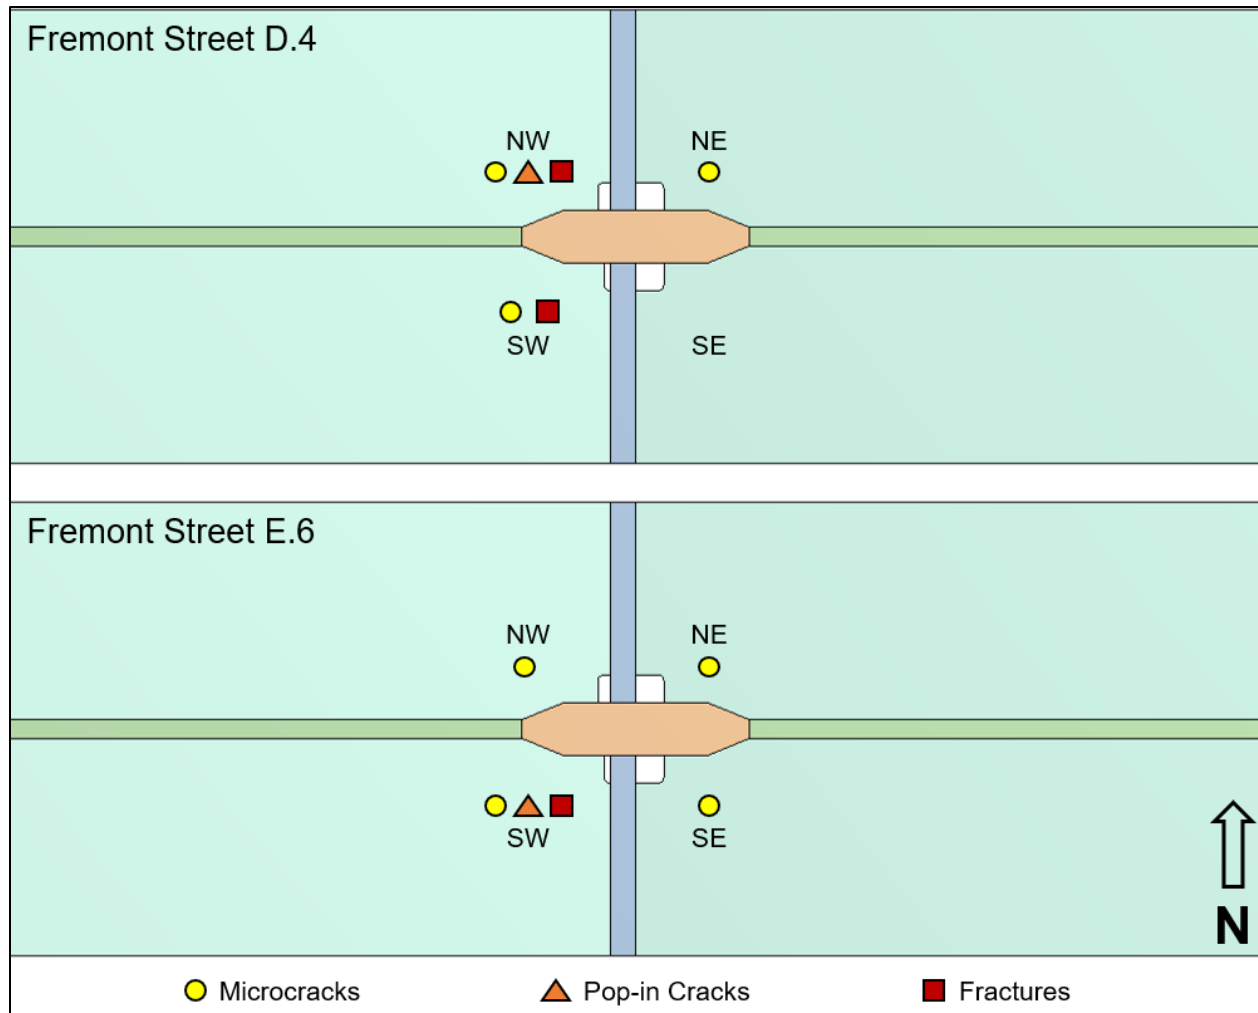
Fig. 19. Summary of observed cracking and fractures. Diagram is generic and not representative of actual weld access hole dimensions. The thin, blue rectangles perpendicular to the orange hangers are the centerline stiffeners.

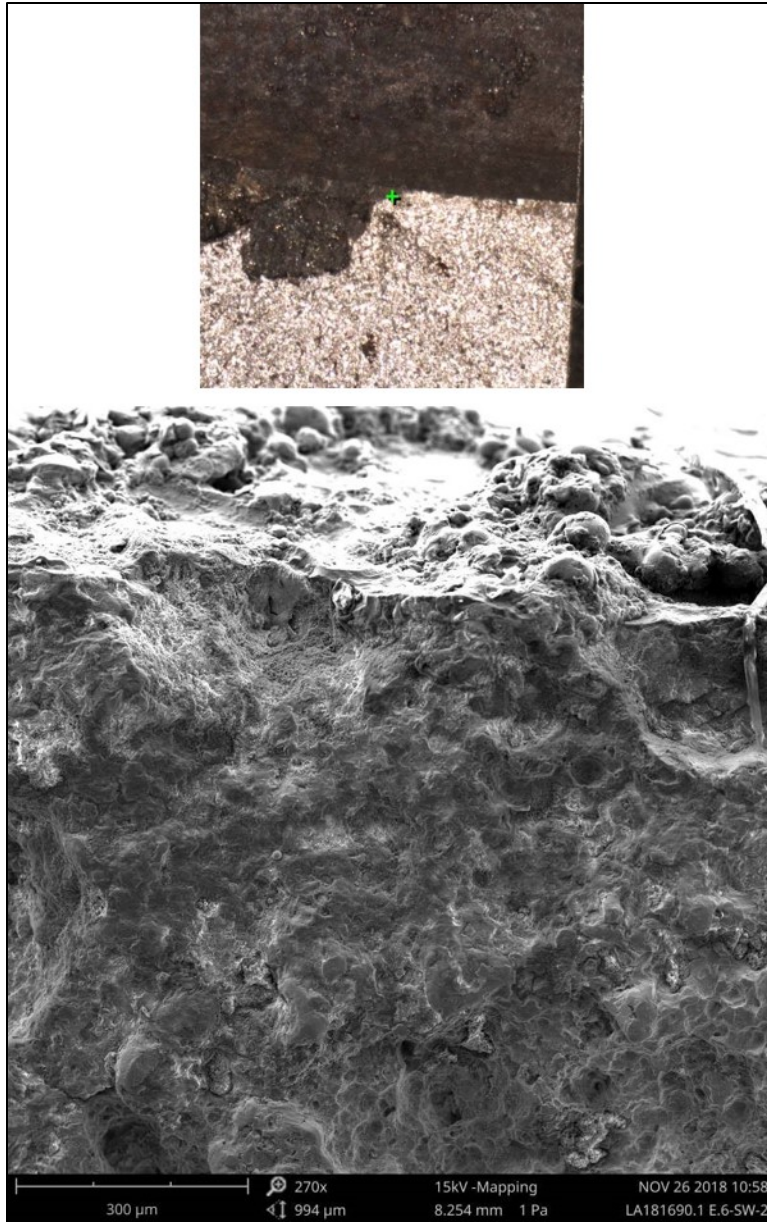
Fig. 20. Oxide covered microcrack fracture origin after cleaning of sample E.6-SW.

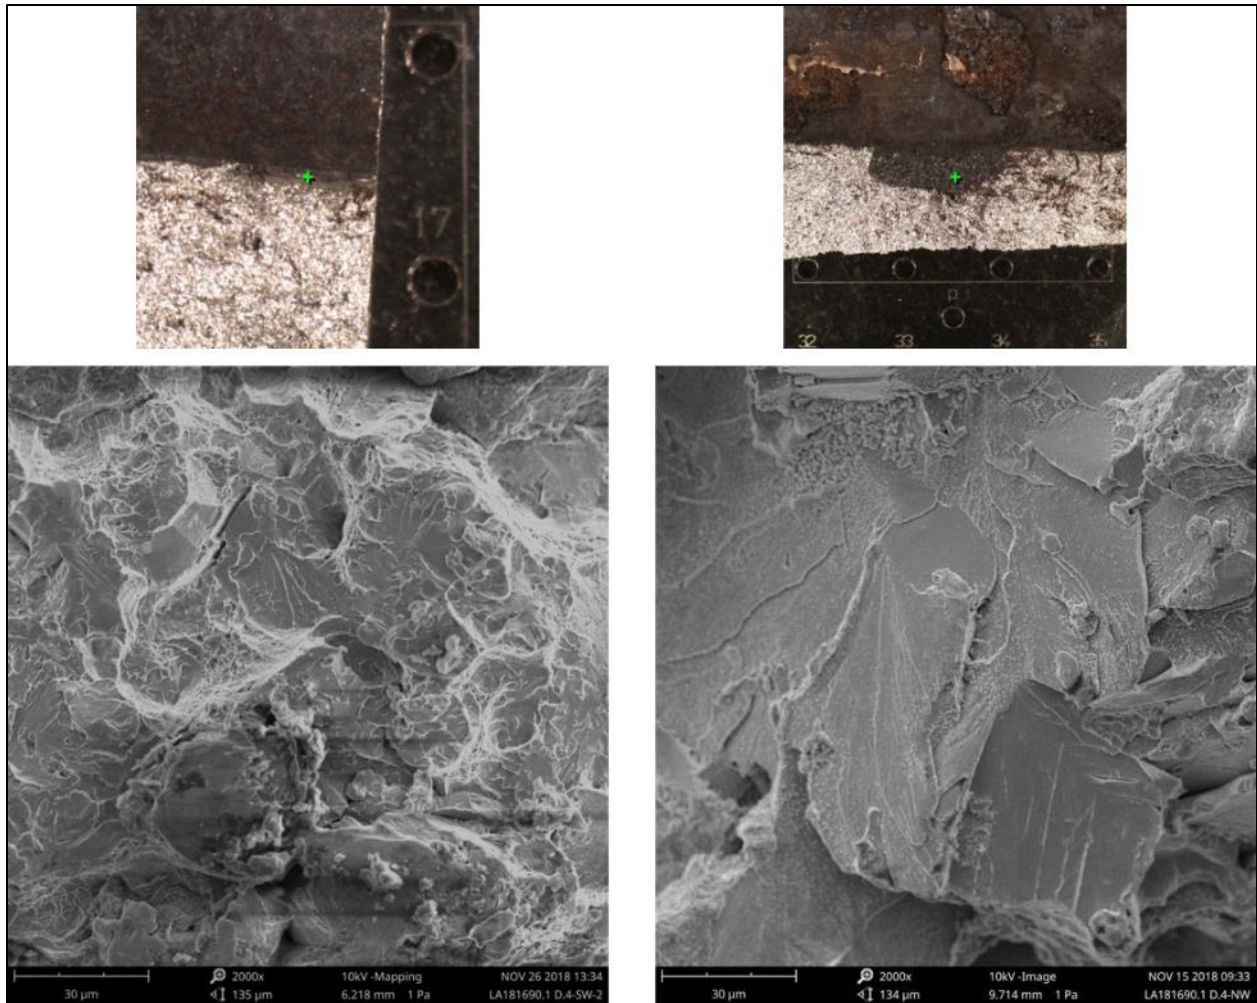
Fig. 21. (Left) Typical SEM image of microcrack fracture after cleaning in sample D.4-SW exhibiting a low-energy cleavage fracture morphology. (Right) Typical SEM image of elliptical pop-in crack fracture in sample D.4-NW exhibiting a low-energy cleavage fracture morphology.

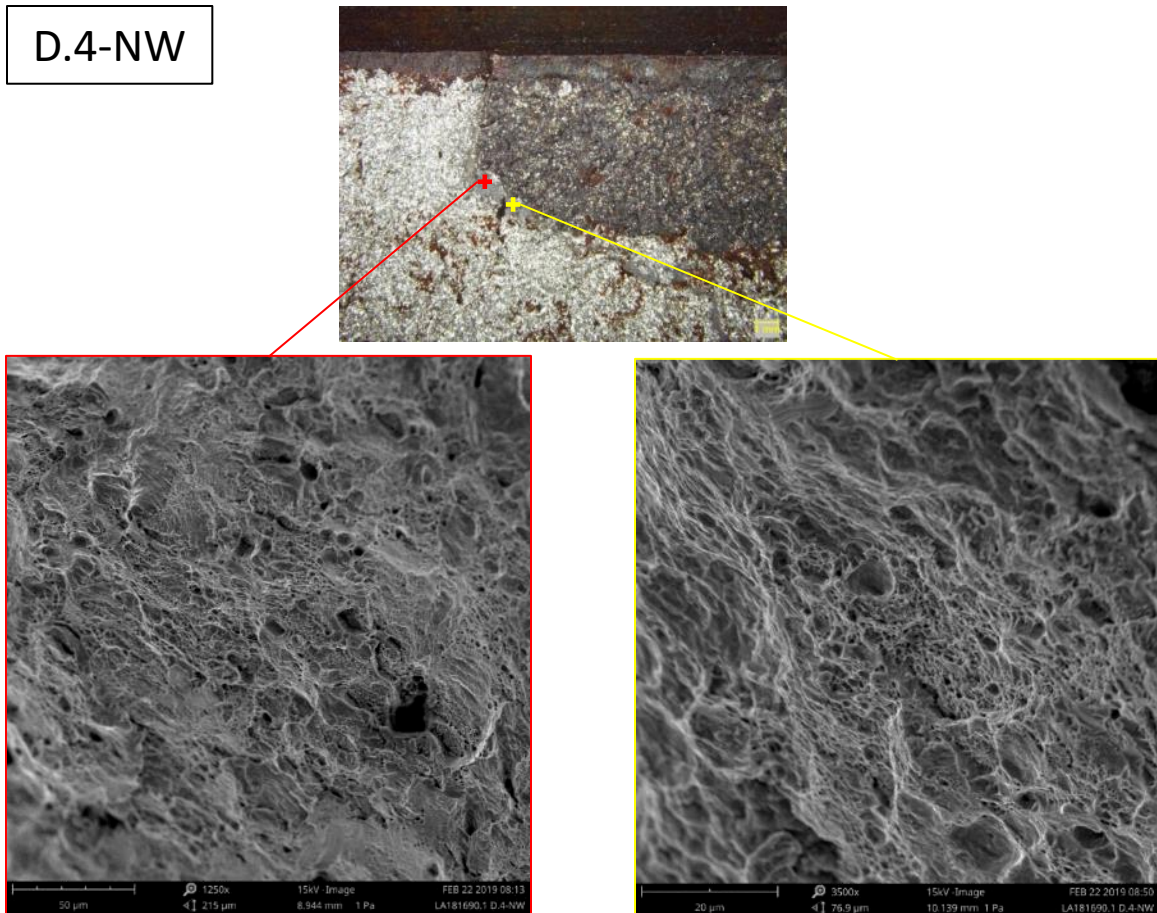
Fig. 22. SEM images at the leading edge of oxidized elliptical crack in girder sample D.4-NW showing a narrow band of microvoid coalescence.

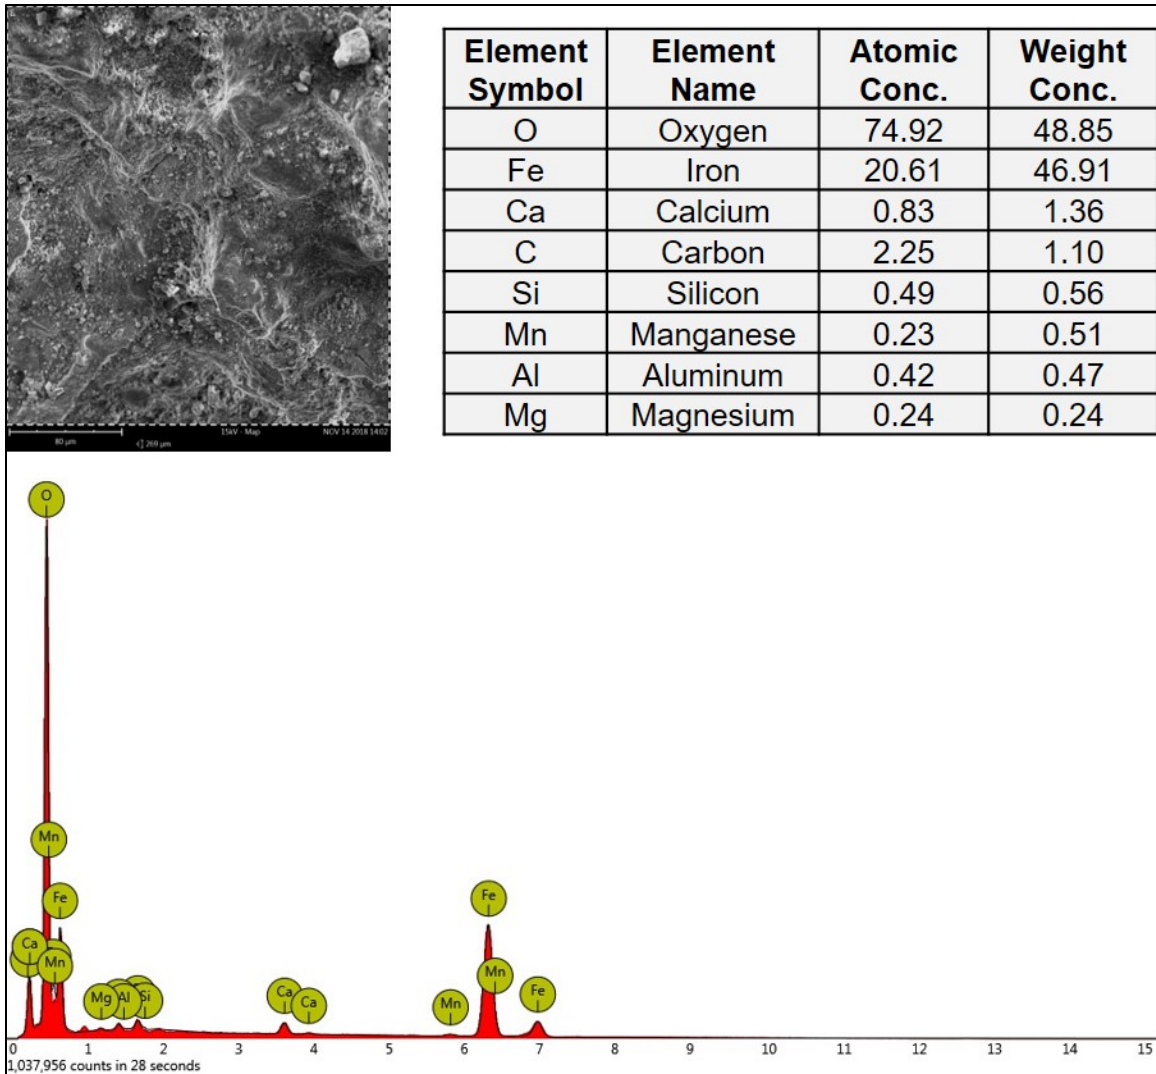
Fig. 23. EDS results from the fracture origin of sample E.6-SW.

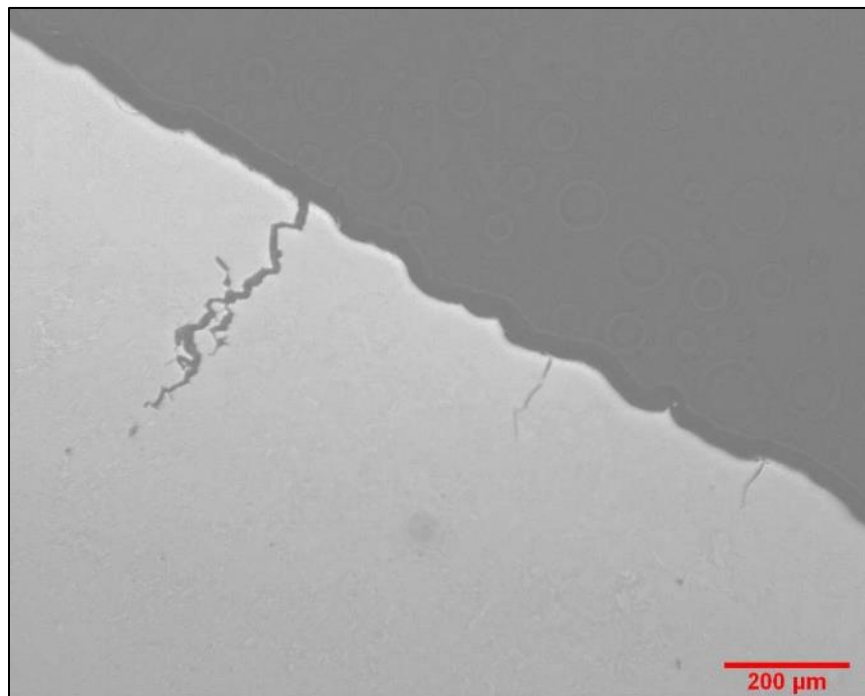
Fig. 24. Multiple secondary, oxide-filled microcracks in the weld access radius of sample D.4-SW.

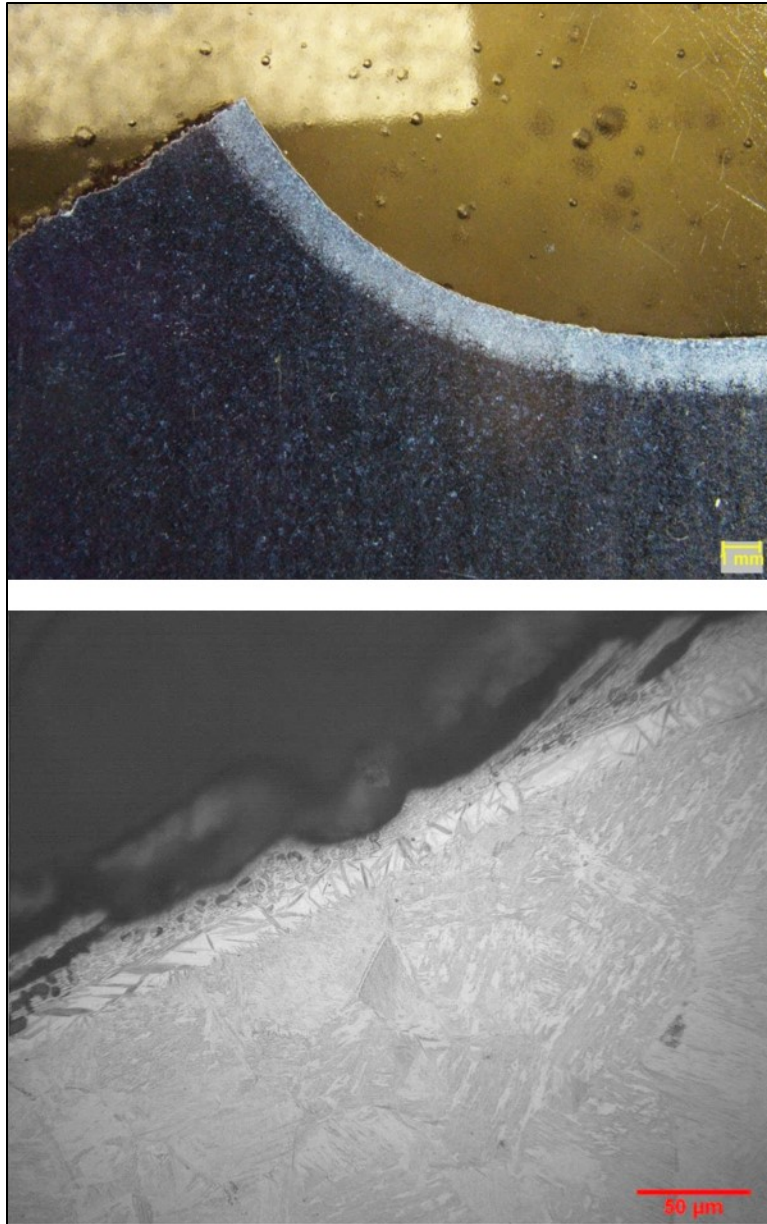
Fig. 26. Martensitic layer at the weld access hole radius of sample E.6-SW (fractured side). The martensitic layer appears as the lighter-etching band in the stereomicroscopic image at the top. The bottom metallographic image shows the martensitic structure within the white band.

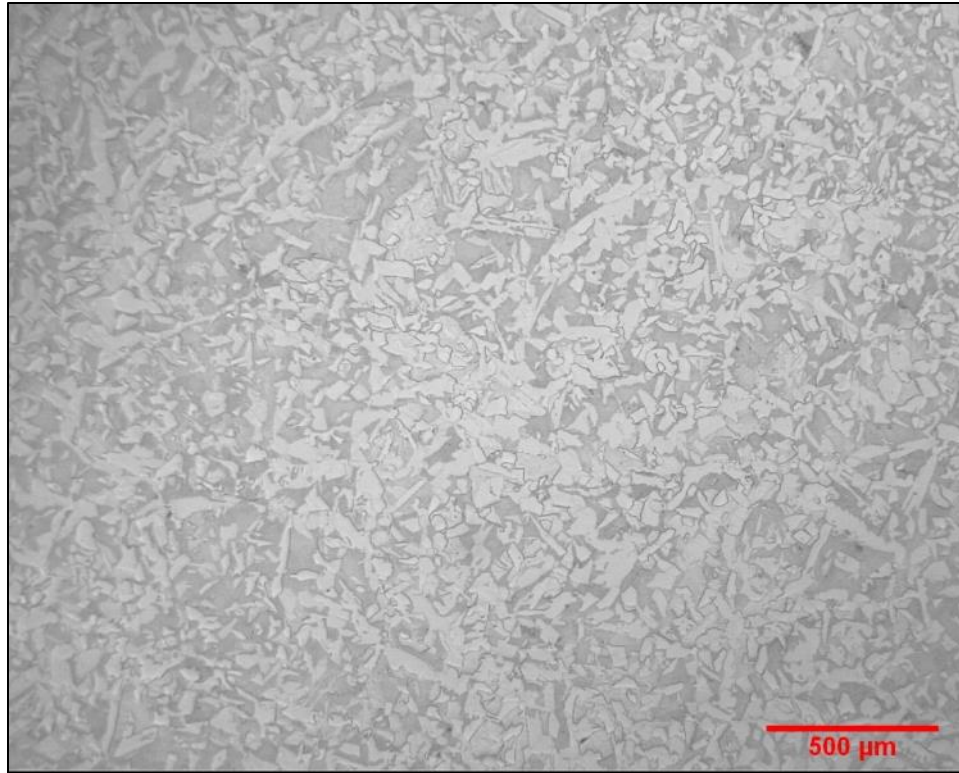
Fig. 27. Fine grained ferrite (bright) and pearlite (dark) grain structure for the flange steel plate of sample D.4-SW.

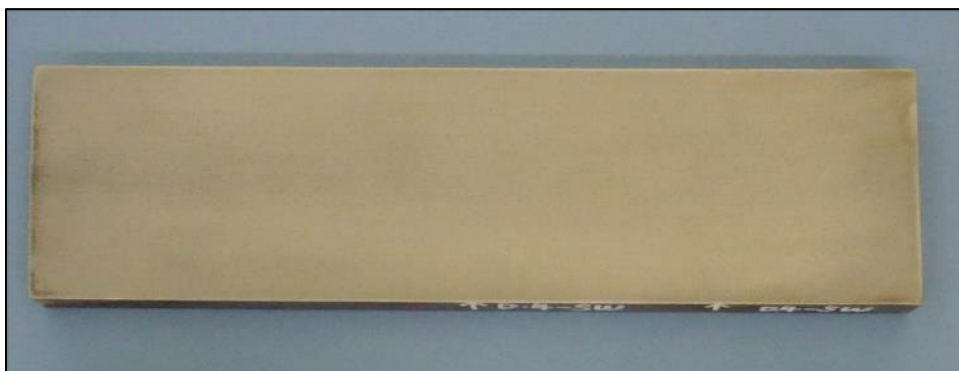
Fig. 28. Macro-section from girder samples D.4-SW.

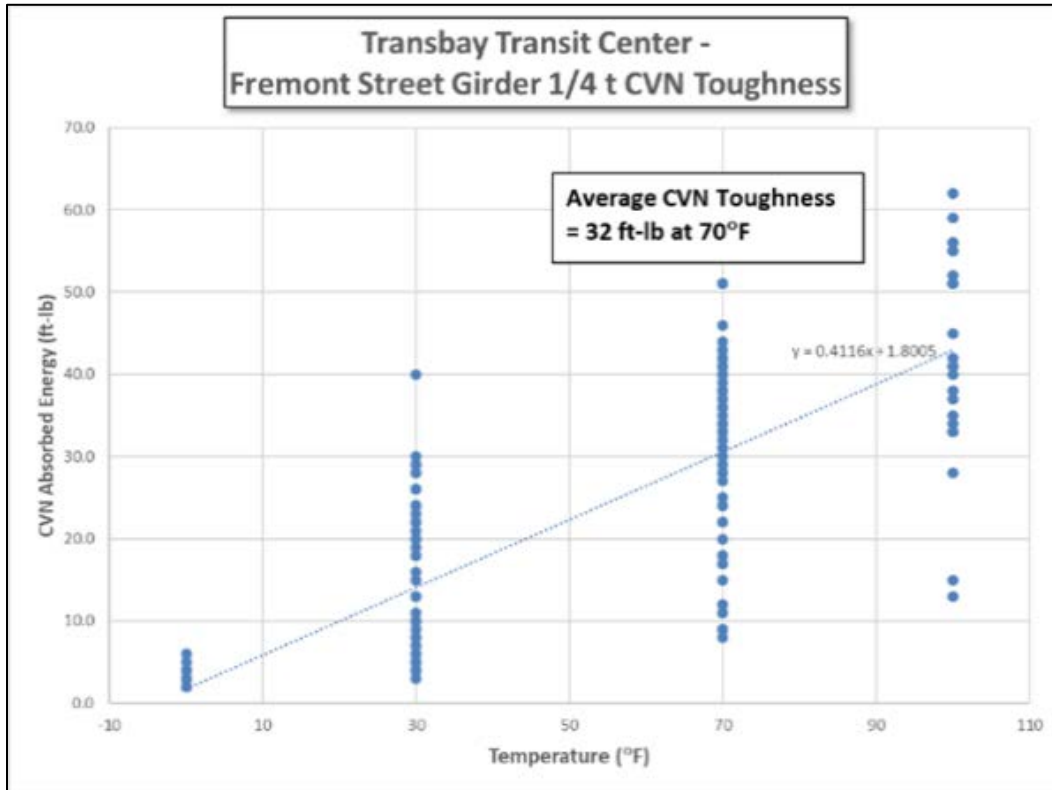
Fig. 29 Fremont Street CVN absorbed energy results for the ¼ - ¾ t location as a function of temperature.

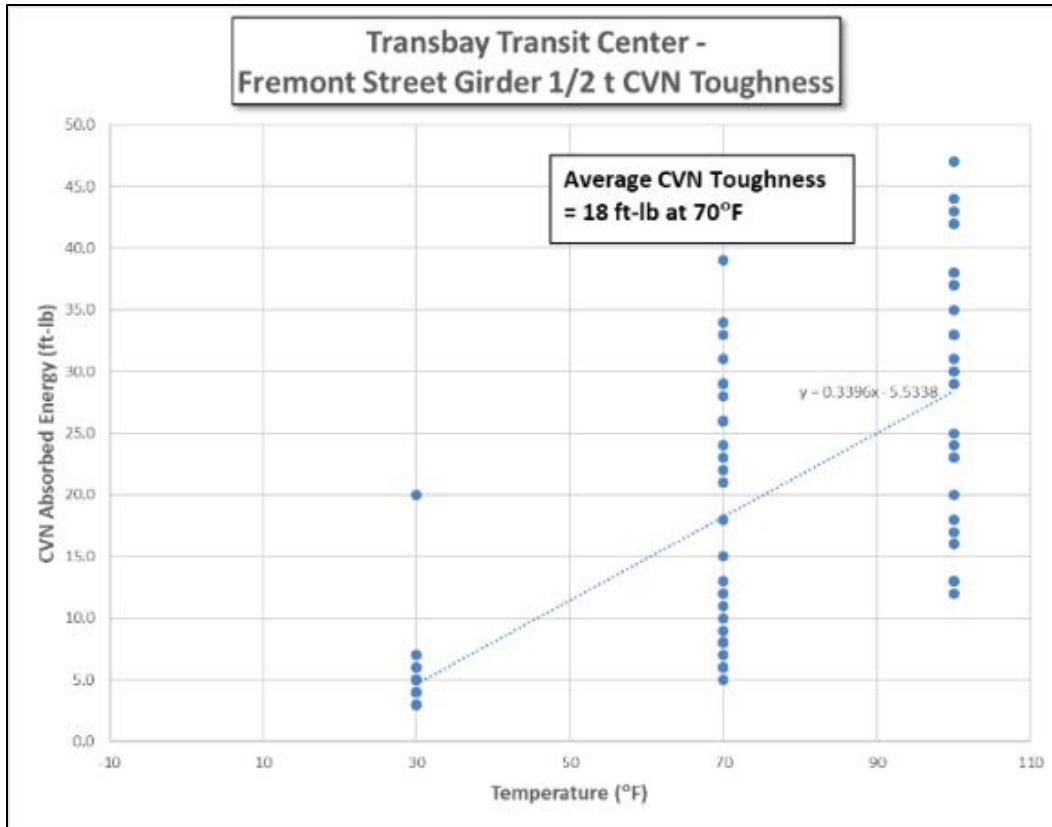
Fig. 30 Fremont Street CVN absorbed energy results for the 1/2 t location as a function of temperature.

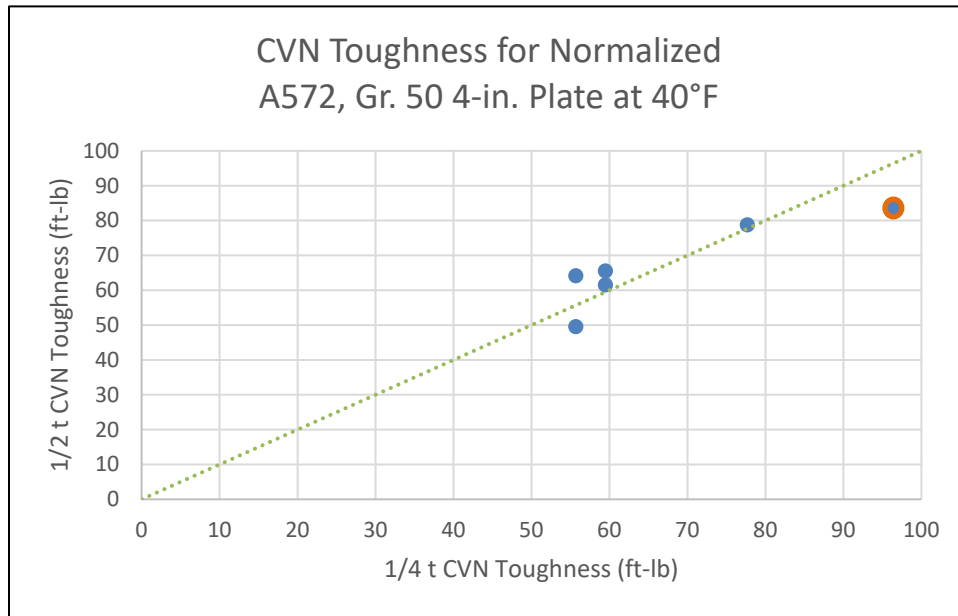
Fig. 31. Relationship between 1/4 t and 1/2 t CVN toughness levels for normalized A572, Gr. 50, structural steel.
