LPI, Inc. Consulting Engineers

*Advanced Analysis & Fitness for Service
Failure & Materials Evaluation
Nondestructive Engineering*

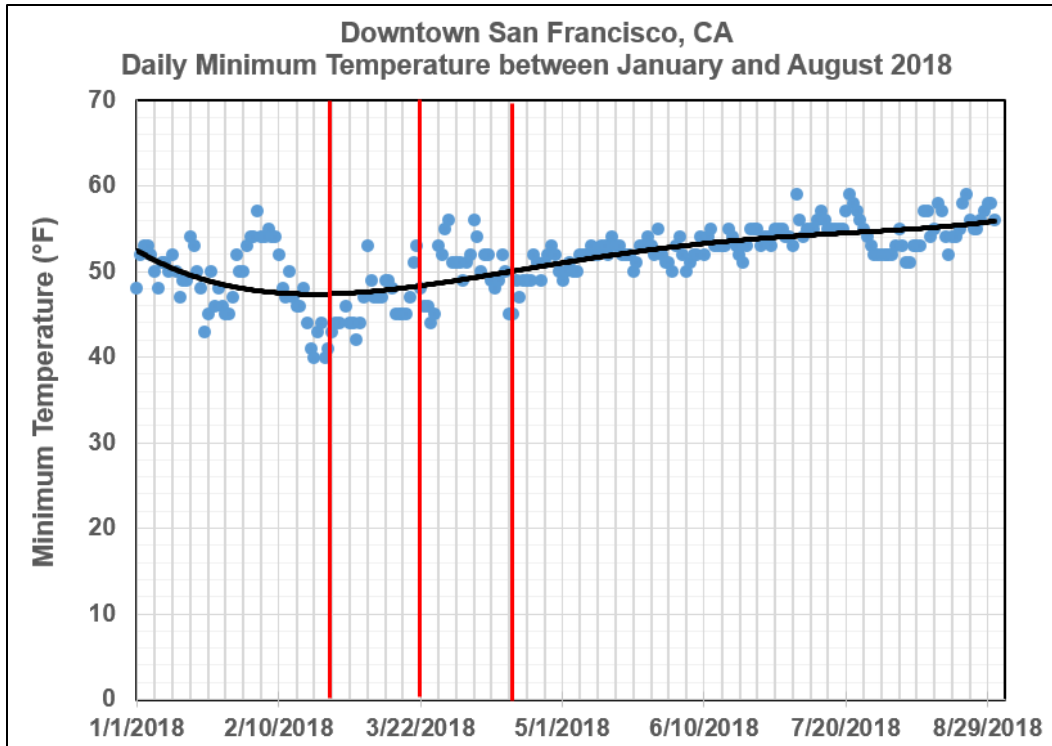
Fig. 32. Daily minimum temperatures in San Francisco, CA, between January and August 2018. A fourth-order polynomial regression is shown with the black line, and the red lines indicate clusters of low-temperature days.

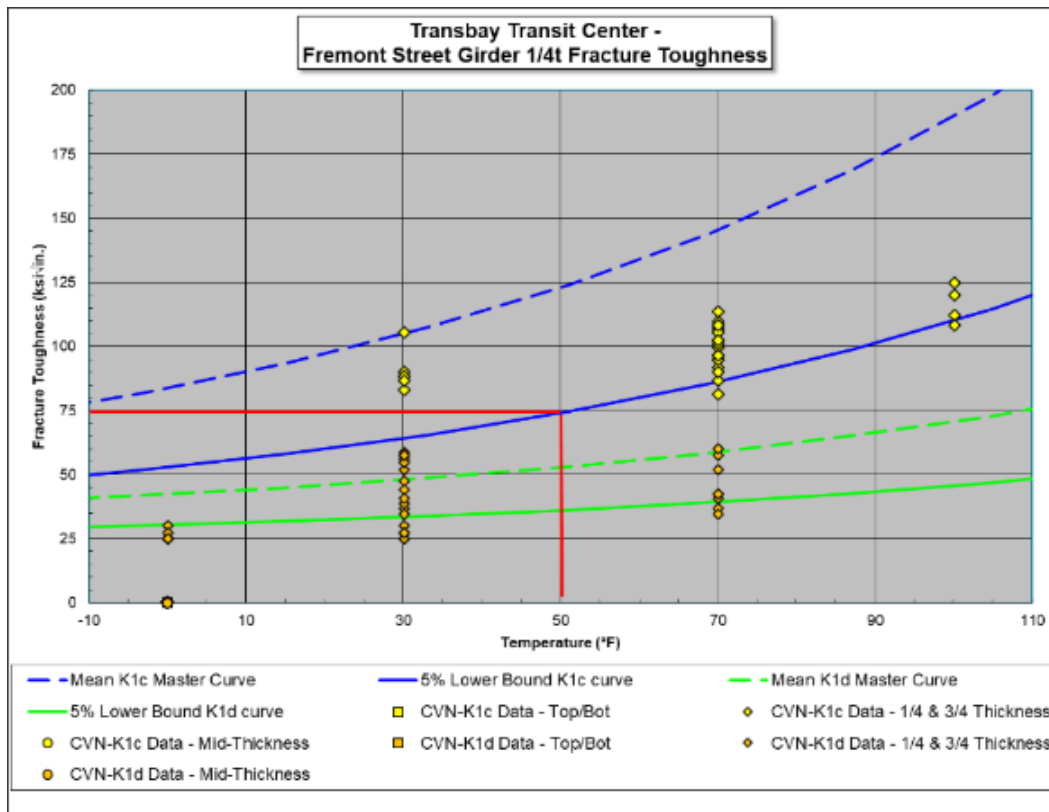
Fig. 33 Flange fracture toughness at the ¼ t location.

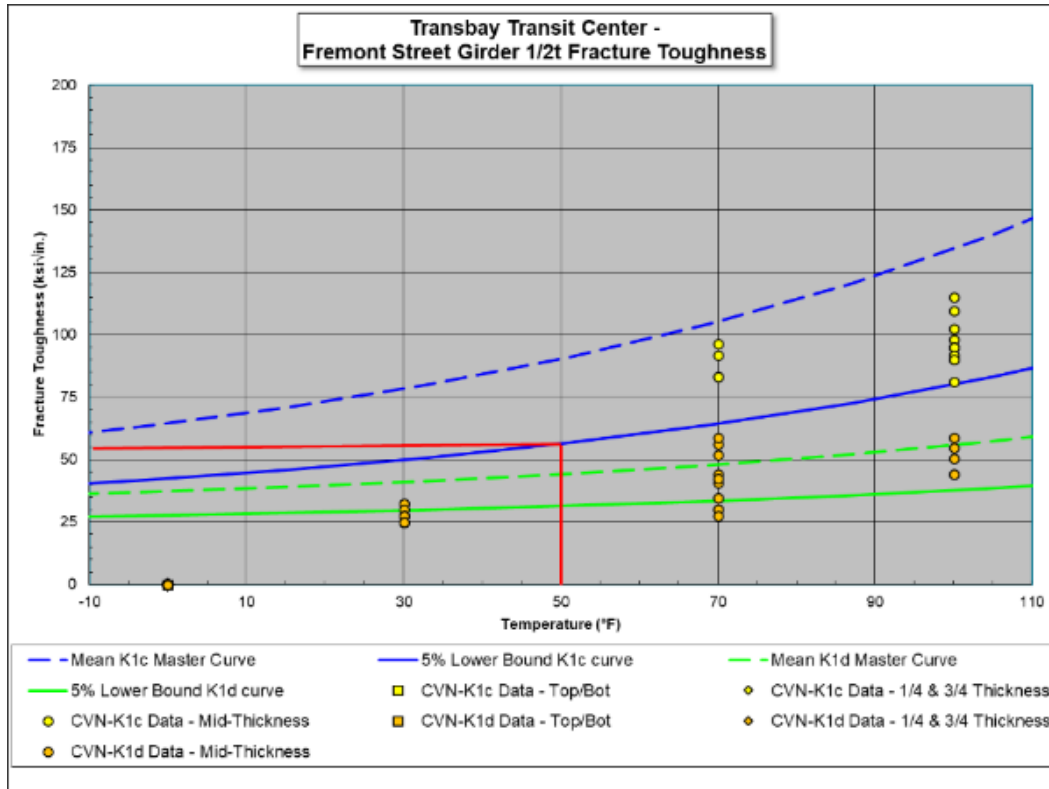
Fig. 34 Flange fracture toughness at the 1/2 t location.

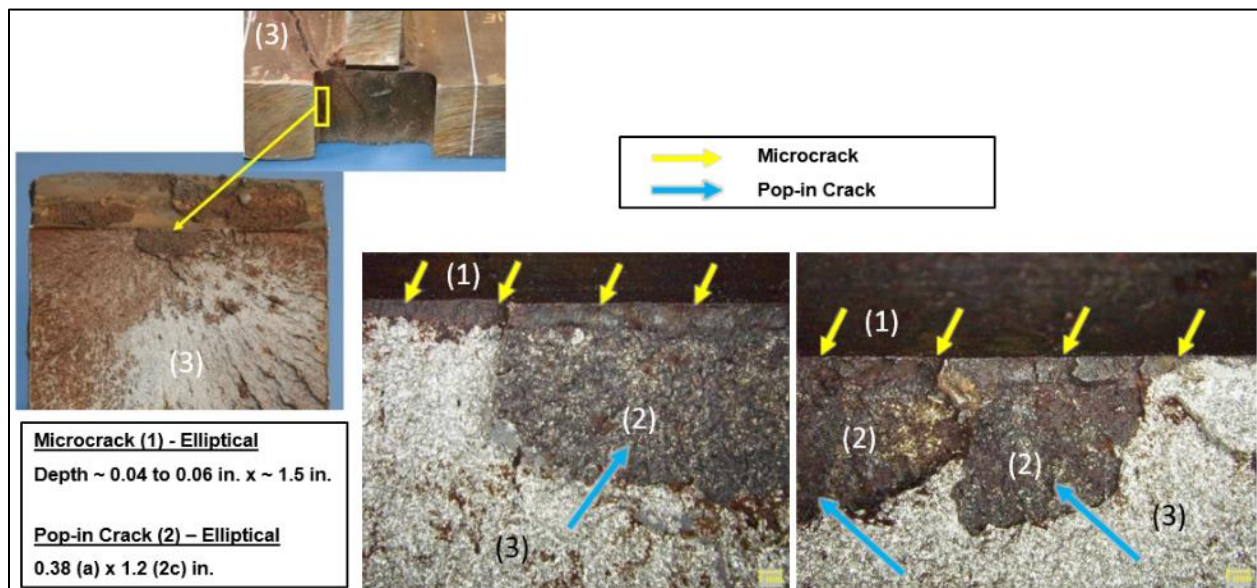
Fig. 35. Fremont Street D.4 girder fracture features: (1) microcracks, (2) pop-in crack, and (3) bottom flange fracture.

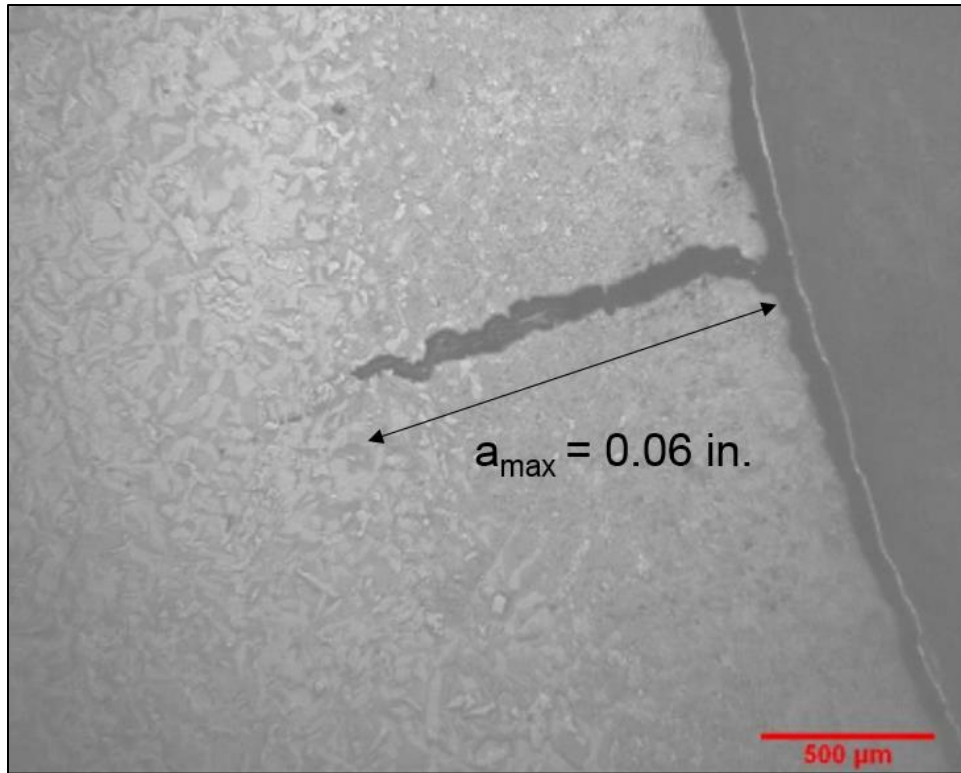
Fig. 36. Cross-sectional view of a weld access hole microcrack with the maximum depth shown for reference.

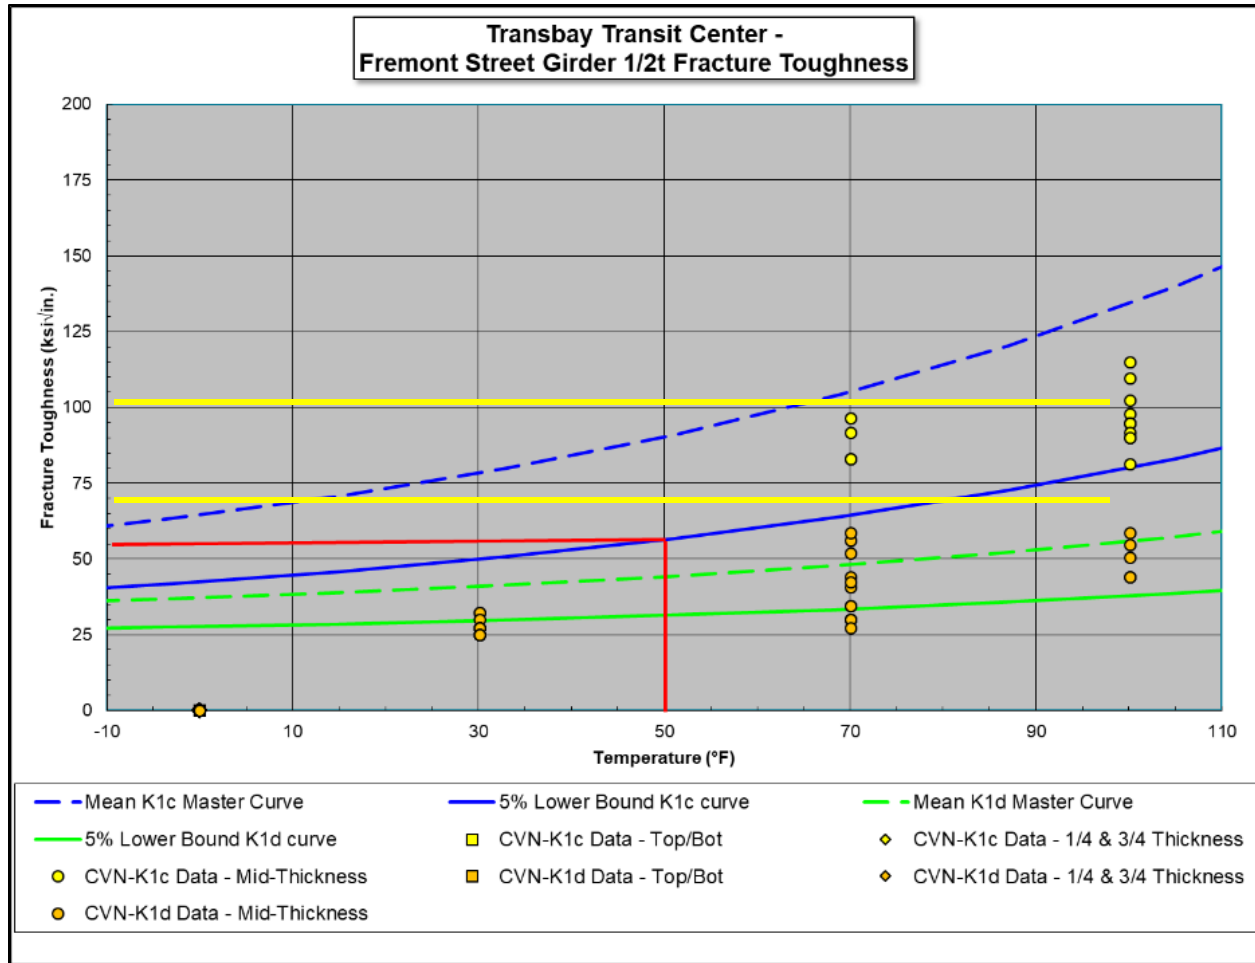
Fig. 37. Fracture toughness data at 1/2 t. The toughness at 50°F is approximately 55 to 60 ksin. (red lines) and the upper shelf fracture toughness is in the range of 70 to 100 ksin. (yellow lines).

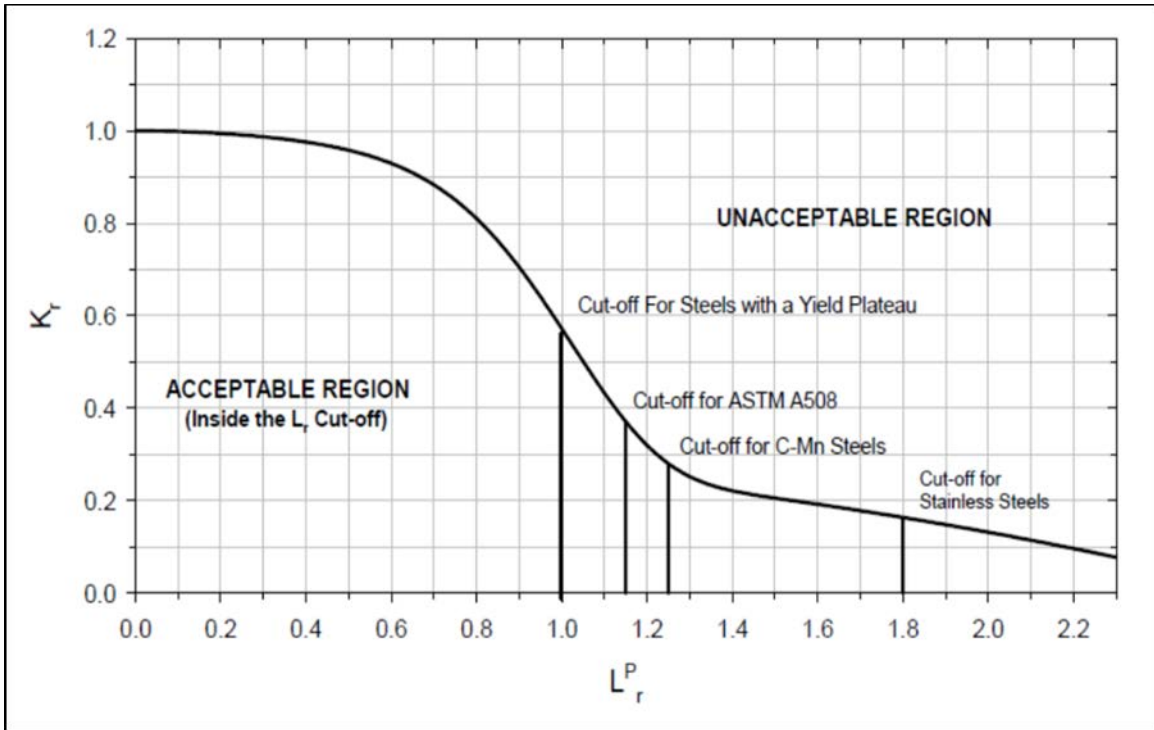
Fig. 38 Failure Assessment Diagram (FAD) from API 579-1/ASME FFS-1 [10]

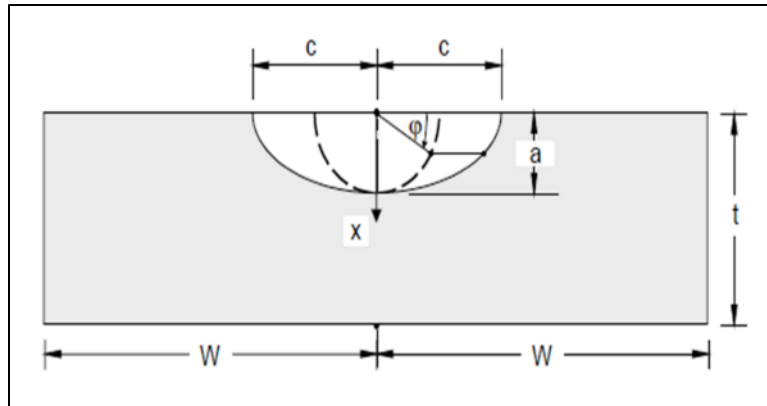
Fig. 39 Geometric representation of a surface-breaking elliptical crack in a plate. In this case, 2W corresponds to the flange thickness and t to the flange width.

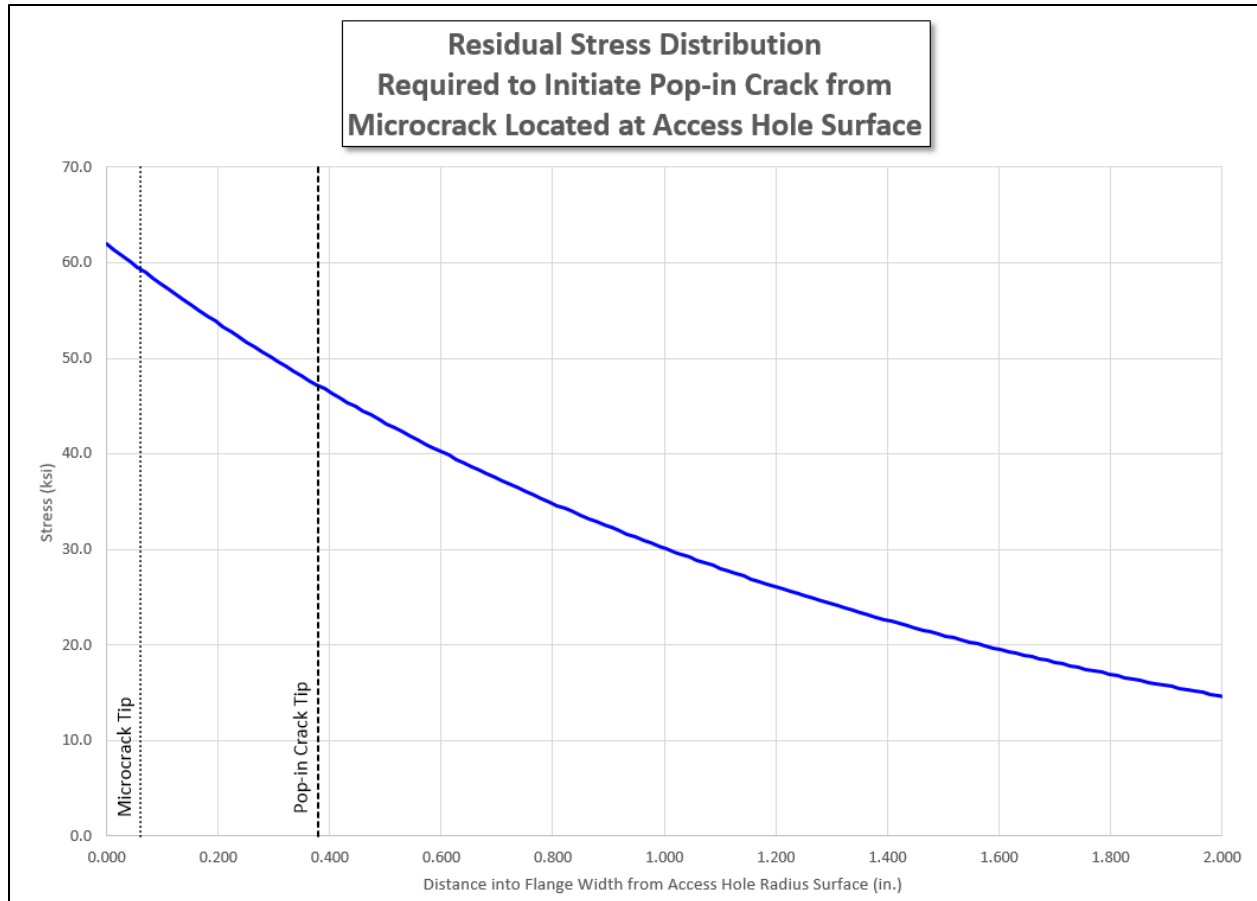
Fig. 40. Approximate residual stress distribution necessary to cause pop-in crack initiation at a fracture toughness of approximately 30 ksivin.

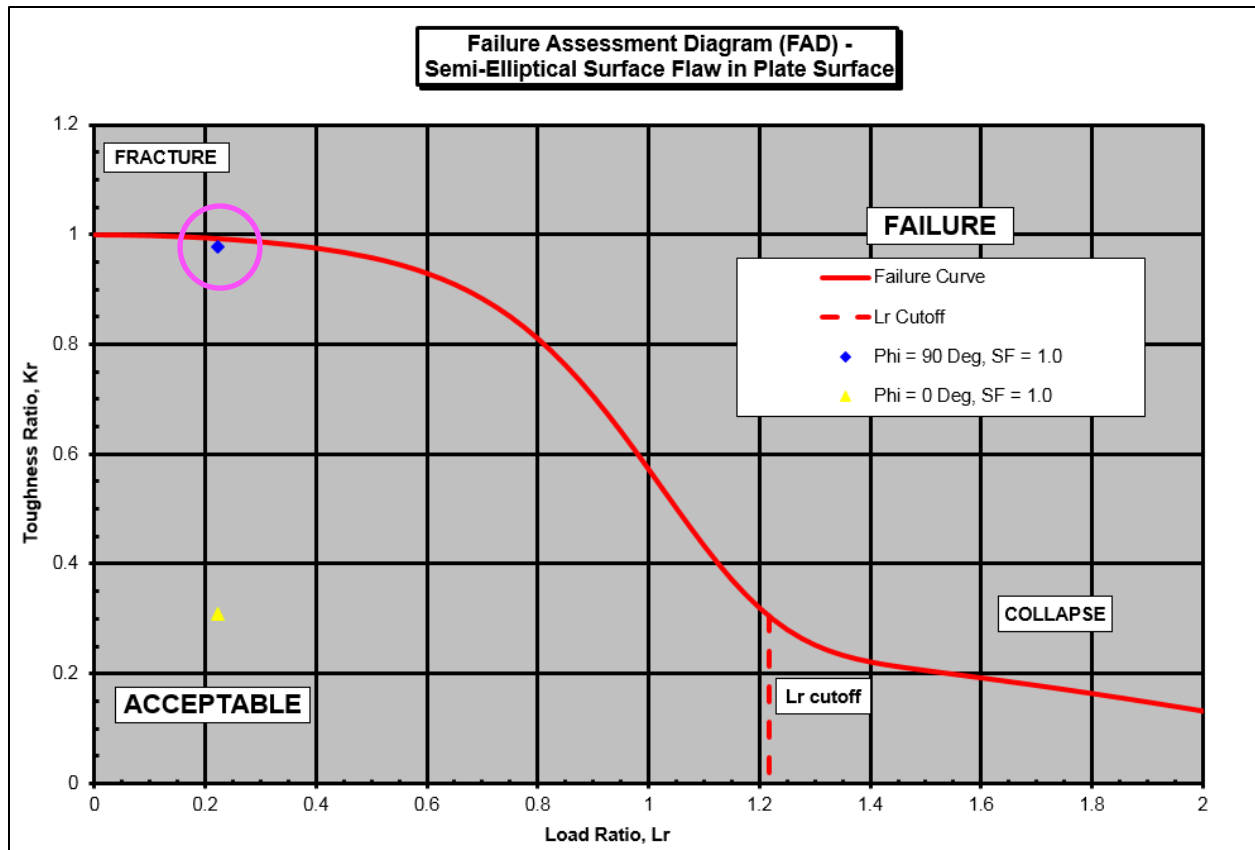
Fig. 41. Failure assessment diagram (FAD) showing pop-in crack initiation at the Fig. 40 residual stresses with a lower bound fracture toughness of approximately 30 ksi/in. See Fig. 39 for definition of Phi (ϕ). SF = Safety Factor.

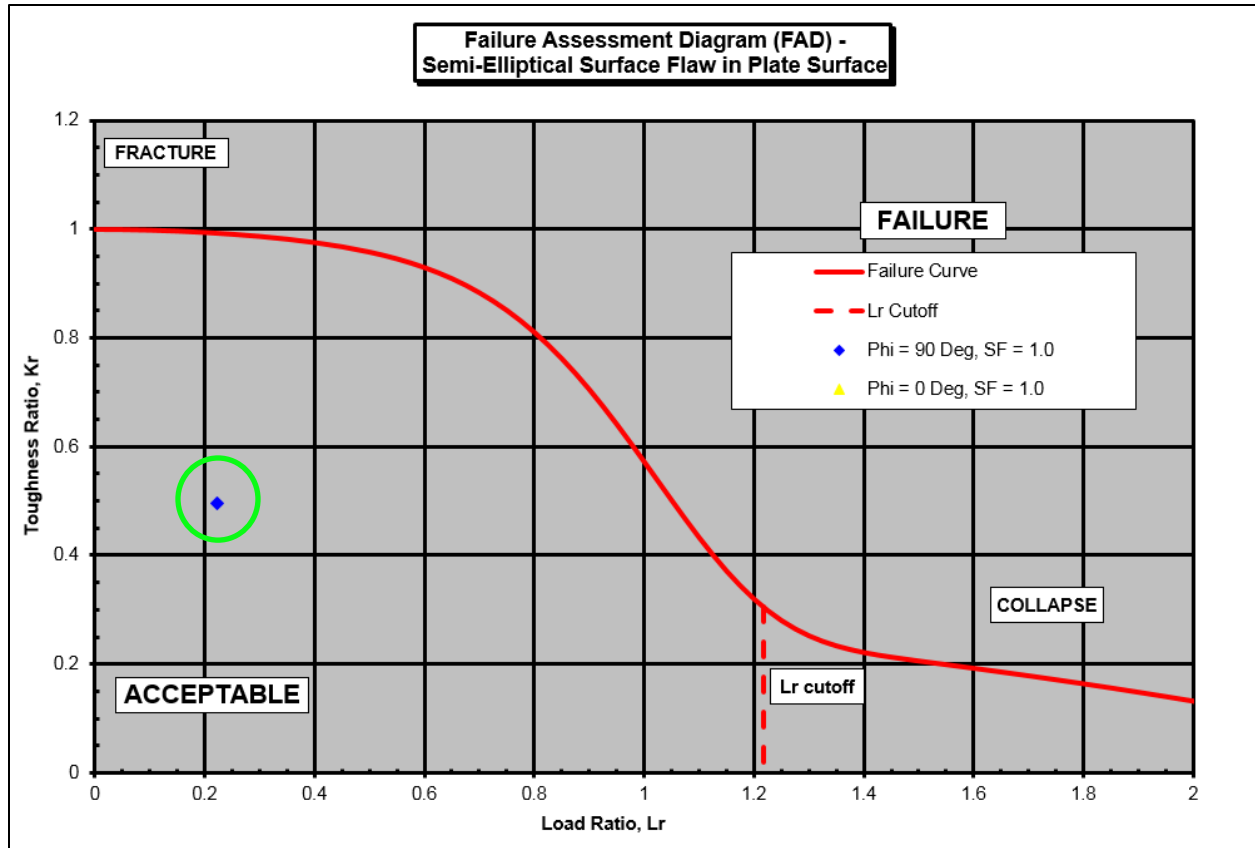
Fig. 42. Failure assessment diagram (FAD) demonstrating that pop-in crack initiation would not have occurred at the Fig. 40 residual stresses with an upper bound fracture toughness of approximately 55 to 60 ksi√in.

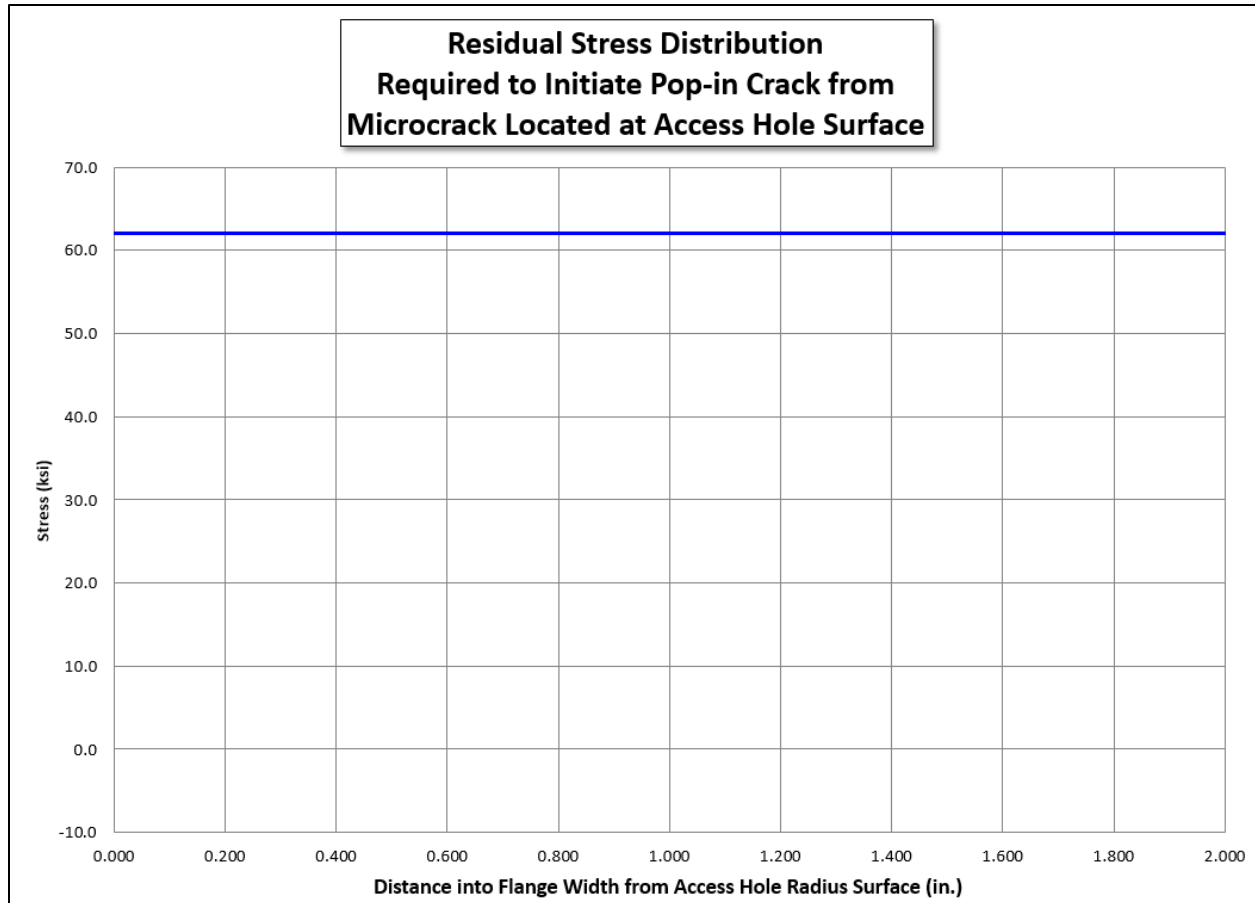
Fig. 43. Residual stress distribution necessary to cause pop-in crack initiation at a fracture toughness of approximately 55 to 60 ksi√in.

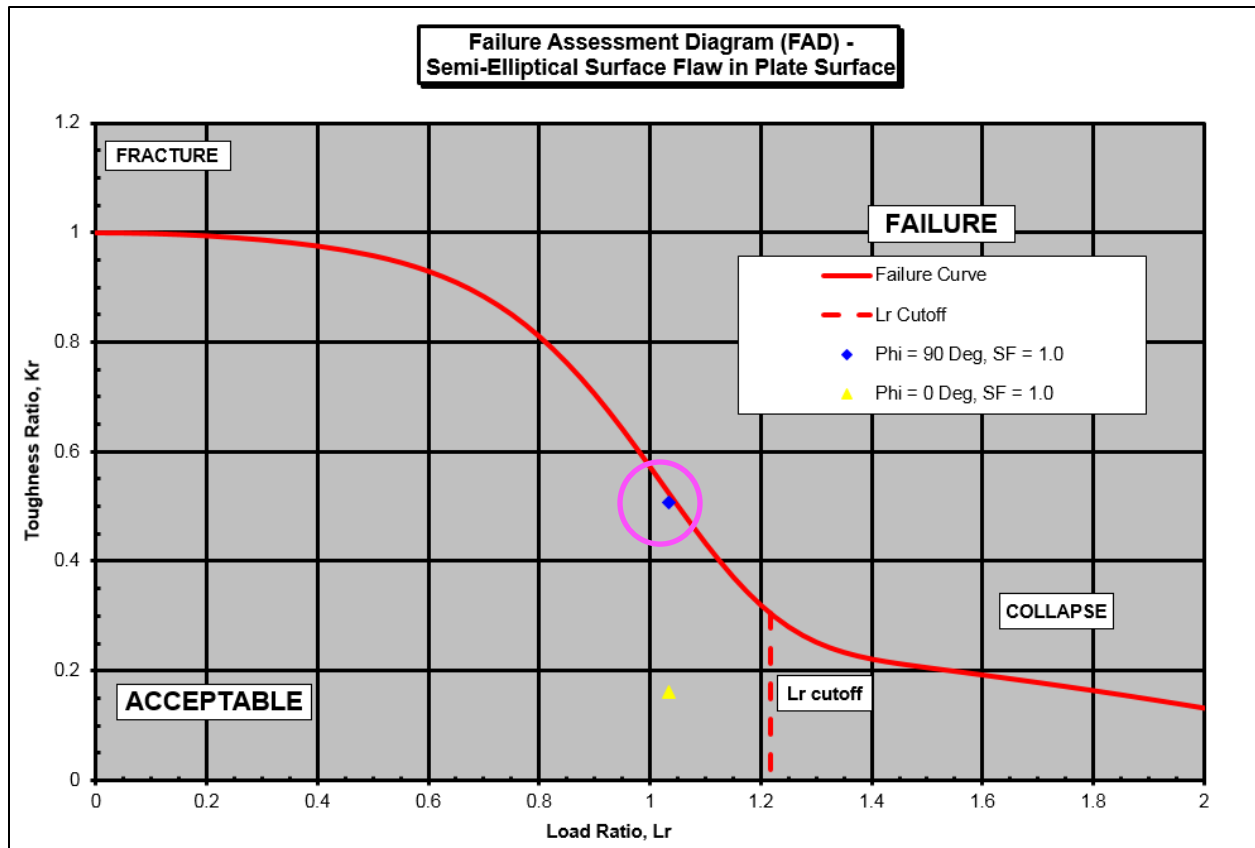
Fig. 44. Failure assessment diagram (FAD) demonstrating that pop-in crack initiation would have been ductile in nature under the Fig. 43 residual stresses with an upper bound fracture toughness of approximately 55 to 60 ksi/in.

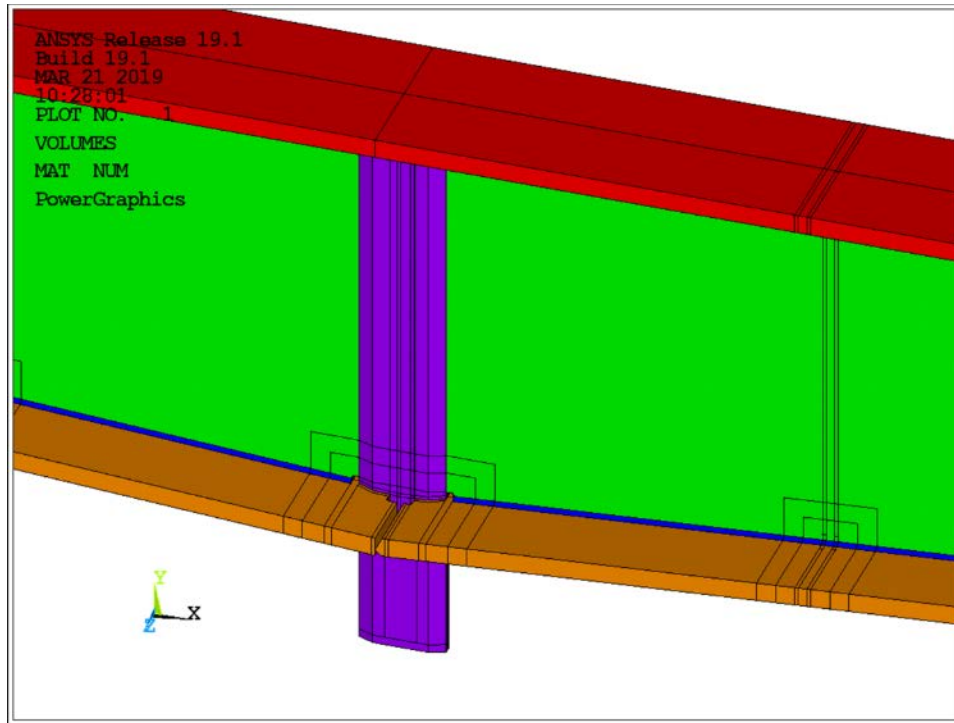
Fig. 48. Girder solid model prior to groove welding the bottom flange plates together. Configuration is based on welding sequence provided to LPI. Note the absence of vertical stiffeners and welds between bottom flange and tapered hanger.

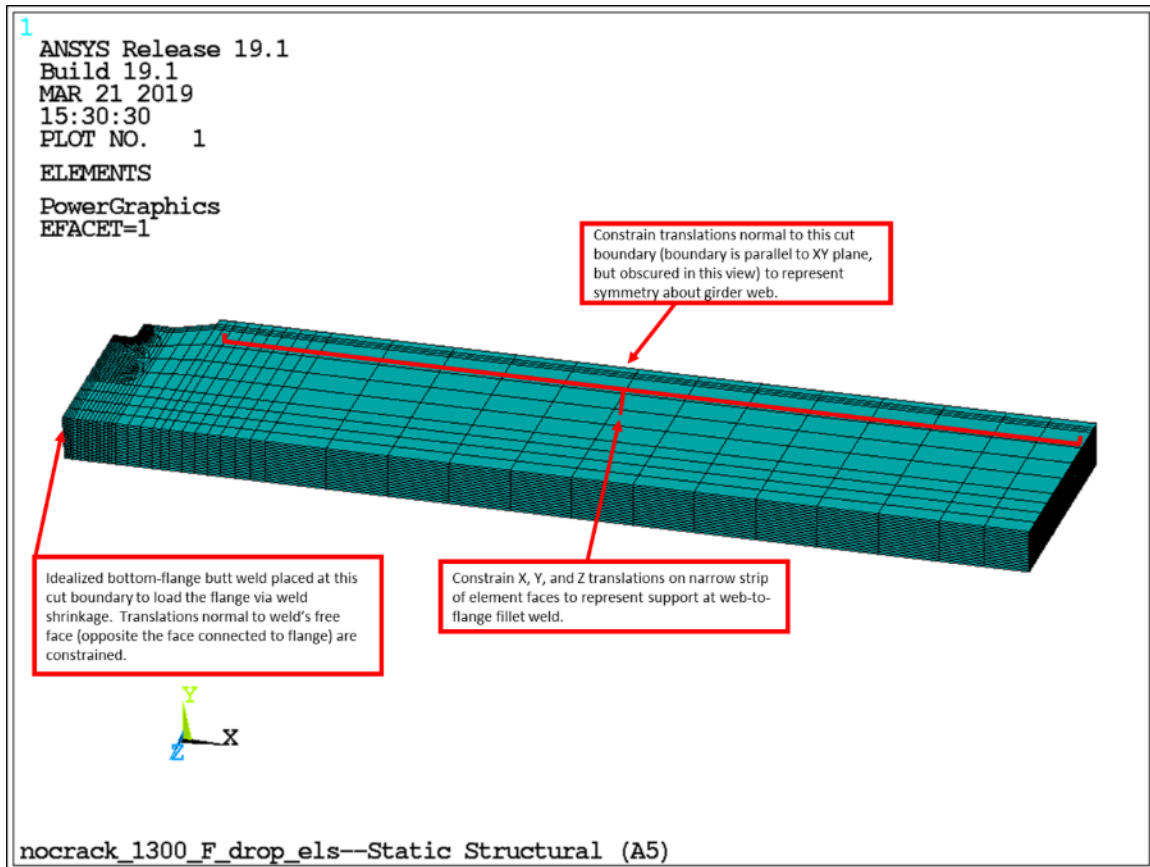
Fig. 49. Boundary conditions for bottom-flange FE model. Boundary conditions represent the effect of support from neighboring structure.

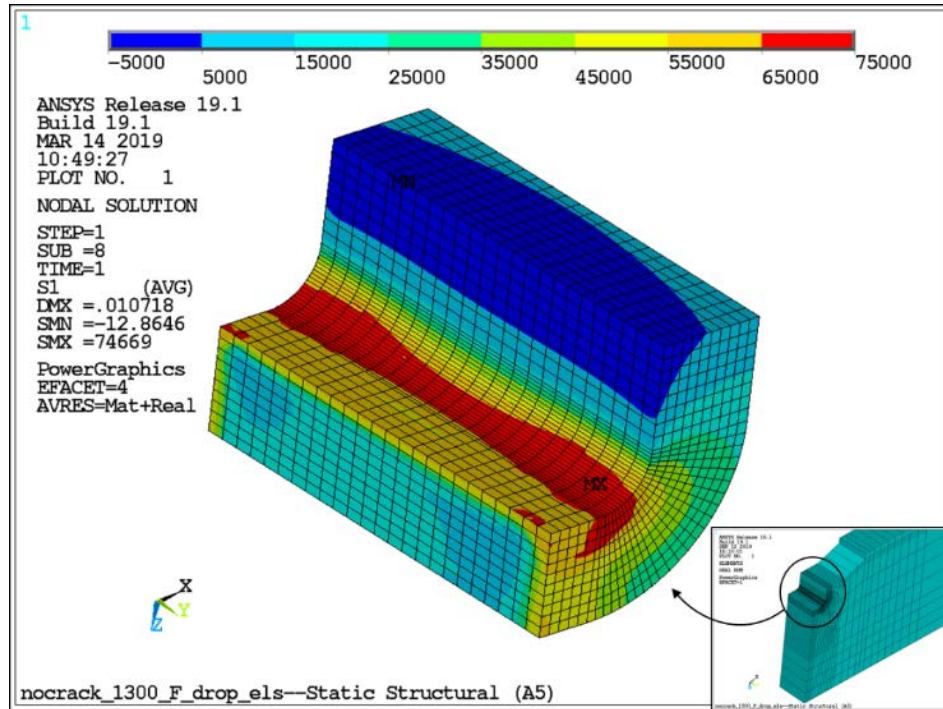
Fig. 53. Distribution of maximum principal stress local to the weld access hole radius the in Fremont Street girder. Stress exceeds 65 ksi across the 4-in. thickness of bottom flange.

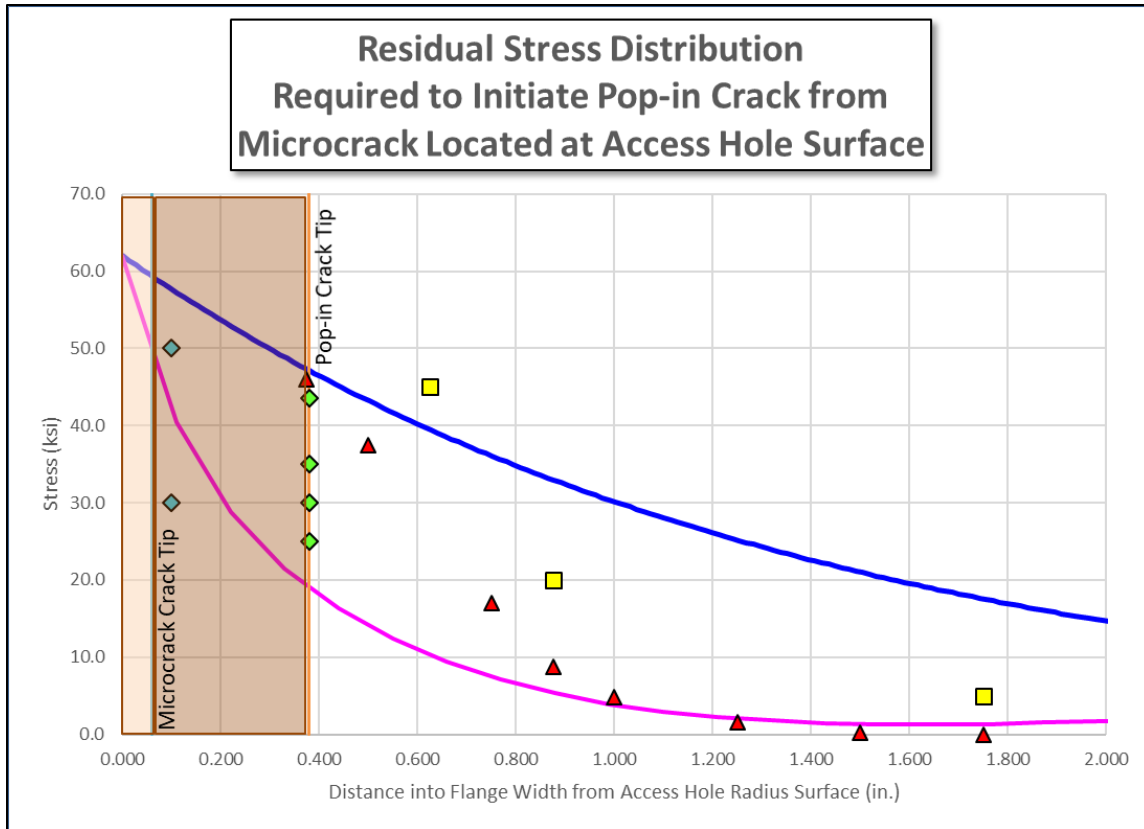
Fig. 55. Residual stress distributions (curves) necessary to initiate pop-in cracking from the pre-existing microcracks. The blue curve is the upper bound, derived distribution and the purple curve is the thermal FE calculated distribution. These curves bound USACE experimental (yellow squares [18] and green diamonds [19]) and FE calculated (red triangles [18] and blue diamonds [19]) residual stress results.

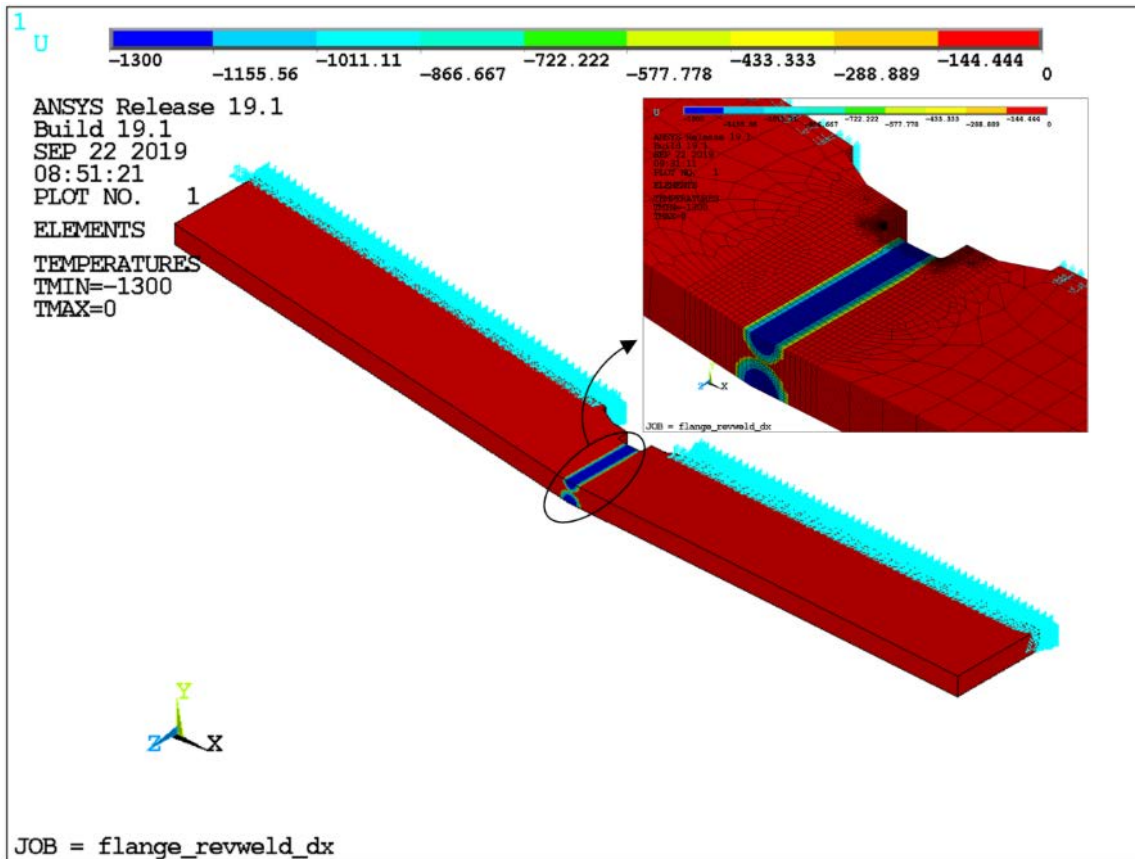
Fig. 56. Local finite-element model of Fremont Street lower flange showing temperature-distribution contour. Boundary conditions are indicated by aqua-colored symbols and are as described in Section 4.1.3.1.

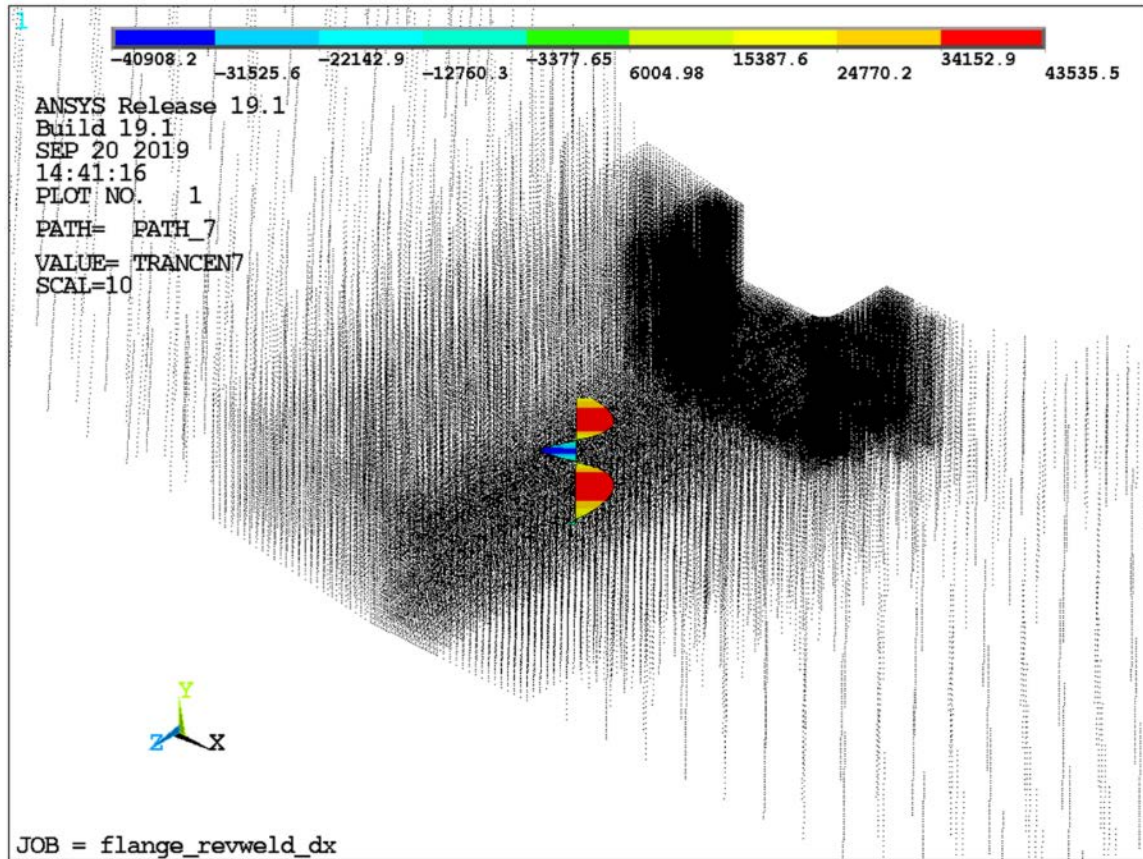
Fig. 60. Through-thickness distribution of calculated transverse residual stress at center of flange groove weld. Note similarity of distribution compared to transverse-stress plot shown in Fig. 58.

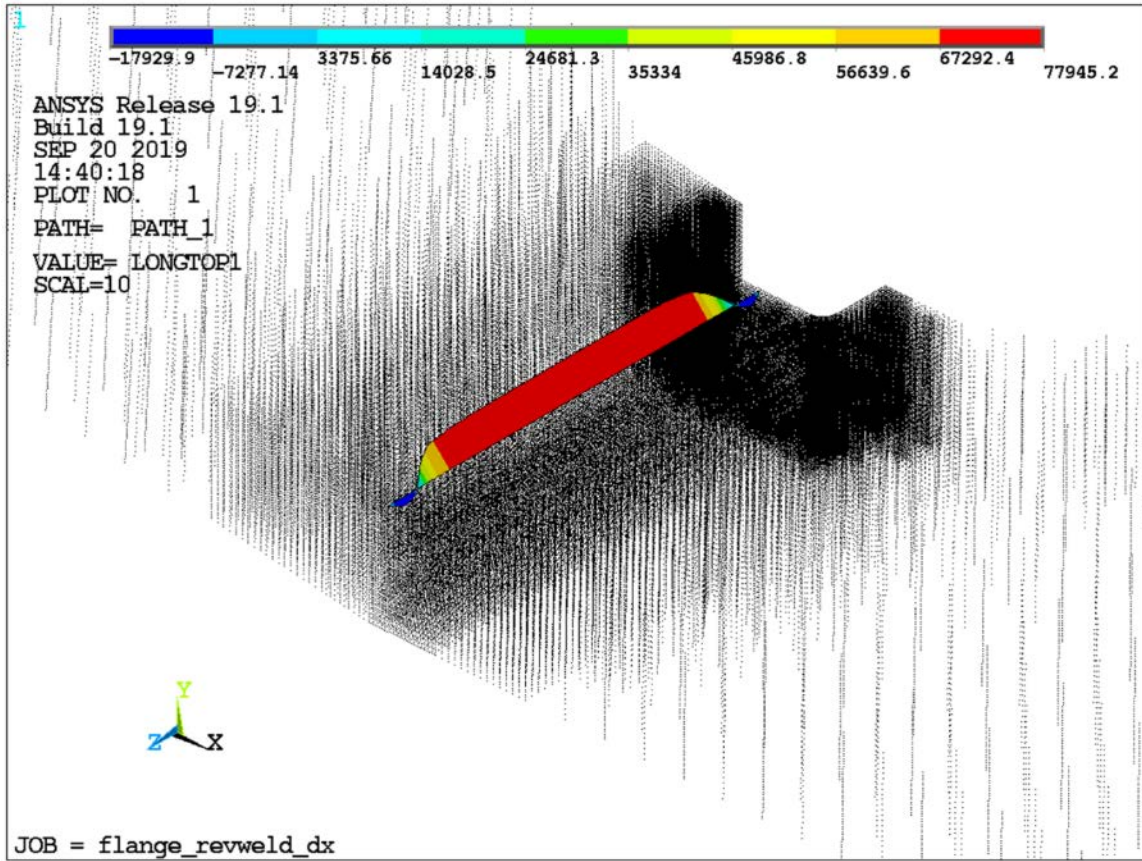
Fig. 61. Longitudinal distribution of longitudinal residual stress, outer surface of Fremont Street lower flange, at groove weld.

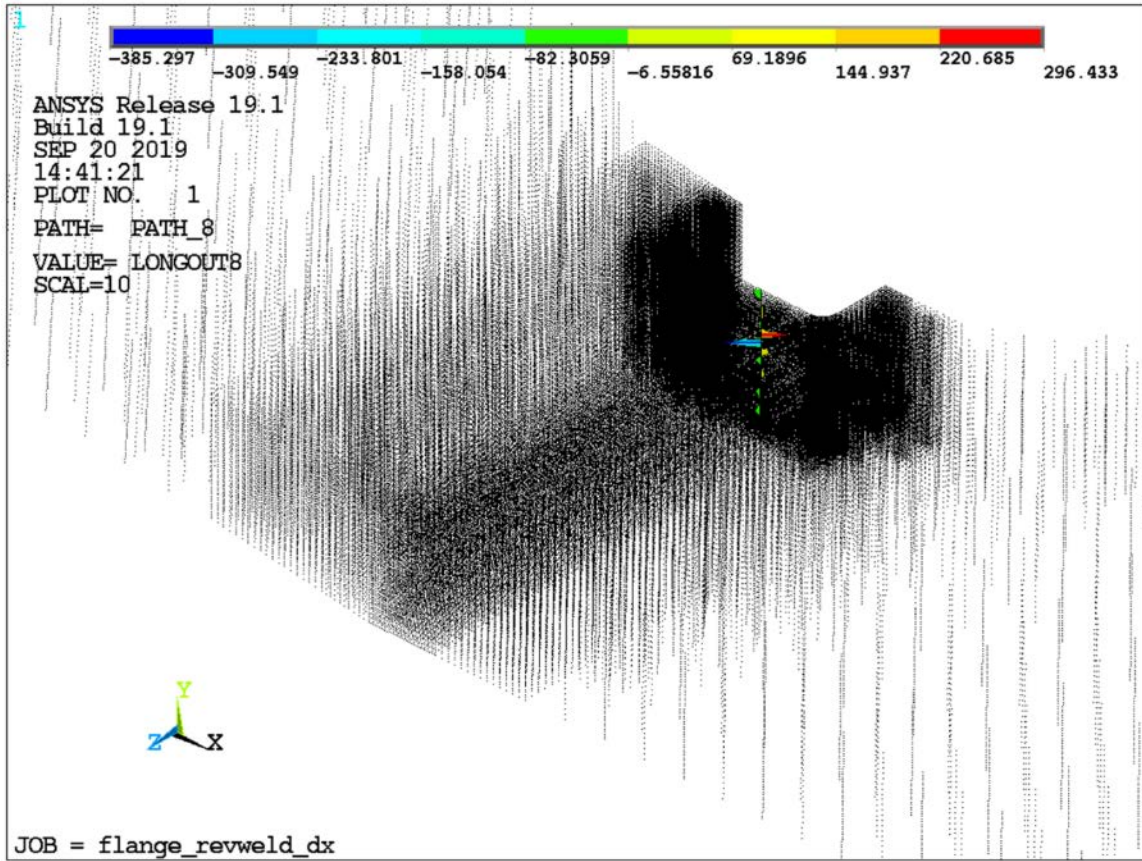
Fig. 64. Through-thickness distribution of longitudinal residual stress at end of groove weld nearest access-hole radii. Near-zero magnitudes consistent with the free-surface condition.

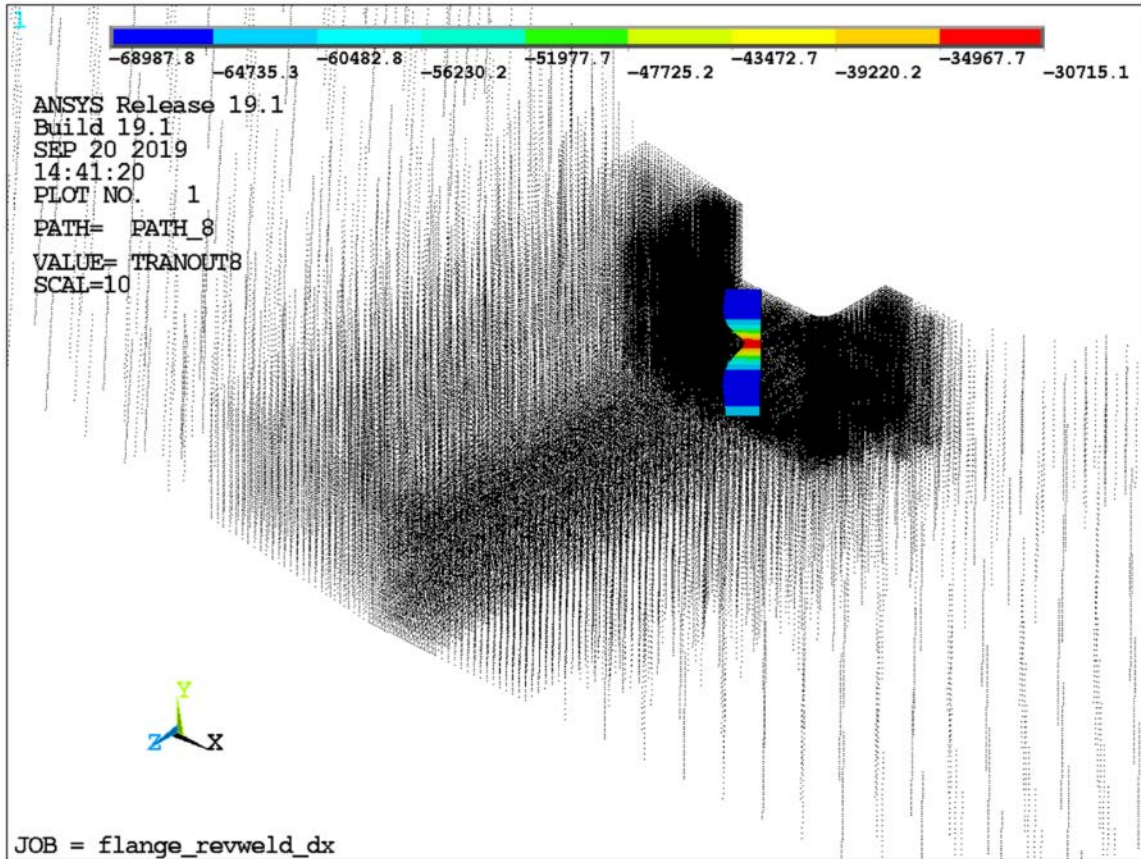
Fig. 65. Through-thickness distribution of transverse residual stress at end of groove weld nearest access-hole radii. Stresses are compressive, though of variable magnitude.

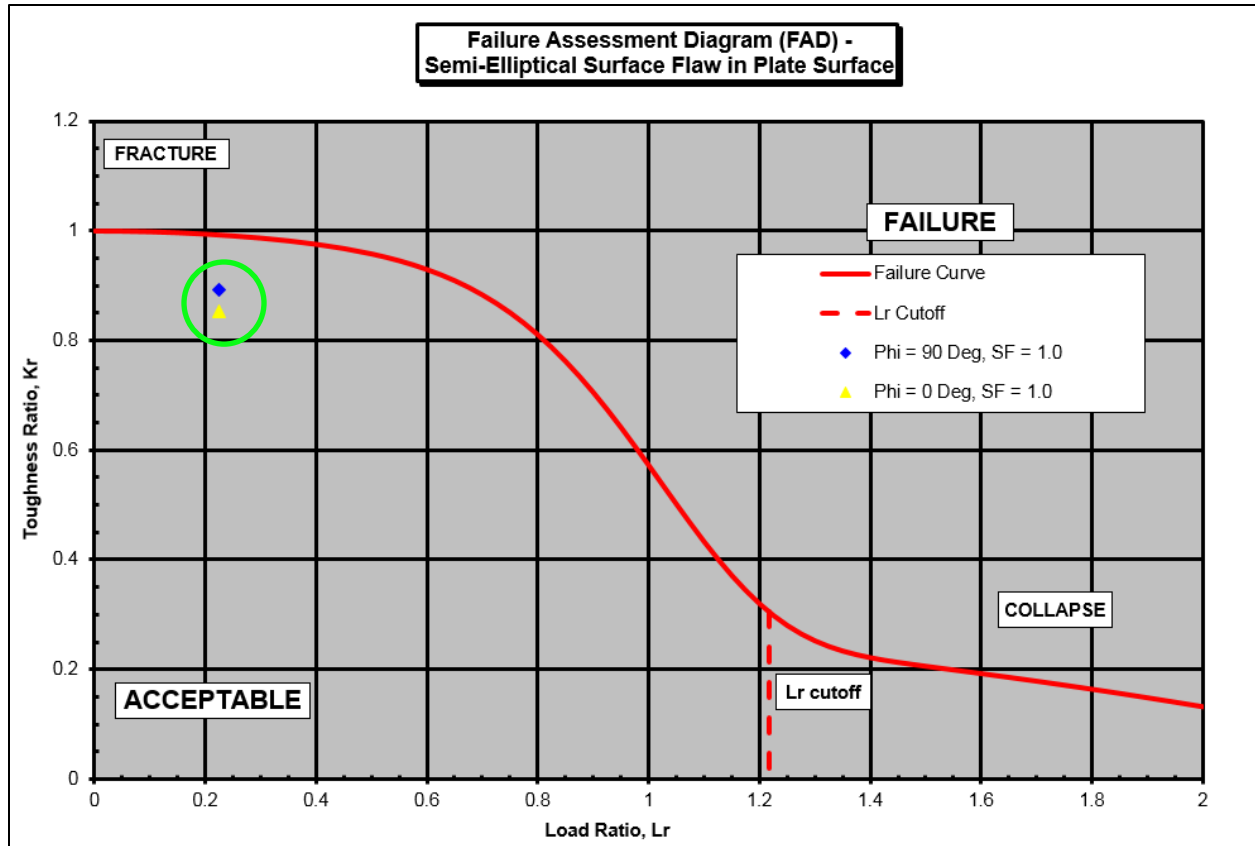
Fig. 68. Failure assessment diagram (FAD) demonstrating that pop-in crack propagation would arrest at a depth of 0.38 in. under the Fig. 40 residual stresses with a crack arrest fracture toughness of approximately 55 to 60 ksi/in.

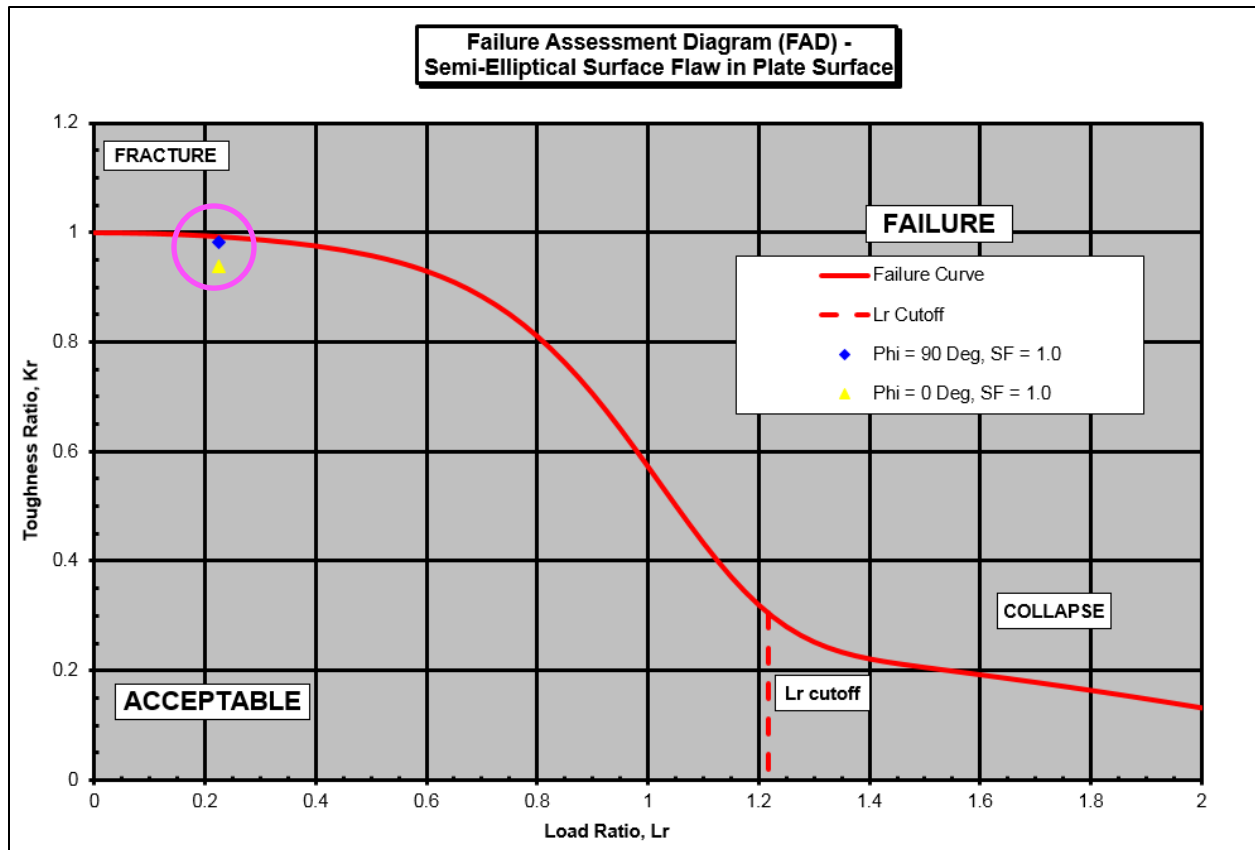
Fig. 69. Failure assessment diagram (FAD) demonstrating that pop-in crack propagation would not arrest at a depth of 0.38 in. under the Fig. 40 residual stresses with a crack arrest fracture toughness lower than approximately 50 ksivin.
