LPI, Inc. Consulting Engineers

*Advanced Analysis & Fitness for Service
Failure & Materials Evaluation
Nondestructive Engineering*

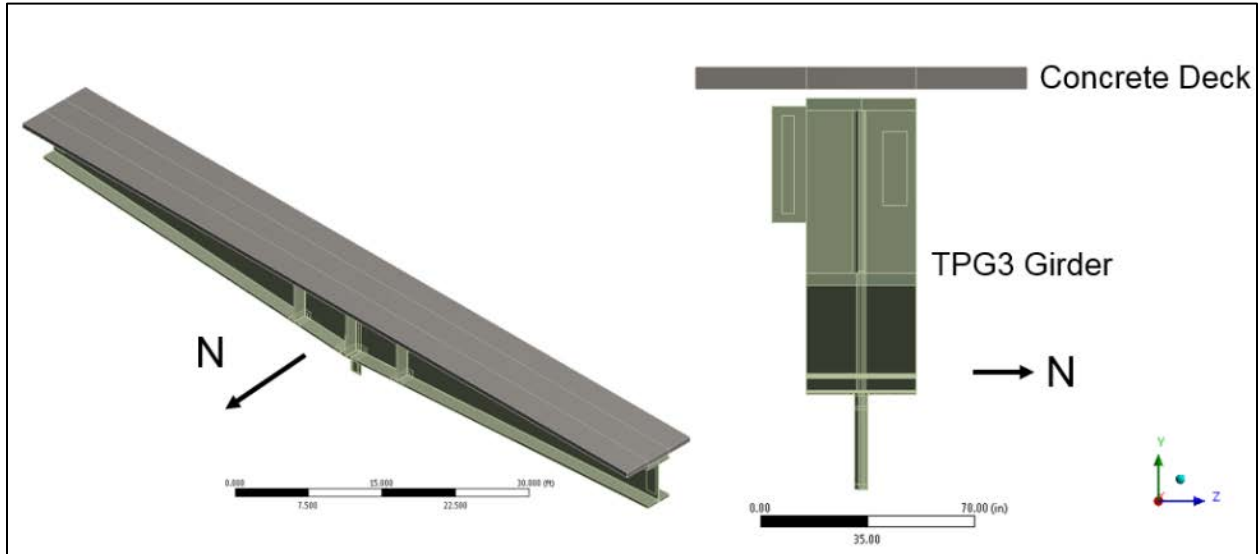
Fig. 71. Composite TPG3 girder geometric model with the concrete deck included – Fremont Street D.4 line

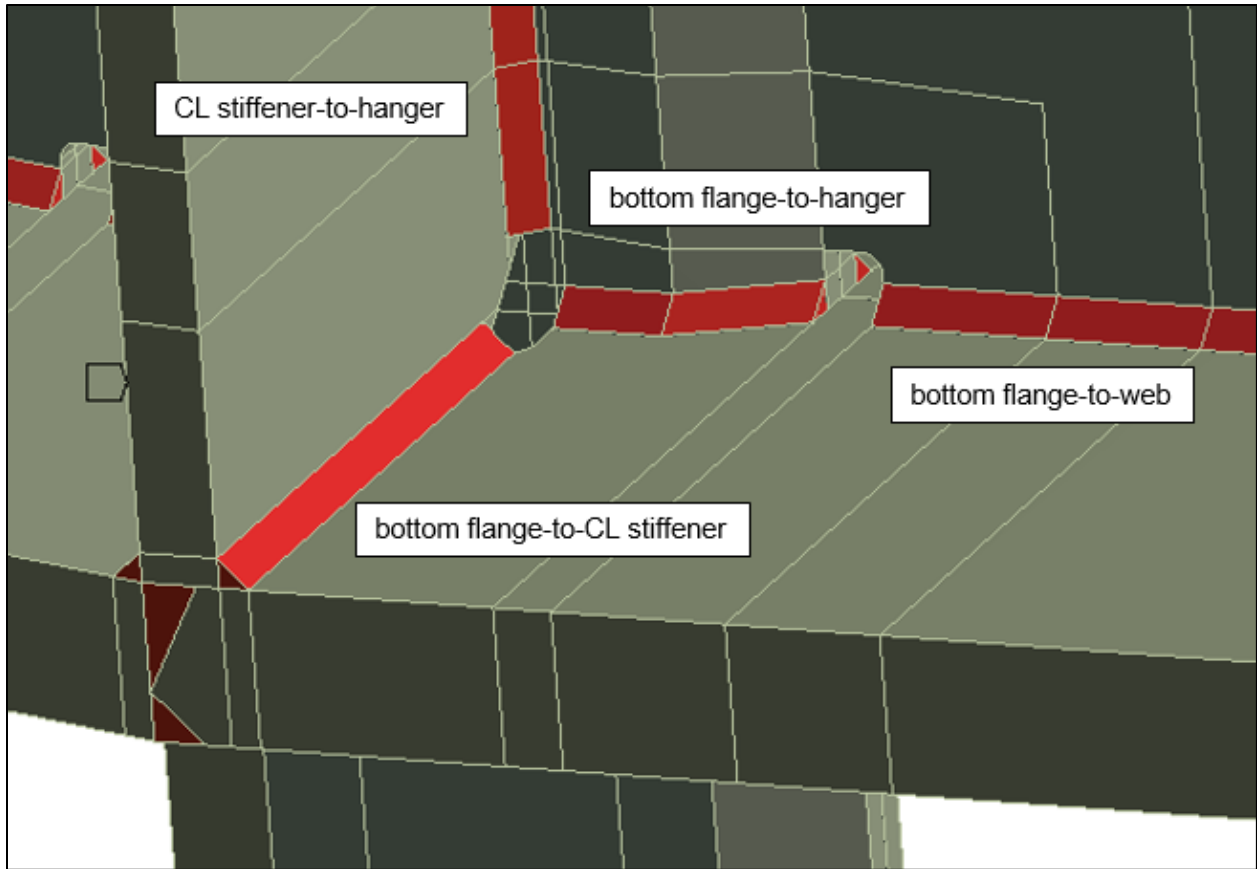
Fig. 72. Fillet welds in the region of interest near the weld access holes (3/4 in. leg length).

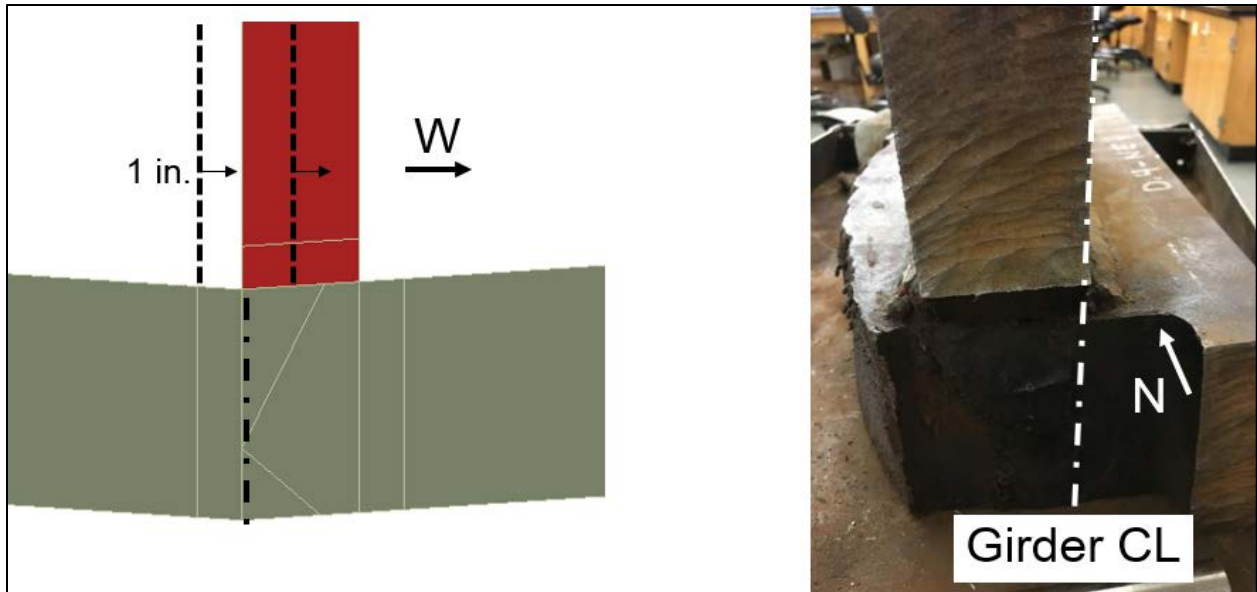
Fig. 74. CL stiffener offset 1 in. to the west of the TPG3 girder CL on the Fremont Street D.4 line

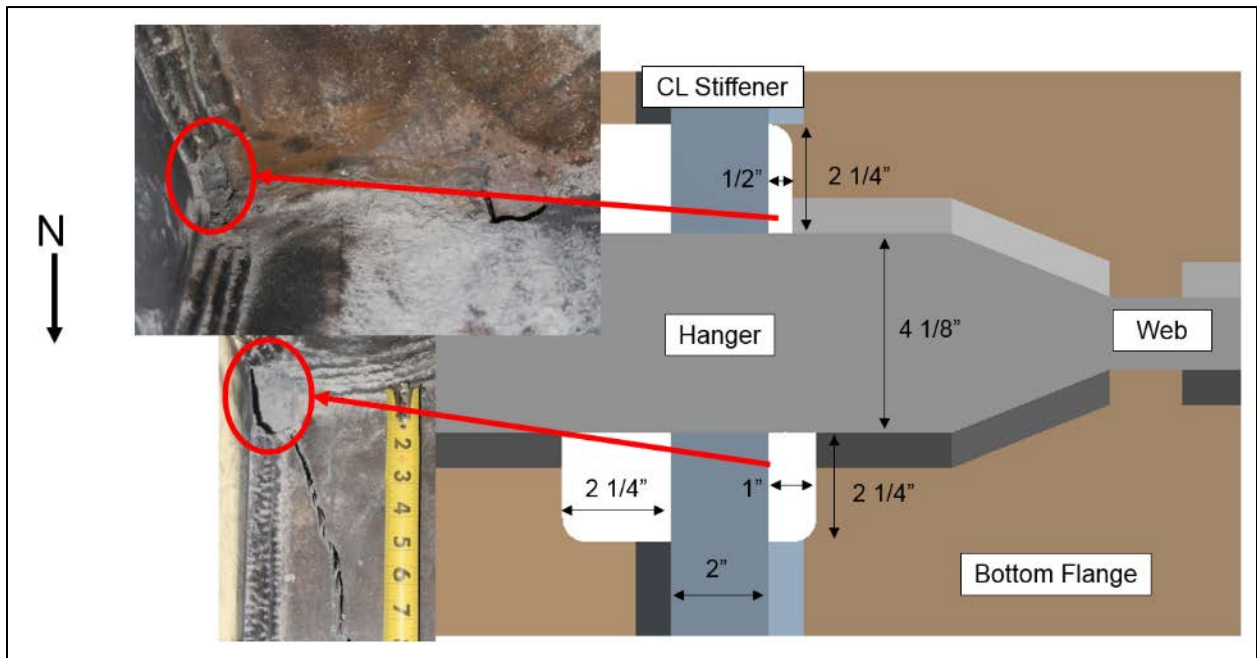
Fig. 75. Weld access hole dimensions for the TPG3 girder on the Fremont Street D.4 line. Note that Appendix D contains all relevant TPG3 girder dimensions.

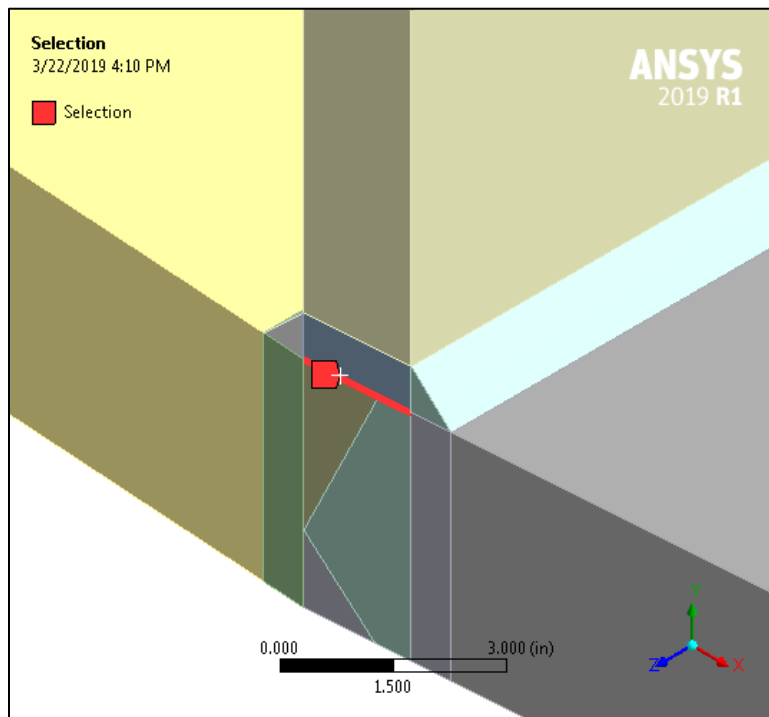
Fig. 79. Instance of frictionless faying contact shown by red-highlighted edge.

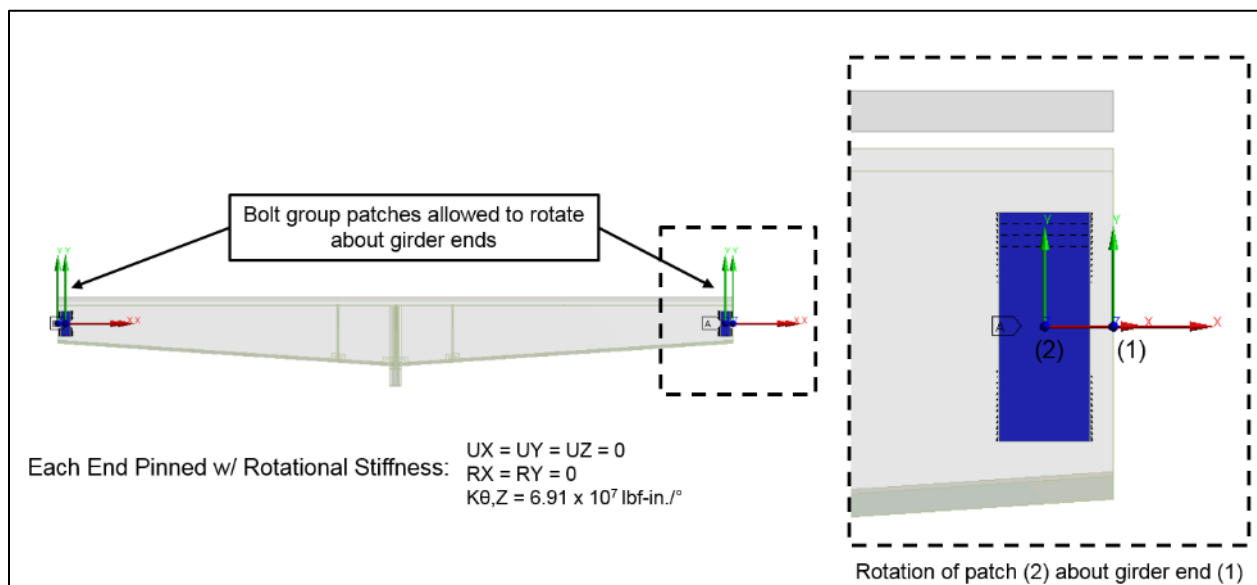
Fig. 80. End boundary conditions showing pinned connections with rotational constraint of the bolt group patches about the girder ends.

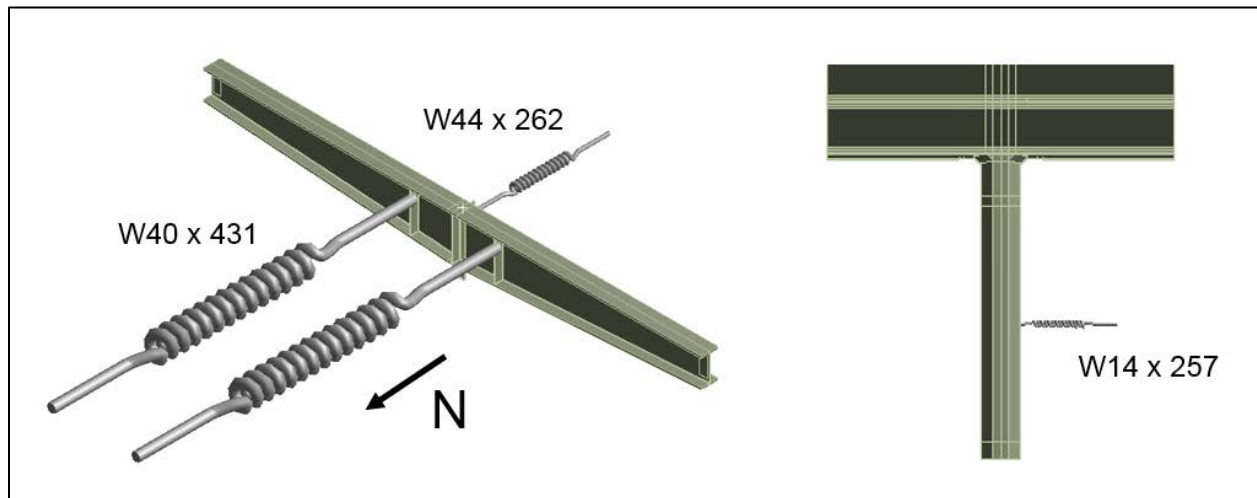
Fig. 81. Lateral constraint boundary conditions. An equivalent linear spring was attached to each respective bolt group patch.

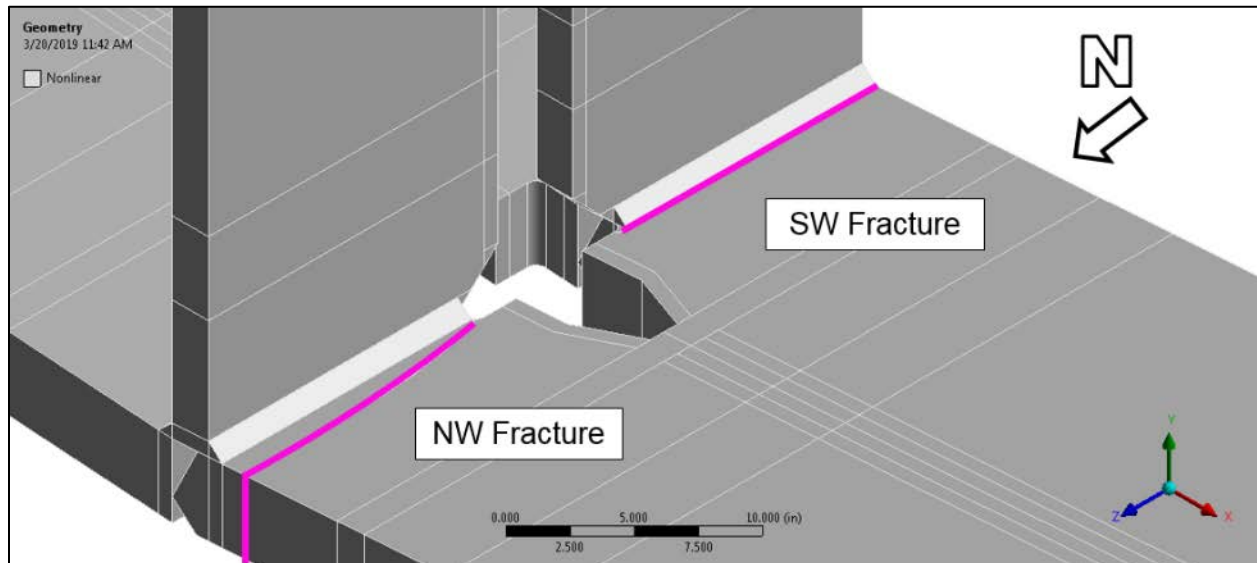
Fig. 84. Fremont Street D.4 FE model with both the NW and SW fractures included (highlighted in purple). Note that only the bottom flange, CL stiffeners, and welds are shown.

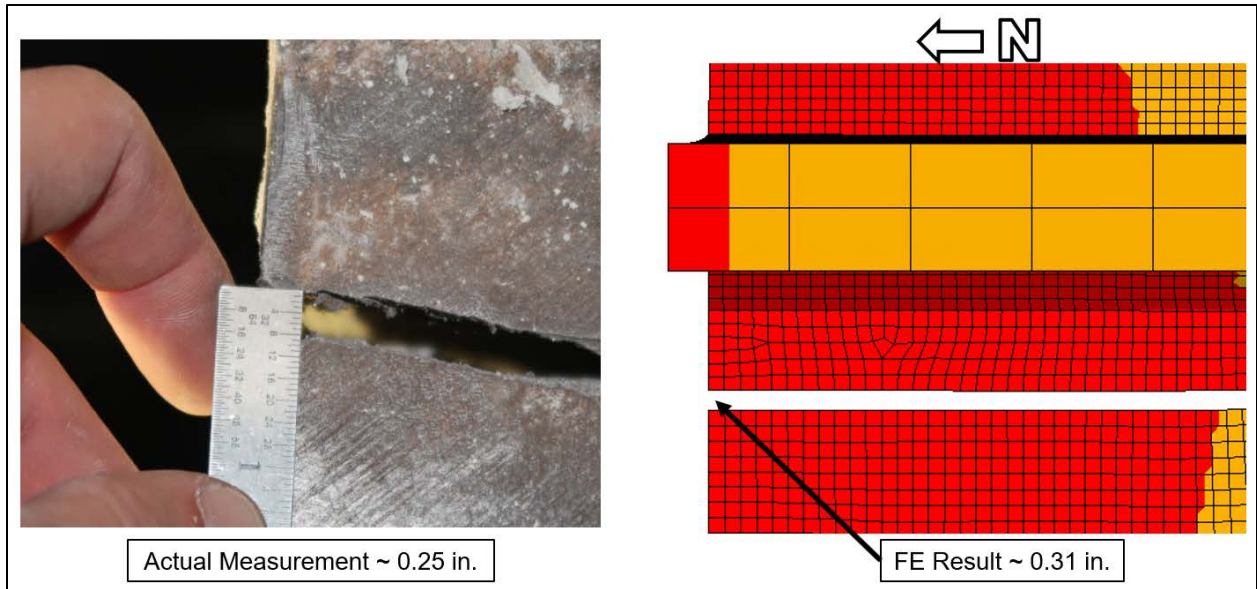
Fig. 85. Fremont Street D.4 crack opening comparison between the measured crack opening and the FE crack opening results – NW fracture at 1.0(DL+SDL) + 1.0(LL).

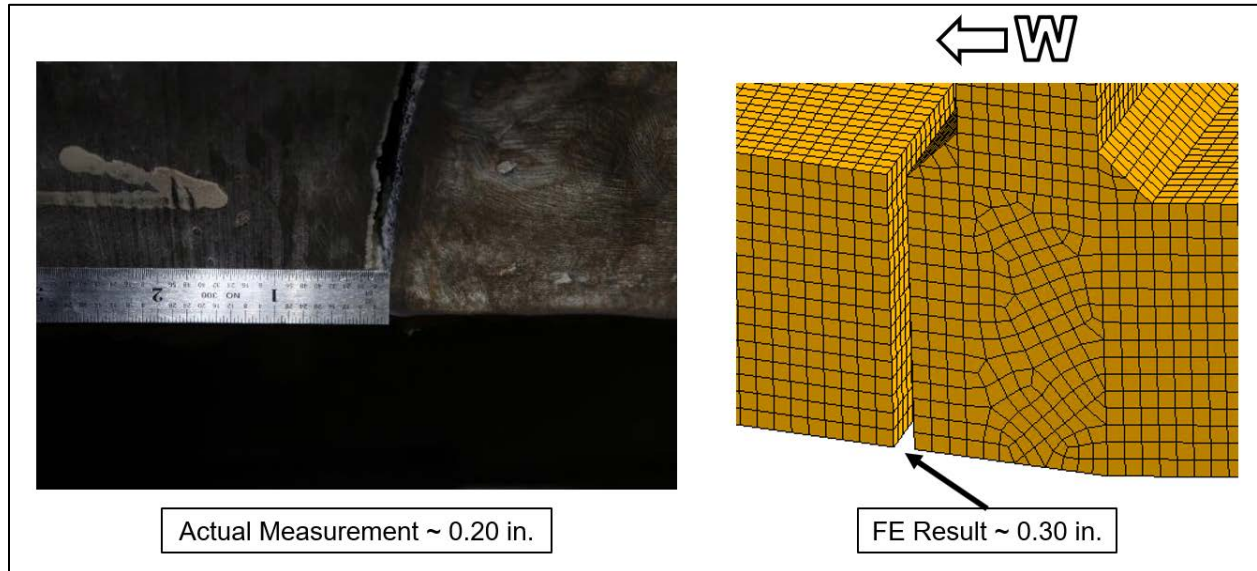
Fig. 86. Fremont Street D.4 crack opening comparison between the measured crack opening and the FE crack opening results – SW fracture at 1.0(DL+SDL) + 1.0(LL).

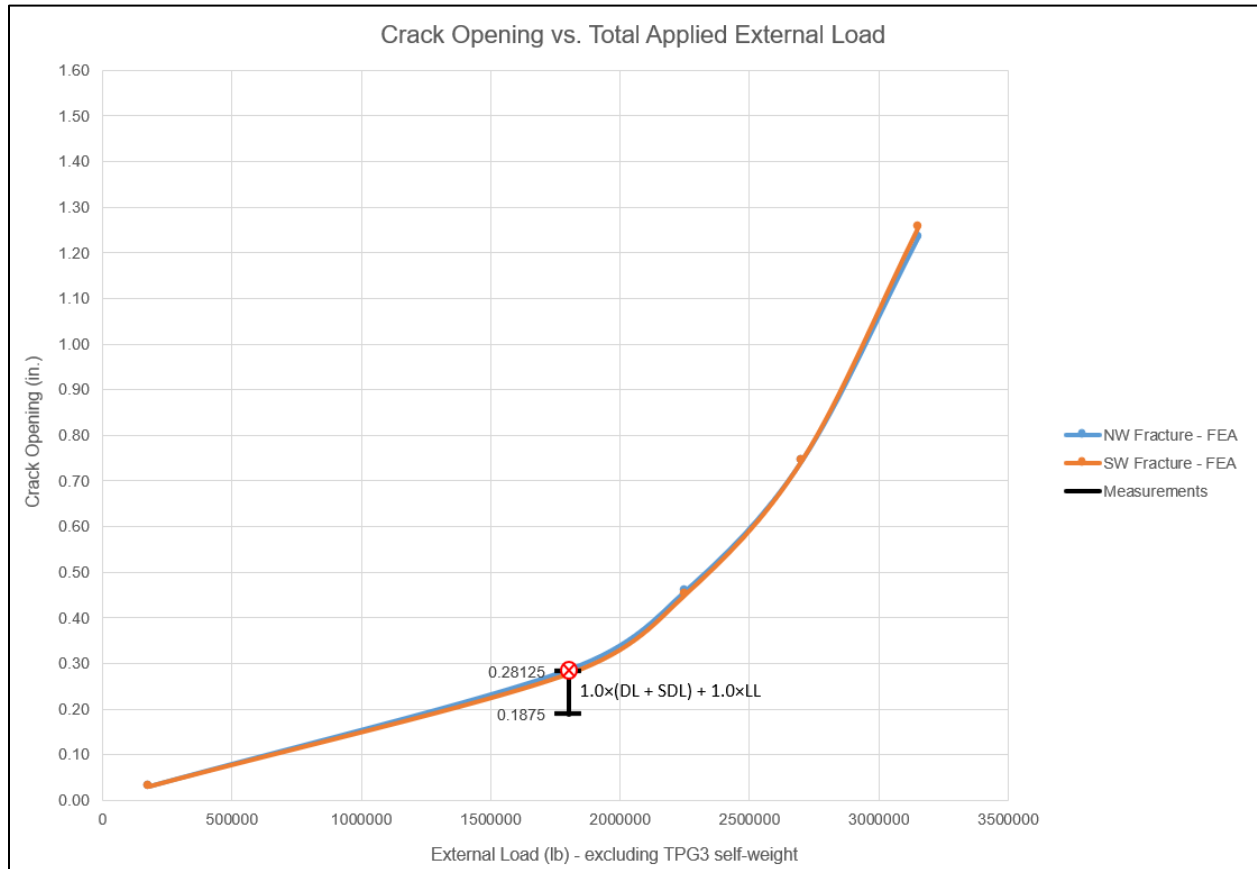
Fig. 87. Fremont Street D.4 crack opening sensitivity to total applied load.

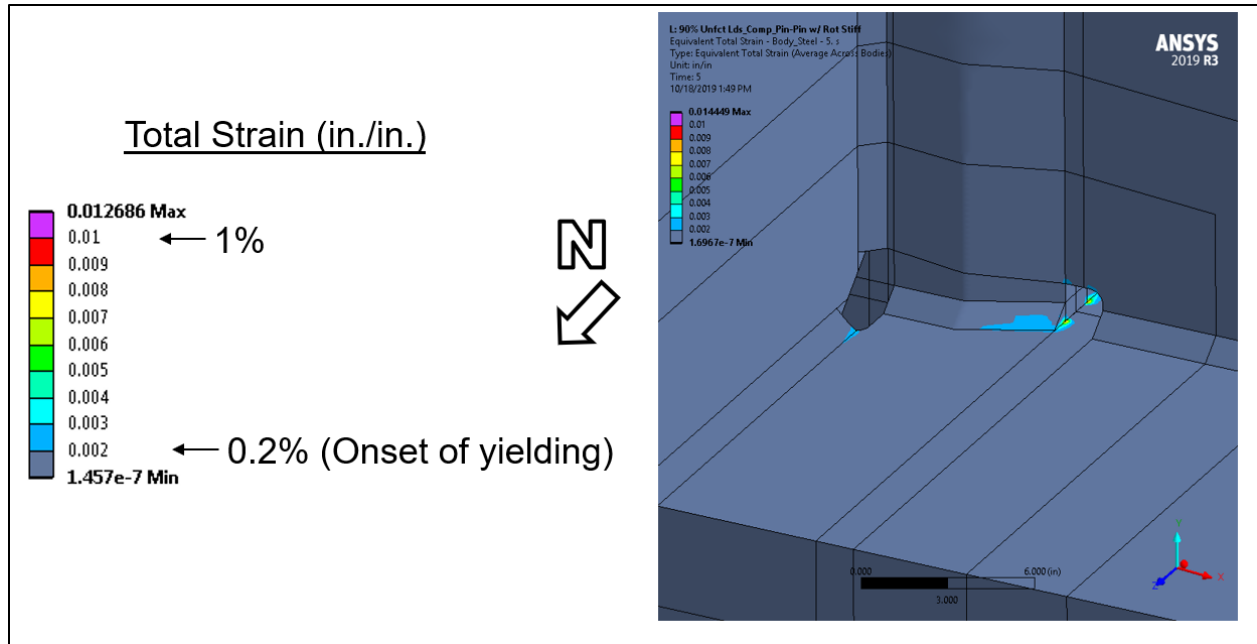
Fig. 88. Total strain (in./in.) near the NW weld access hole indicating only localized areas at fillet weld toes exceeded the material yield strength (grey is below yield) at 1.0(DL+SDL) + 1.0(LL).

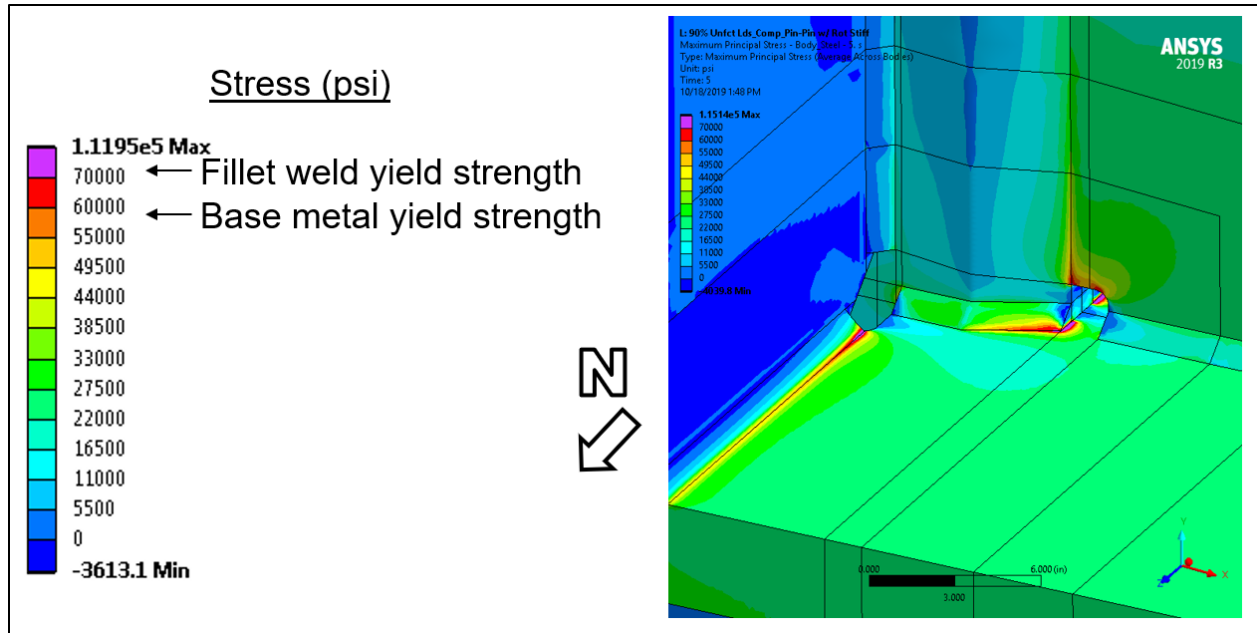
Fig. 89. Maximum principal stress (psi) near the NW weld access hole indicating only localized areas experienced tensile stresses that exceeded the material yield strength at 1.0(DL+SDL) +1.0(LL).

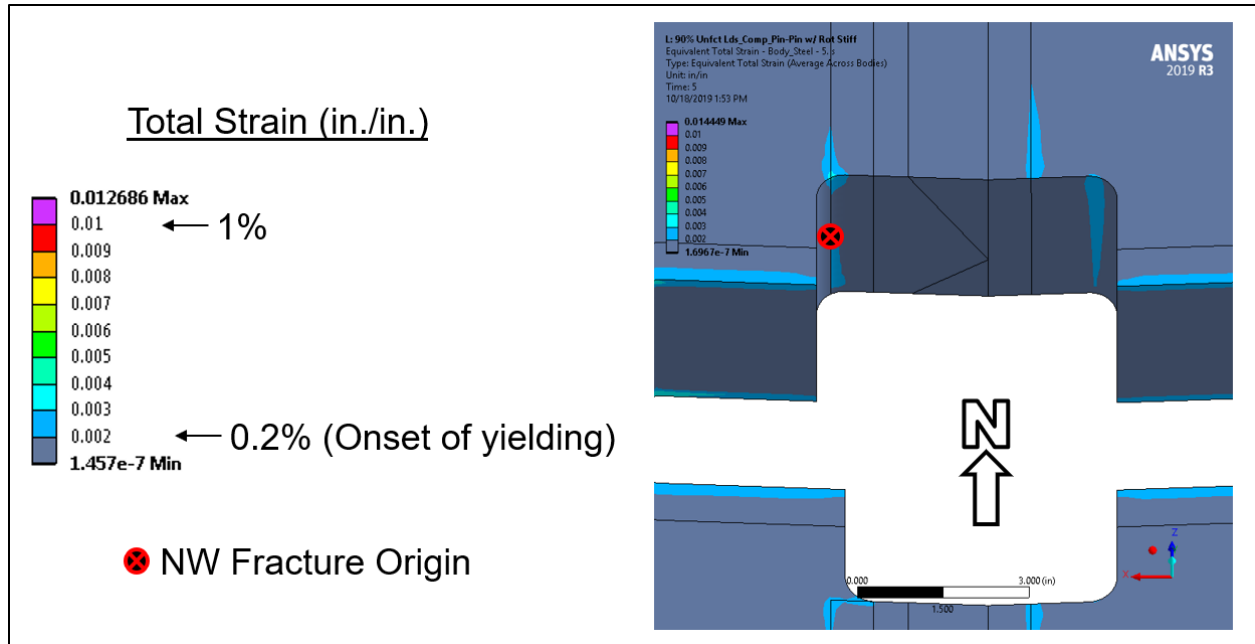
Fig. 90. D.4 north bottom flange weld access hole total strain (in./in.) with the NW fracture origin highlighted (red circle) at loading corresponding to 1.0(DL+SDL) + 1.0(LL). Contour plot is at an angled view looking into the access hole with the hanger removed.

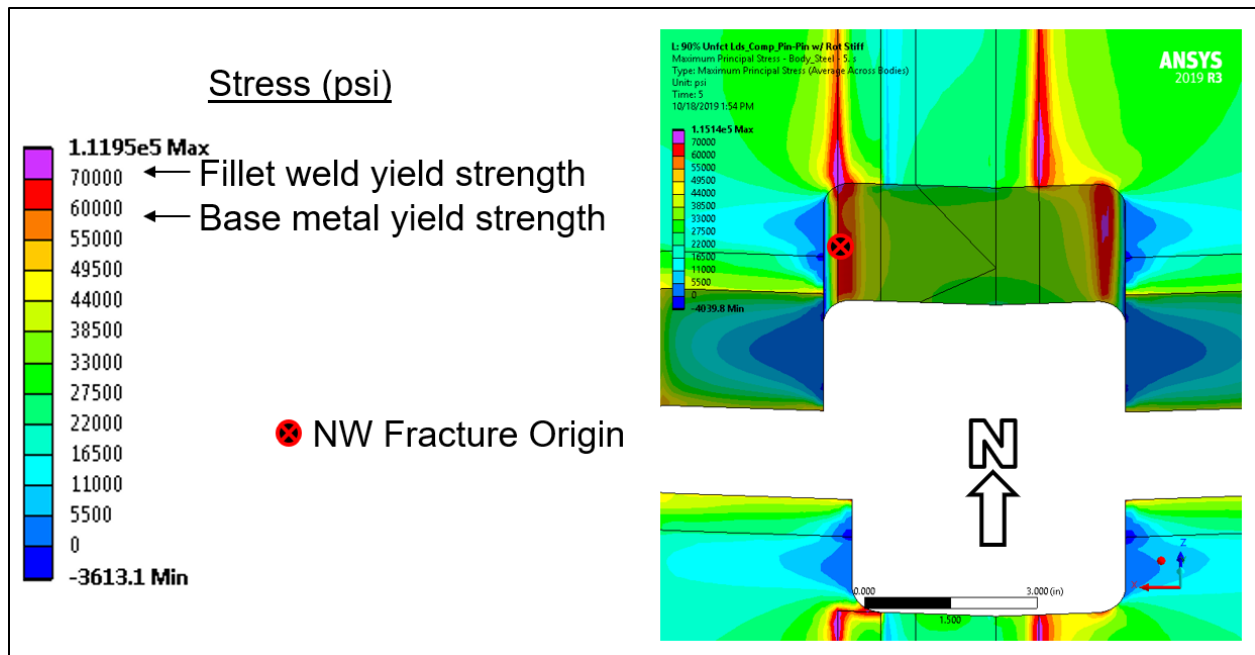
Fig. 91. D.4 north bottom flange weld access hole maximum principal stress (psi) with the NW fracture origin highlighted at 1.0(DL+SDL) + 1.0(LL). Contour plot is at an angled view looking into the access hole with the hanger removed.

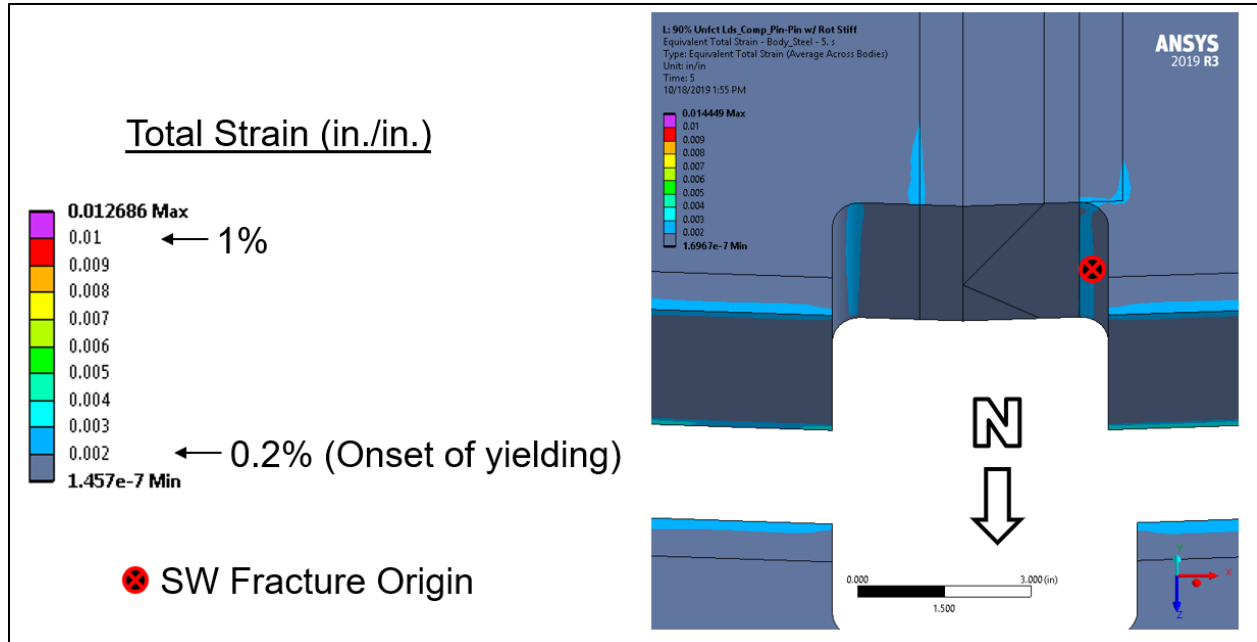
Fig. 92. South bottom flange weld access hole total strain (in./in.) with the SW fracture origin highlighted at 1.0(DL+SDL) + 1.0(LL). Contour plot is at an angled view looking into the access hole with the hanger removed.

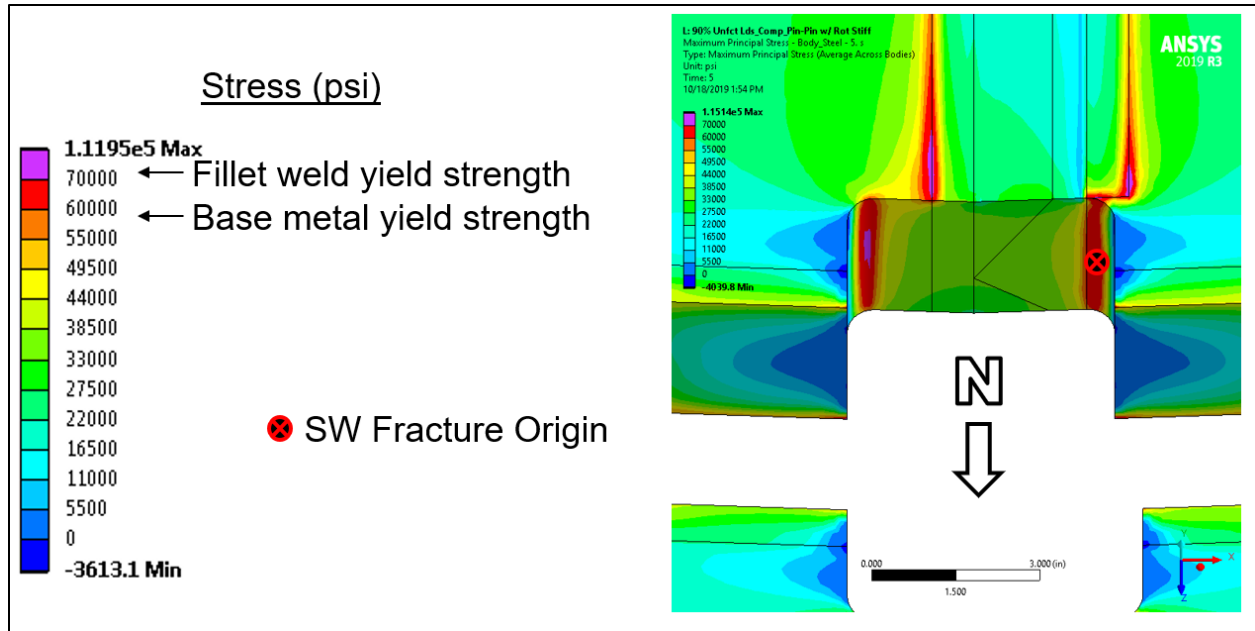
Fig. 93. South bottom flange weld access hole maximum principal stress (psi) with the SW fracture origin highlighted at 1.0(DL+SDL) + 1.0(LL). Contour plot is at an angled view looking into the access hole with the hanger removed.

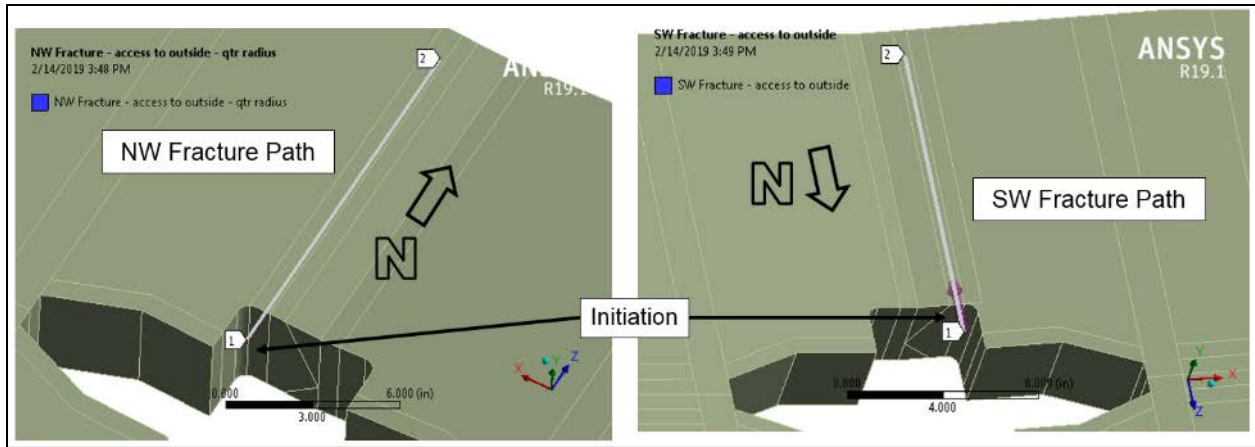
Fig. 94. Stress paths through the mid-thickness of the bottom flange originating at the NW and SW weld access hole fracture initiation sites.

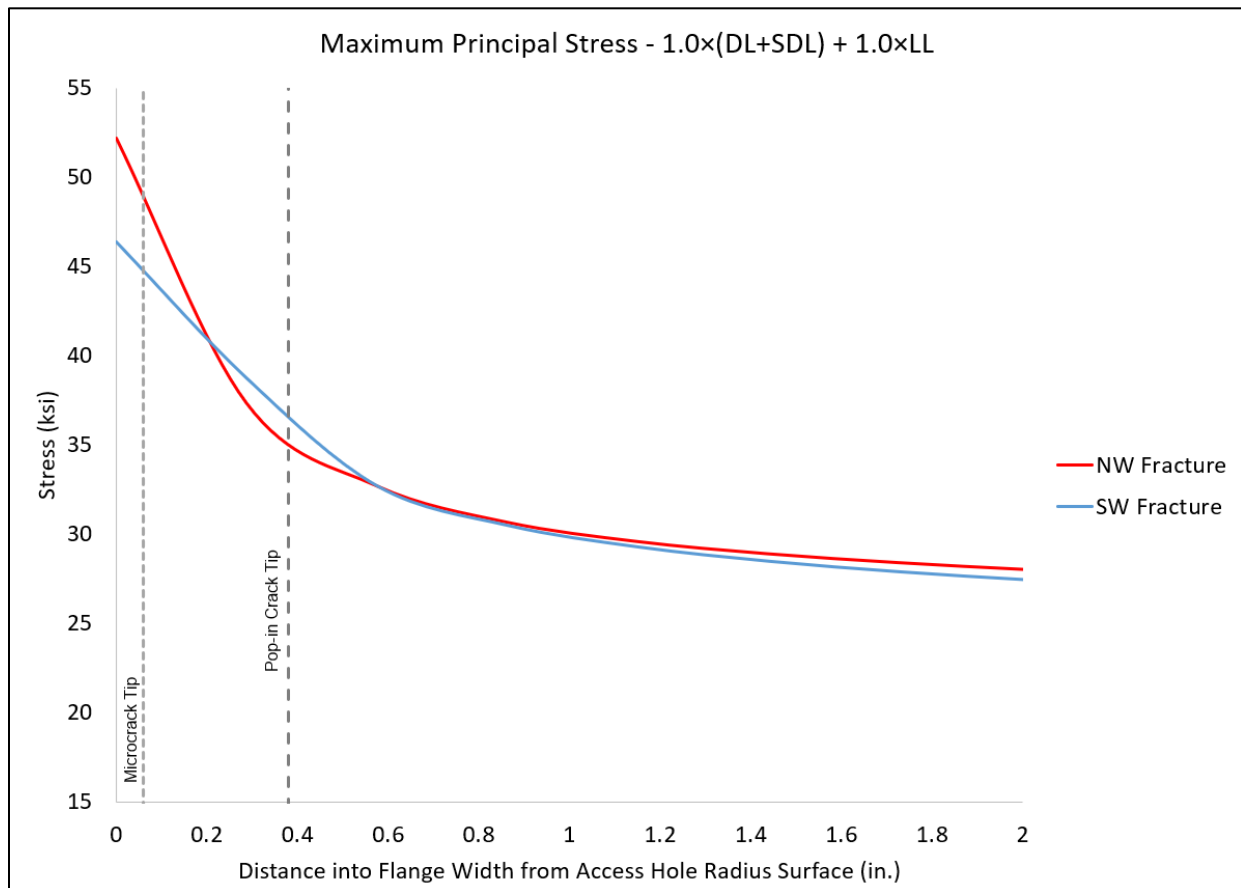
Fig. 95. Maximum principal stress along the NW and SW fracture paths (shown in Fig. 94). The relative locations on the microcrack and pop-in crack tips are identified by dashed vertical lines.

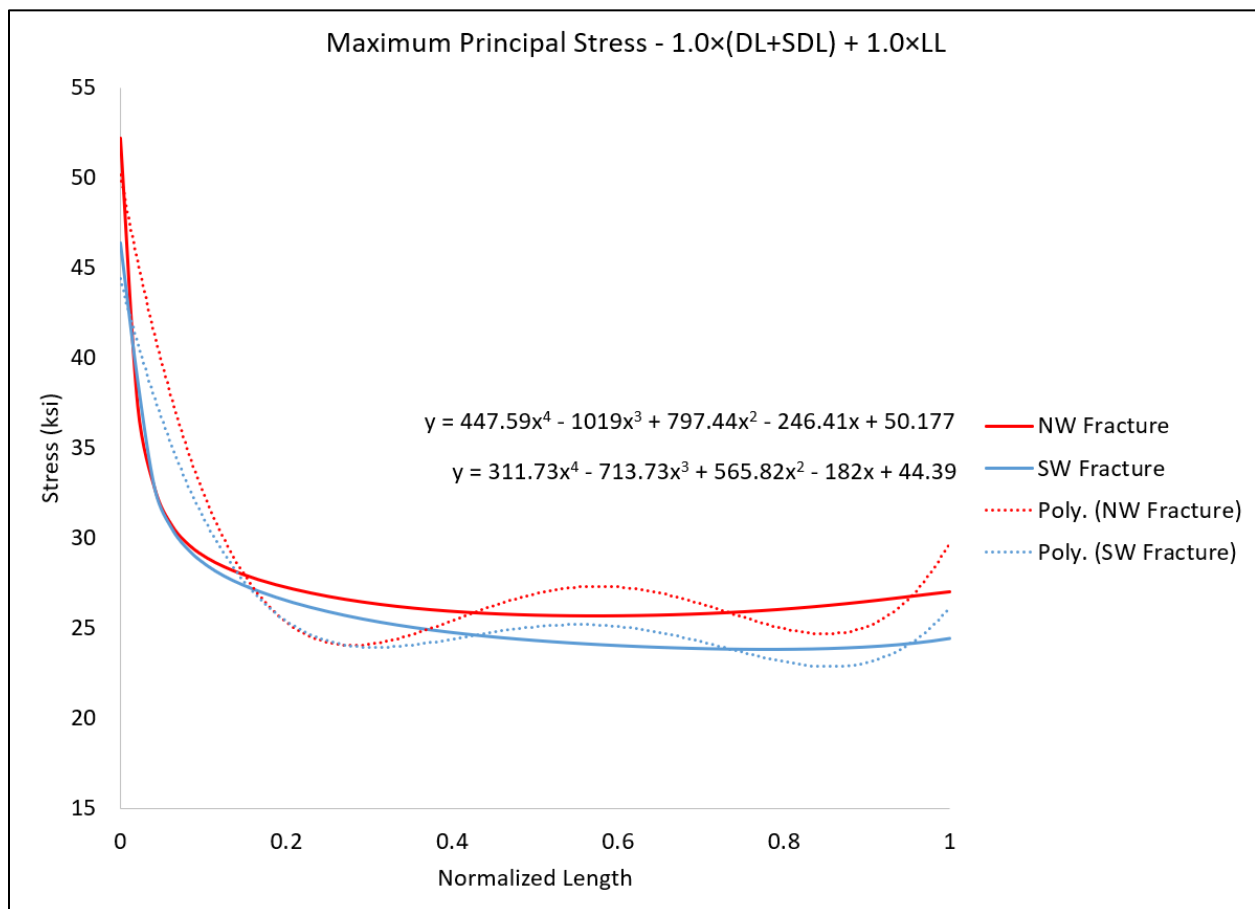
Fig. 96. Flange maximum principal stress along the normalized fracture paths from the weld access holes (0) to the flange edges (1) (see Fig. 94) with the 4th order polynomial fit shown (dashed lines).

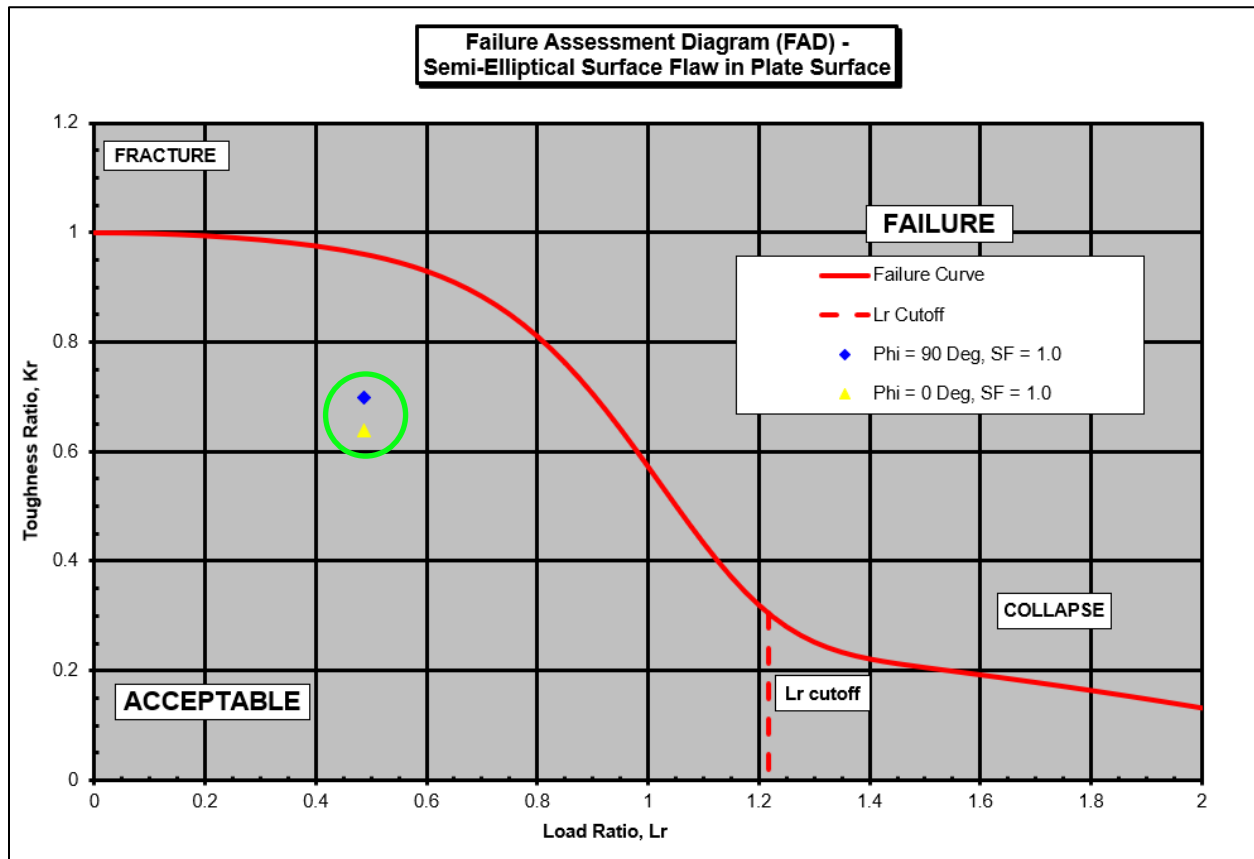
Fig. 97. FAD assessment points, circled in green, due to service stresses only at a fracture toughness of approximately 55 to 60 ksiv.in.

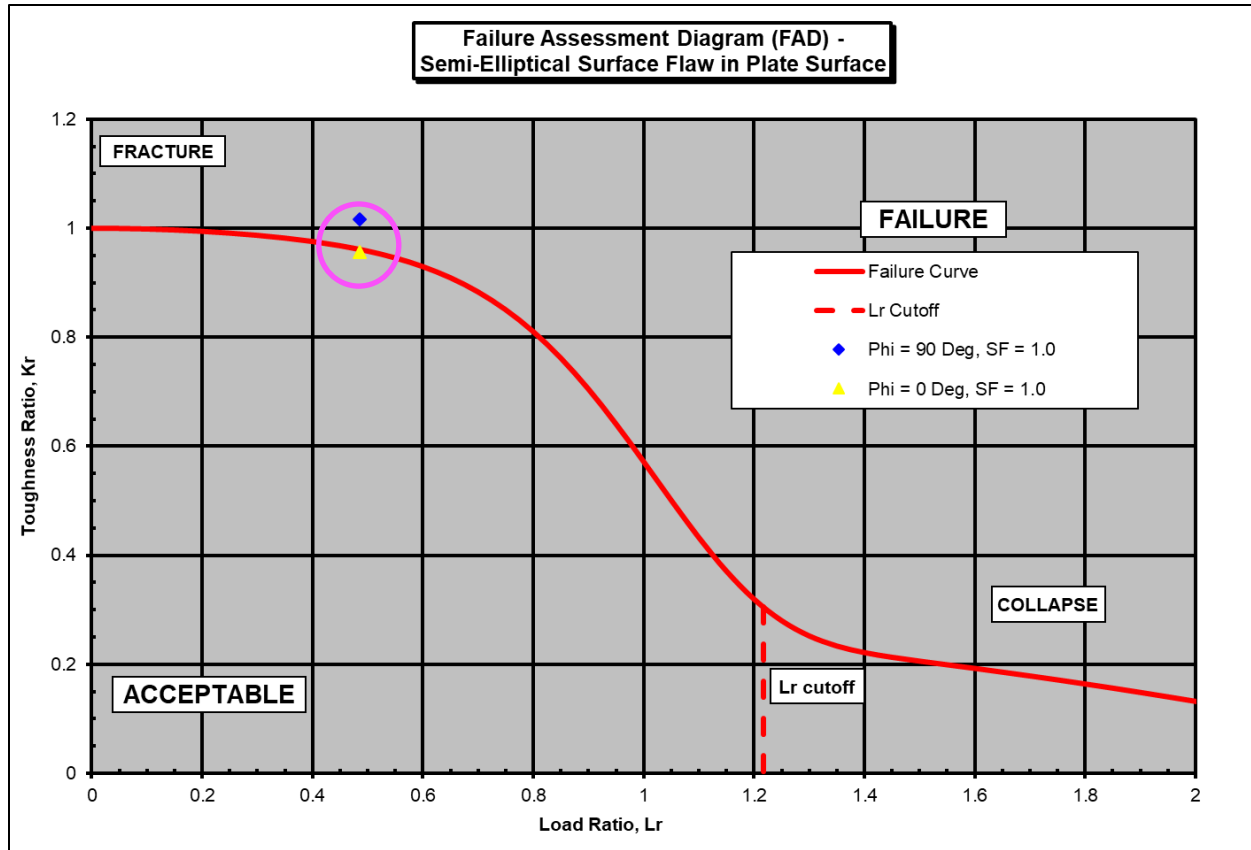
Fig. 98. FAD assessment points, circled in purple, due to service stresses and an additional stress intensity factor due to residual stresses at a fracture toughness of approximately 55 to 60 ksivin.

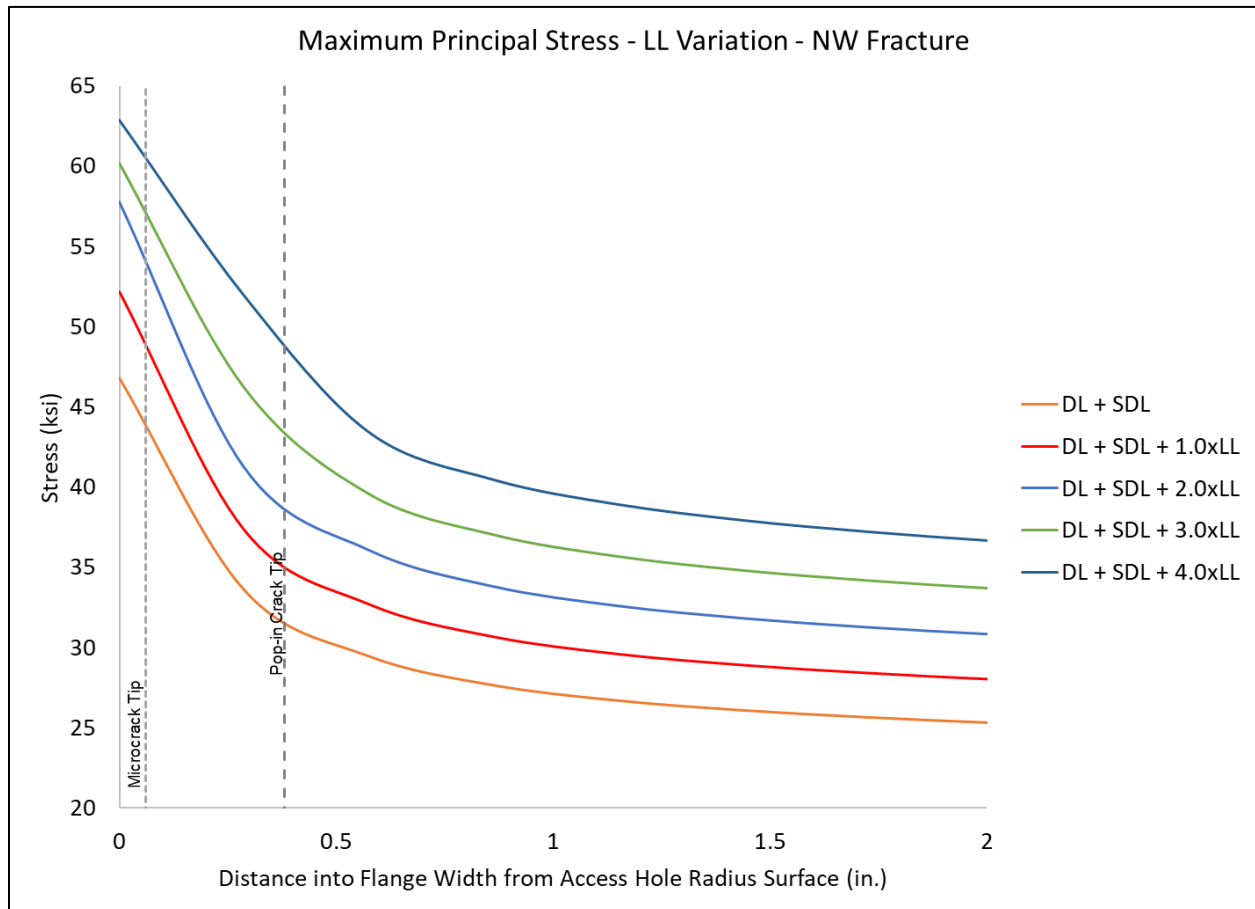
Fig. 99. Maximum principal stress along the NW fracture path for various applied LL. The relative locations on the microcrack and pop-in crack tips are identified by dashed vertical lines.

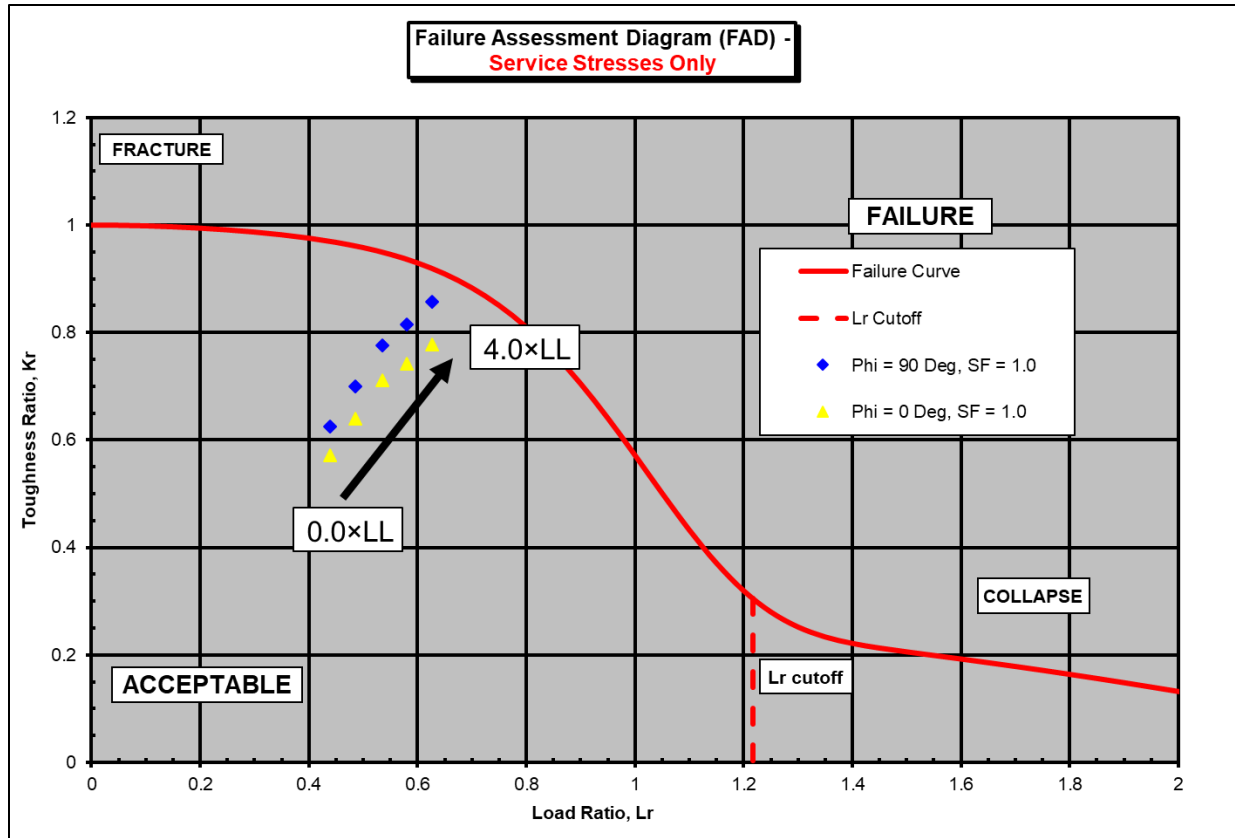
Fig. 100. FAD assessment points due to service stresses only at a fracture toughness of approximately 55 to 60 ksi/in. – LL sensitivity analyses

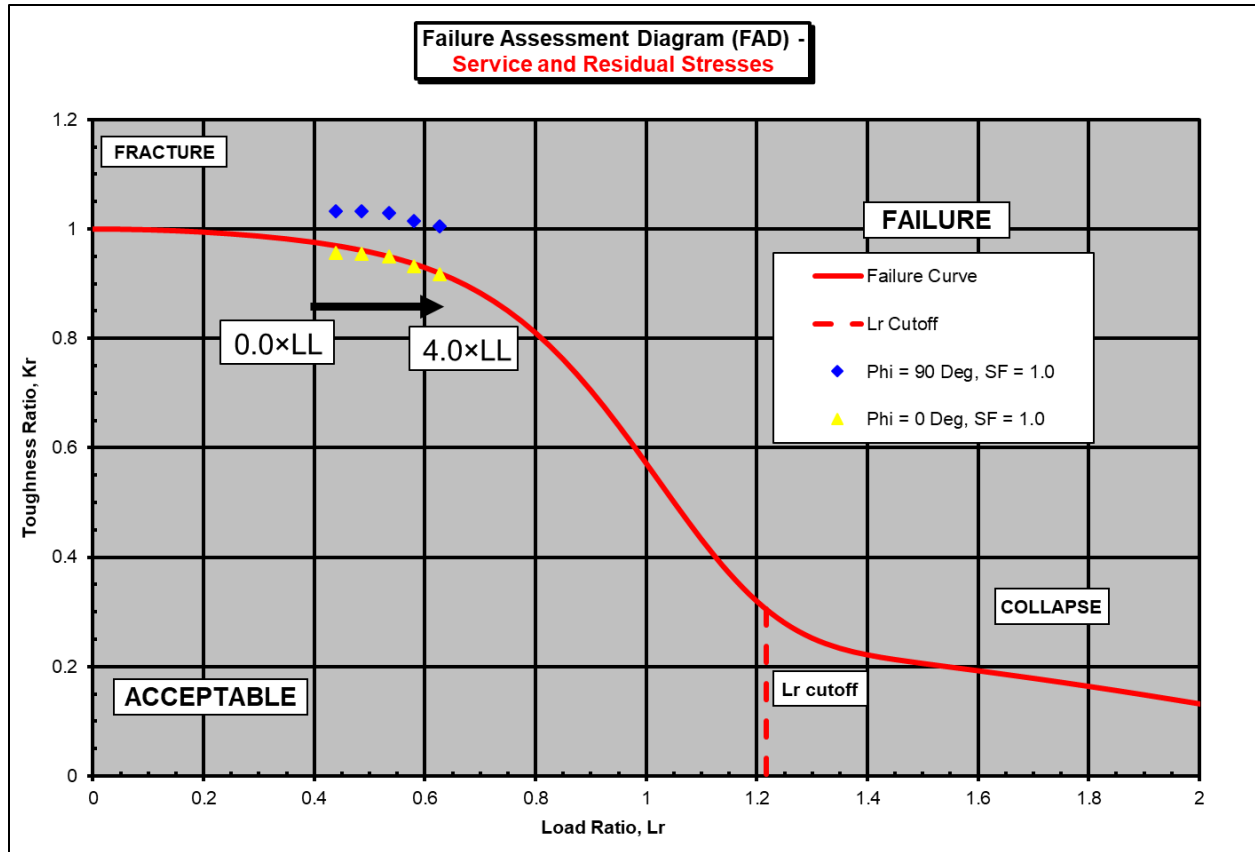
Fig. 101. FAD assessment points due to service stresses and an additional stress intensity factor due to residual stresses at a fracture toughness of approximately 55 to 60 ksi√in. – LL sensitivity analyses
