LPI, Inc. Consulting Engineers

*Advanced Analysis & Fitness for Service
Failure & Materials Evaluation
Nondestructive Engineering*

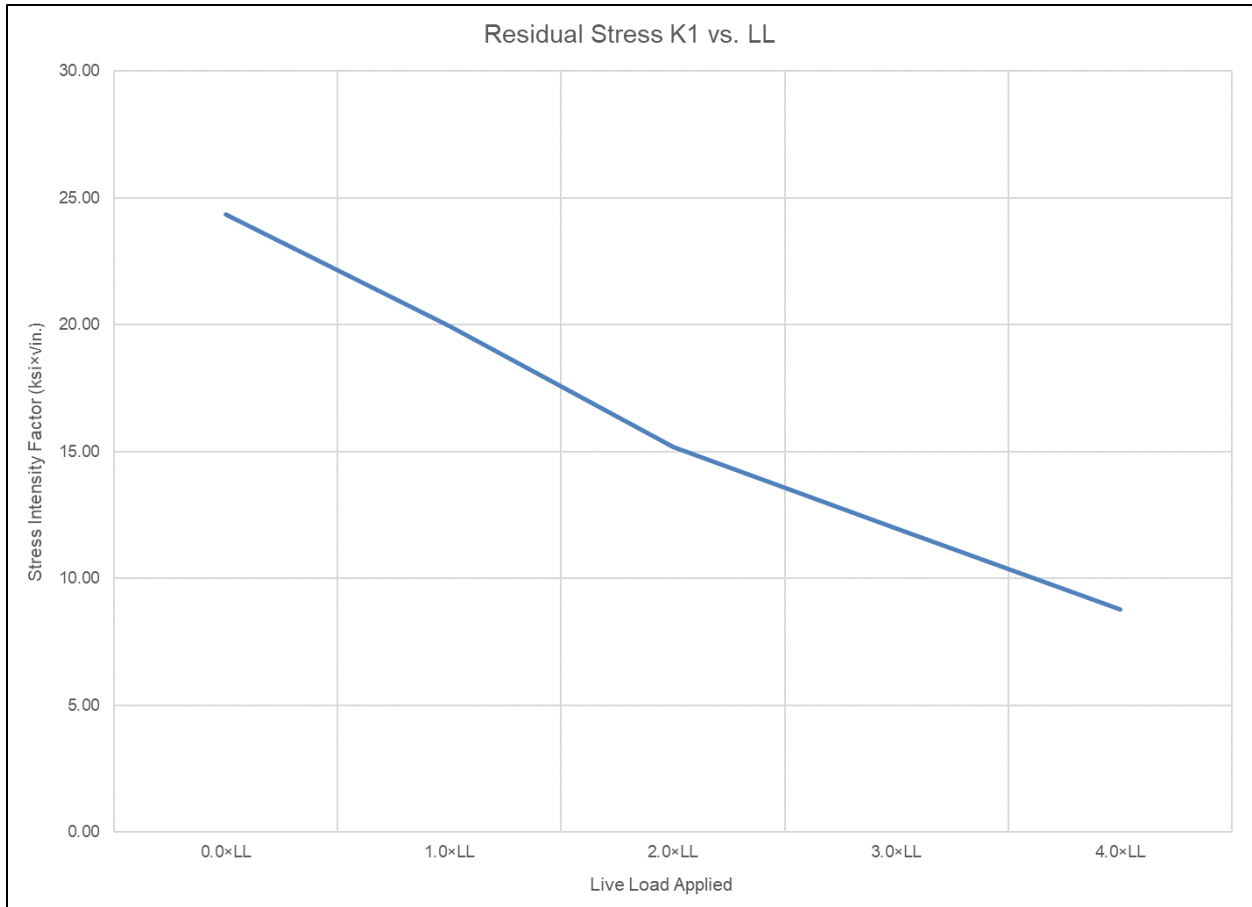
Fig. 102. Residual stress K_1 necessary to cause fracture of the Fig. 100 assessment points, as shown in Fig. 101, at a fracture toughness of approximately 55 to 60 ksi√in. – LL sensitivity analyses

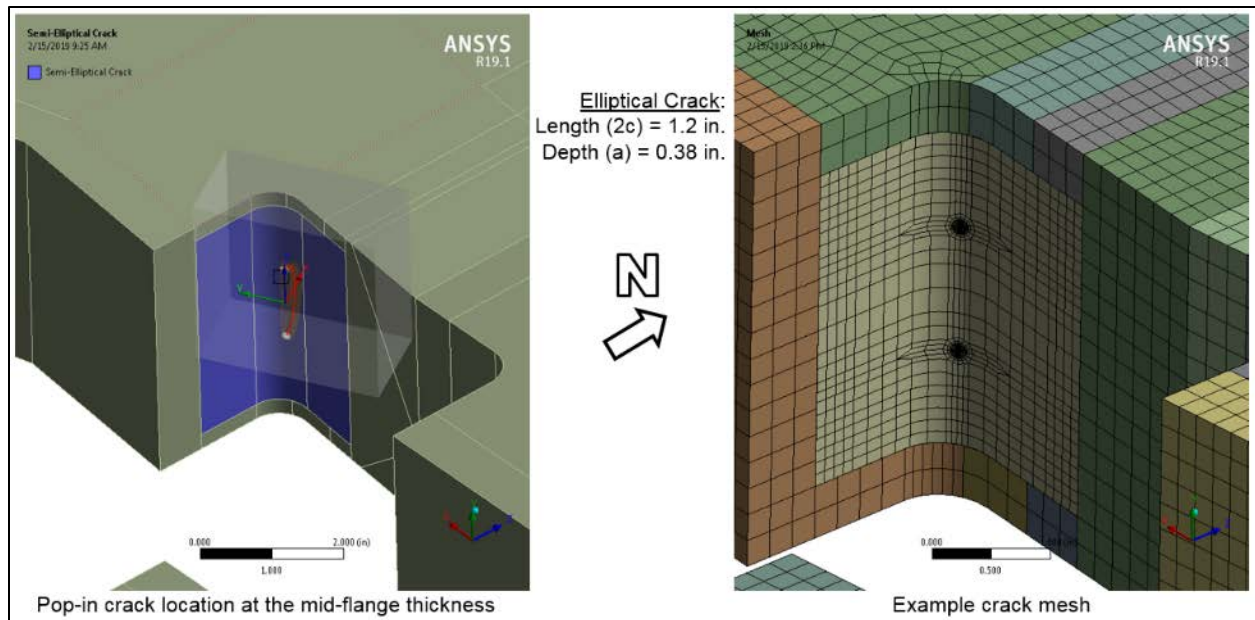
Fig. 103. FE model and mesh with the pop-in crack included.

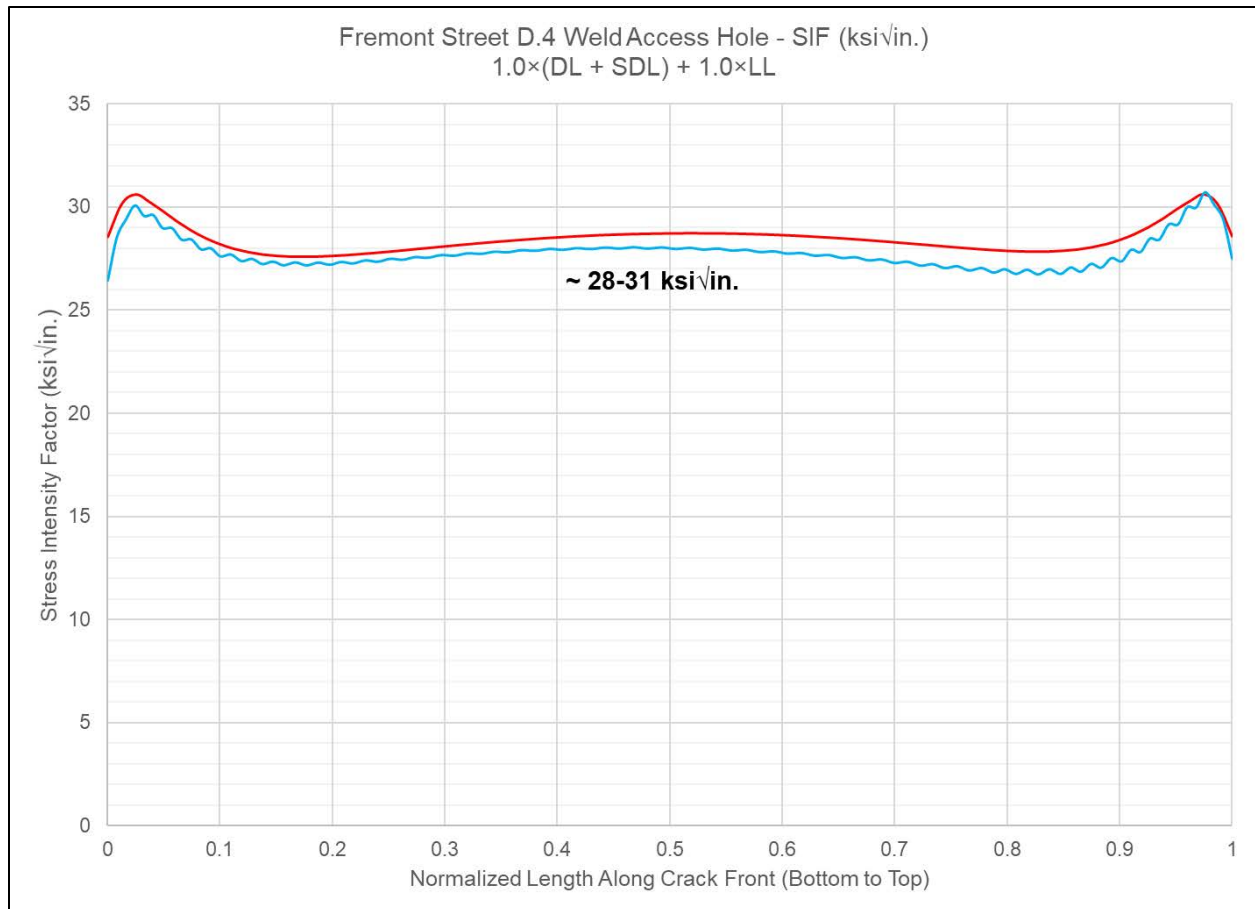
Fig. 104. FE stress intensity factor along the pop-in crack front due to service loading.

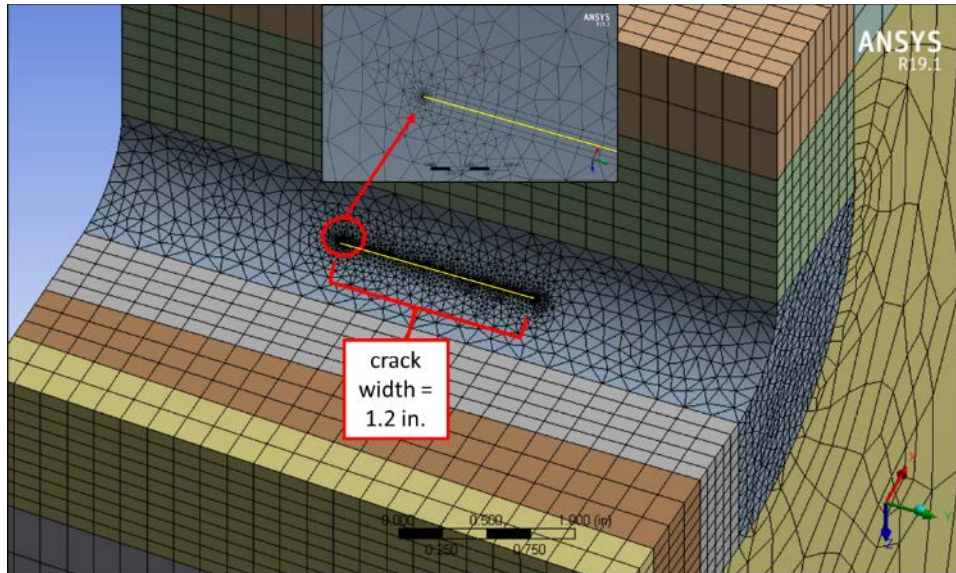
Fig. 105. Fremont Street crack mesh for the 0.06 in. deep x 1.2 in. long pre-existing microcrack prior to pop-in crack formation. Free surface of microcrack is shown in yellow.

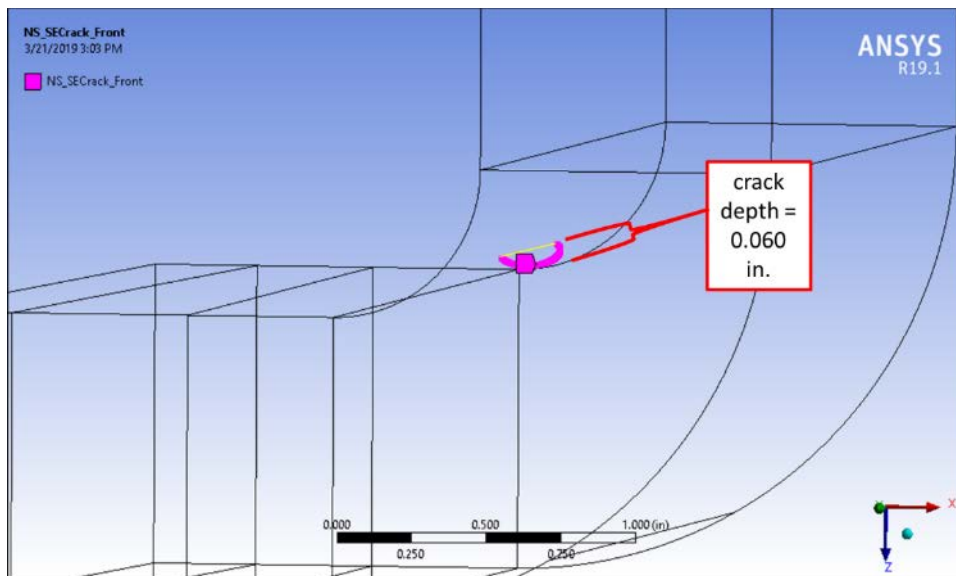
Fig. 106. Wireframe view showing depth of the microcrack of Fremont Street FE model. The purple line indicates the crack front.

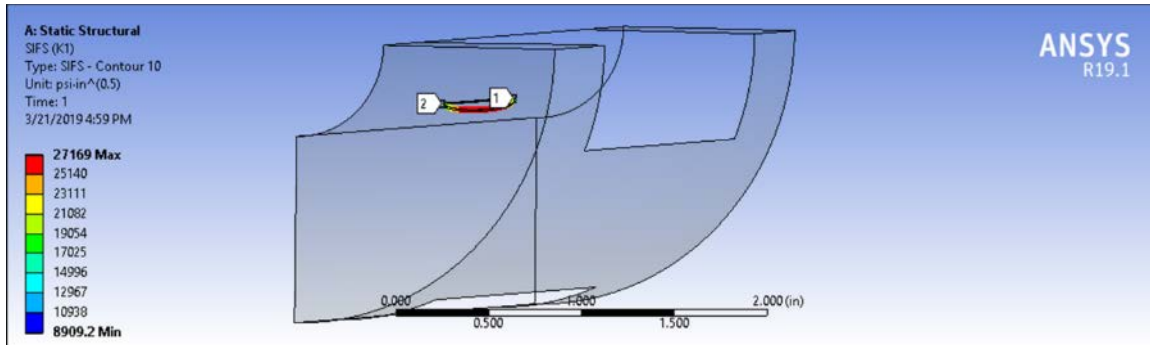
Fig. 107. Microcrack stress intensity factor plot the Fremont Street FE model subject to weld-shrinkage loading. Plot corresponds to outermost contour around the crack front, with a peak K_1 of approximately 27 ksi $\sqrt{\text{in}}$.

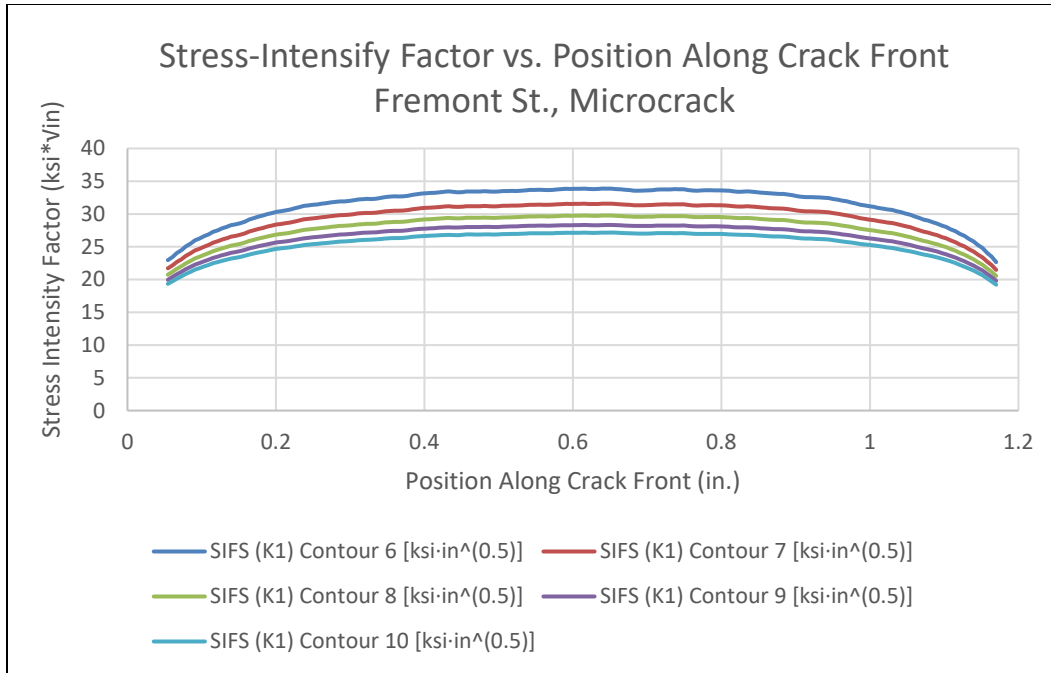
Fig. 108. Stress intensity factor (K_1) versus position along crack front for the microcrack in the Fremont Street FE model under groove-weld-shrinkage loading. Contours 6 through 10 show a converging trend (from top curve to bottom curve) toward a K_1 of approximately $27 \text{ ksi}\sqrt{\text{in}}$.

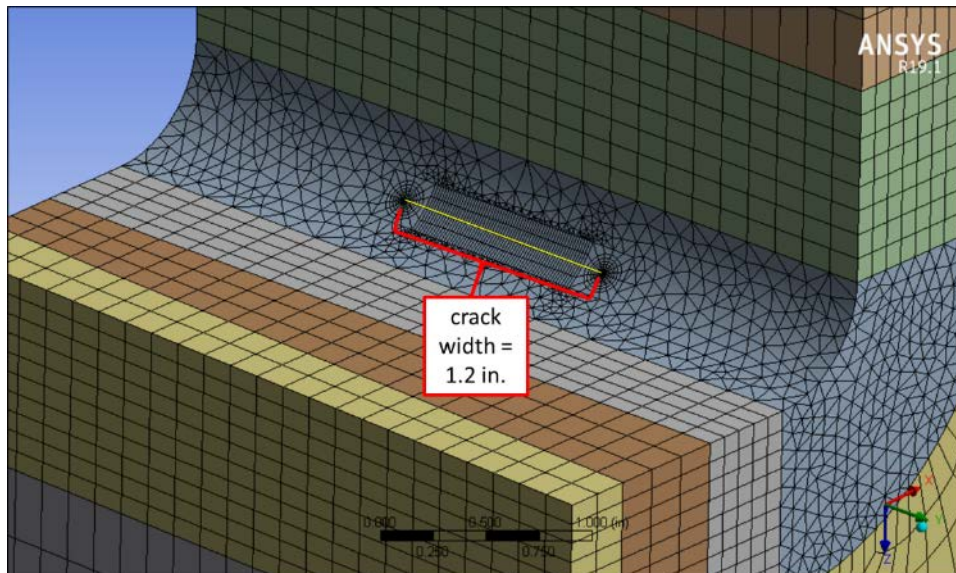
Fig. 109. Fremont Street crack mesh for the 0.38 in. deep x 1.2 long pre-existing pop-in crack. The free surface of crack is shown in yellow.

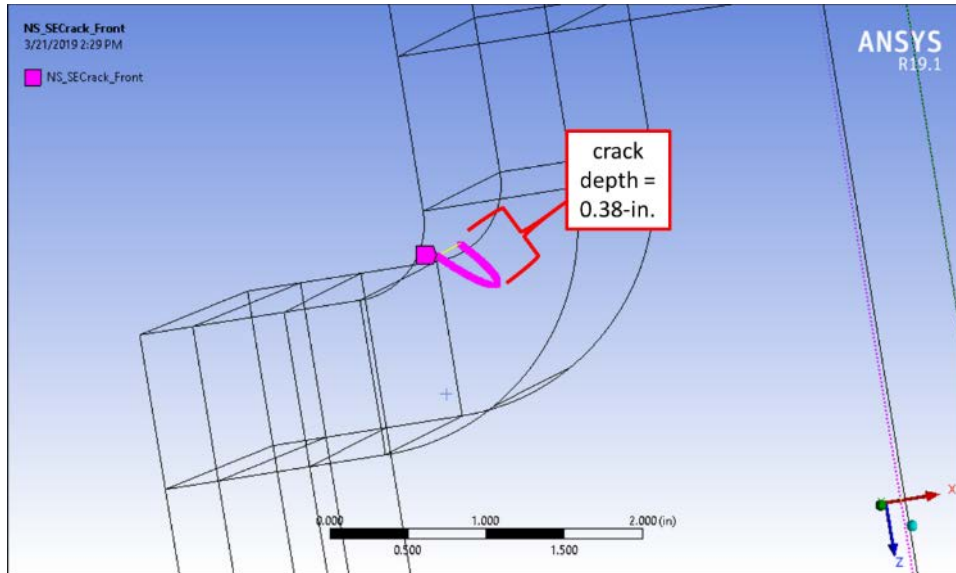
Fig. 110. Wireframe view showing the depth of the Fremont Street pop-in crack. The purple line indicates the crack front.

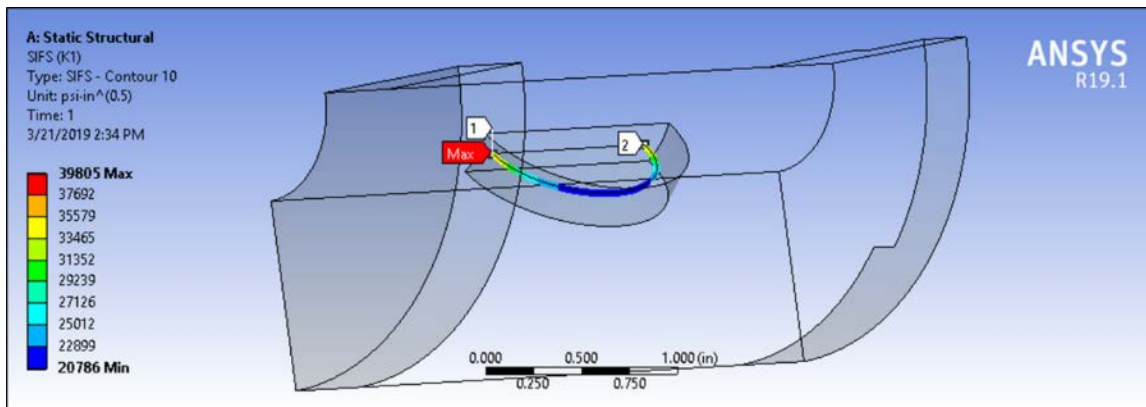
Fig. 111. Stress intensity factor across the crack front of the Fremont Street pop-in crack due to weld-shrinkage loading.

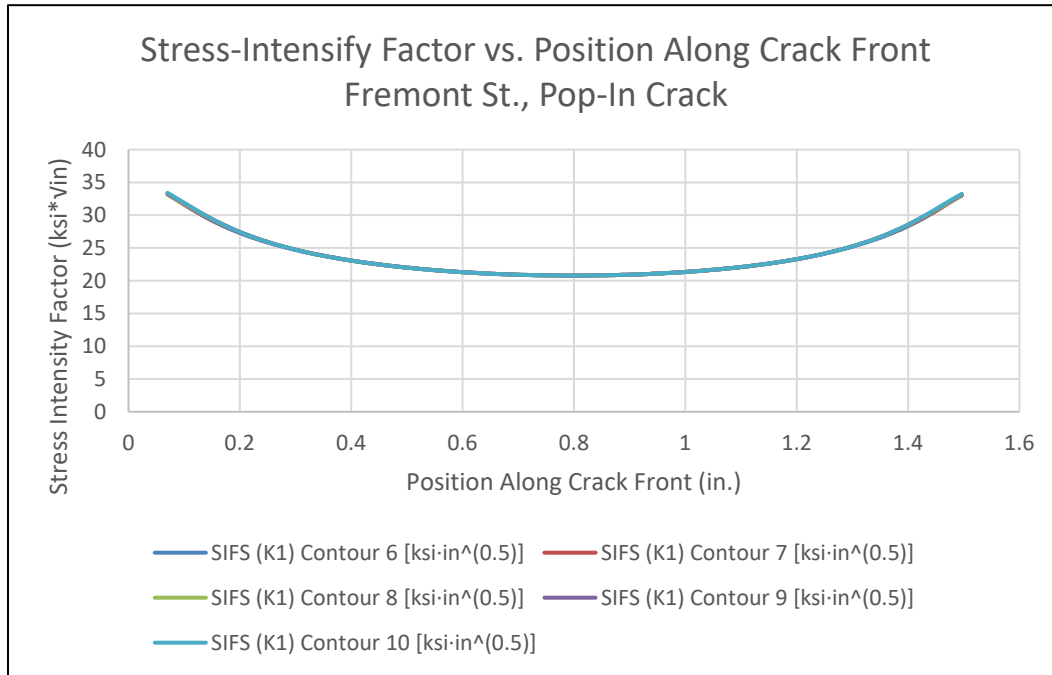
Fig. 112. Stress intensity factor (K_1) versus position along crack front for the pop-in crack in the Fremont Street FE model under groove-weld-shrinkage loading. Contours 6 through 10 show a converging trend (from top curve to bottom curve) toward a K_1 of approximately $21 \text{ ksi}\sqrt{\text{in}}$.

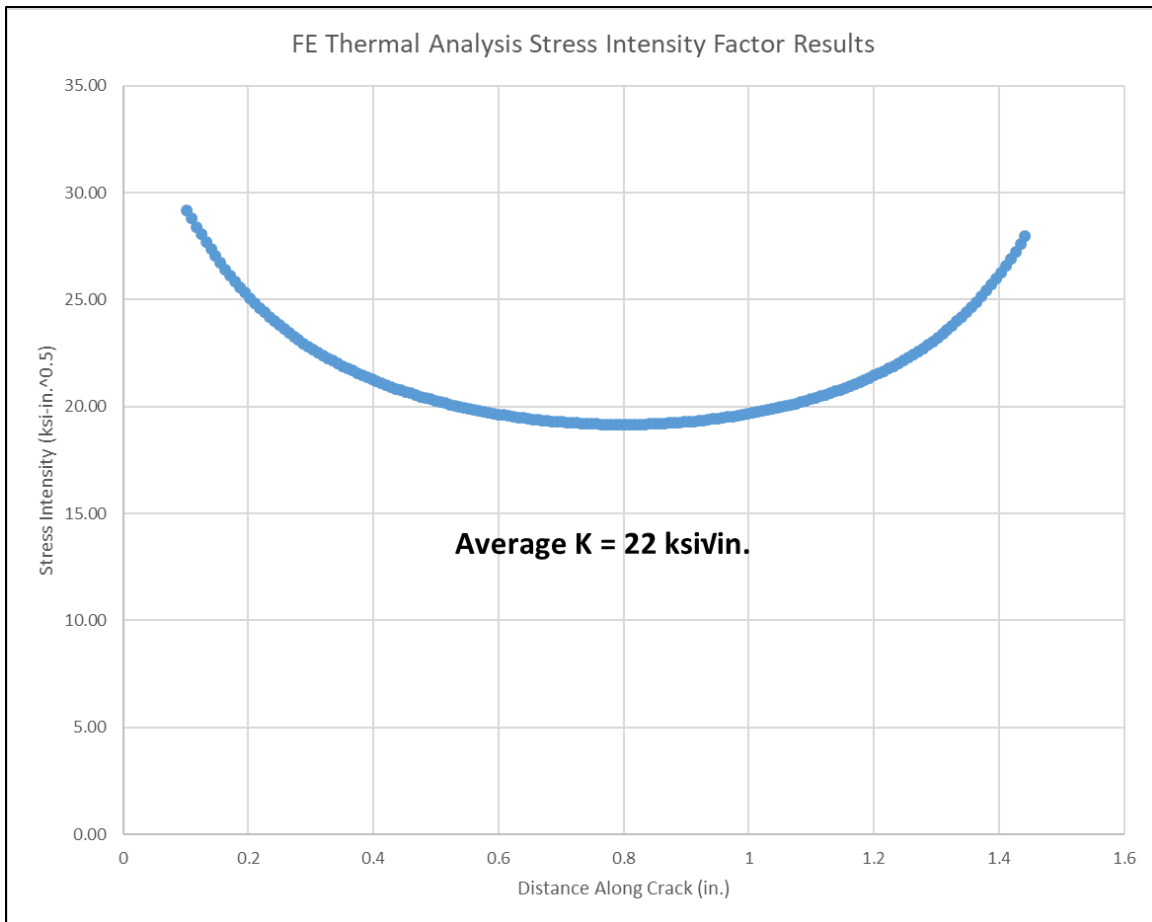
Fig. 113. FE stress intensity factor along the pop-in crack front due to weld-shrinkage thermal loading (residual stresses).

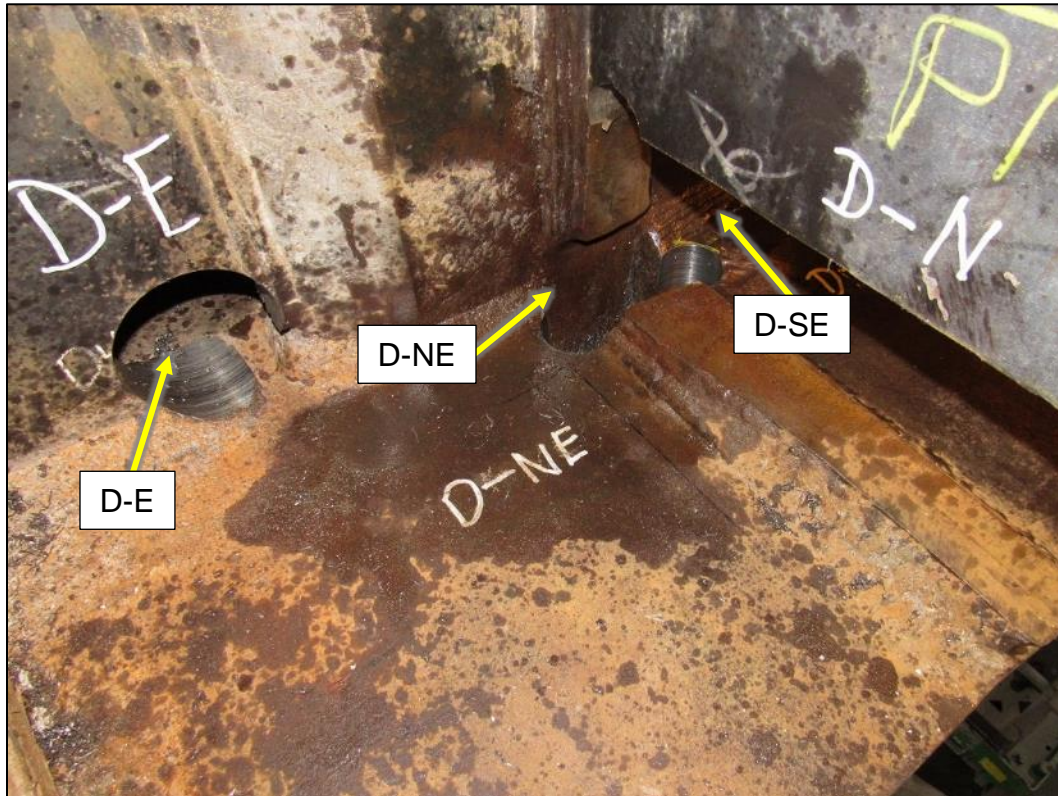
Fig. 114. North girder above First Street after core sample removal.

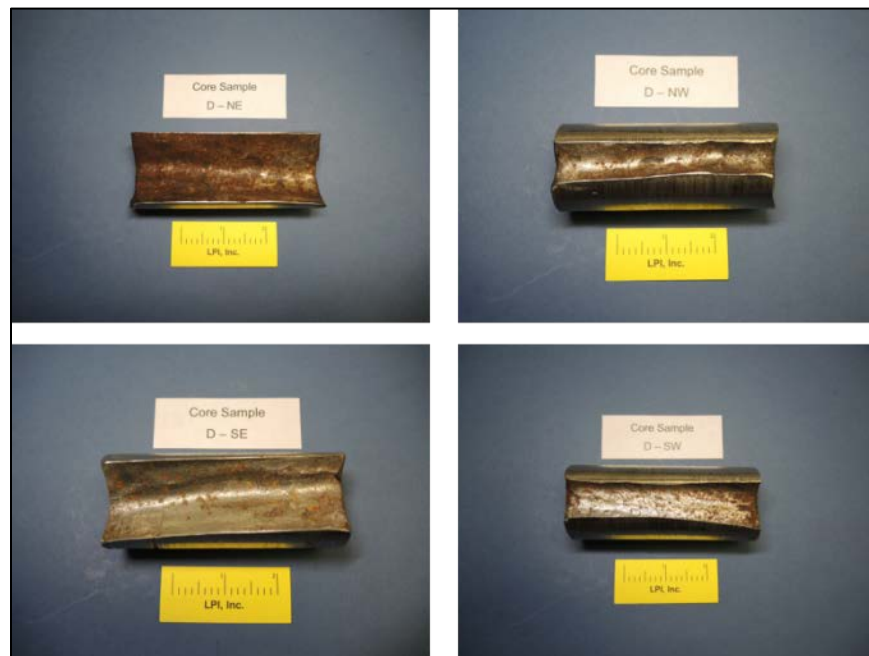
Fig. 115. Flange core samples from the north girder above First Street (Girder D) in the as-received condition.

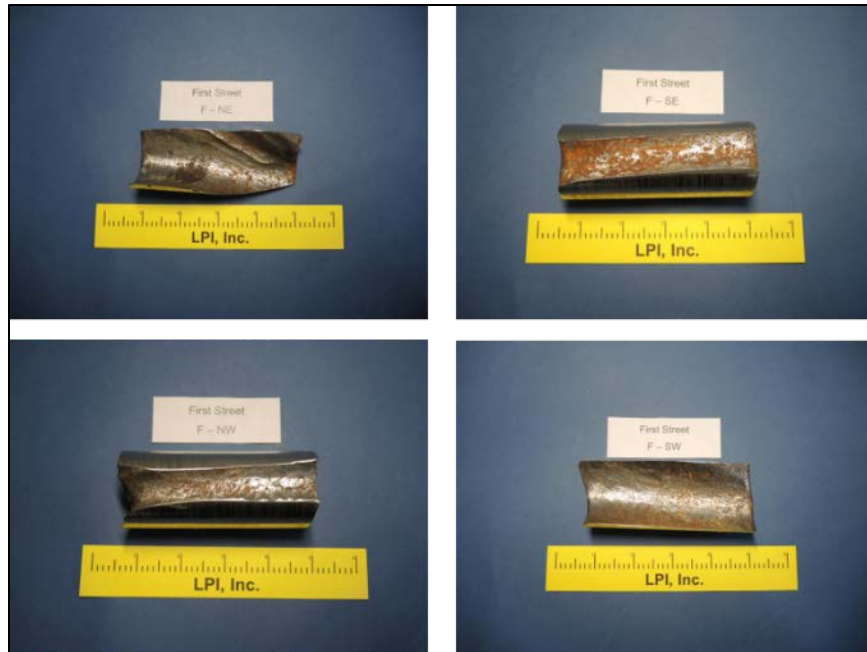
Fig. 116. Flange core samples from the south girder above First Street (Girder F) in the as-received condition.

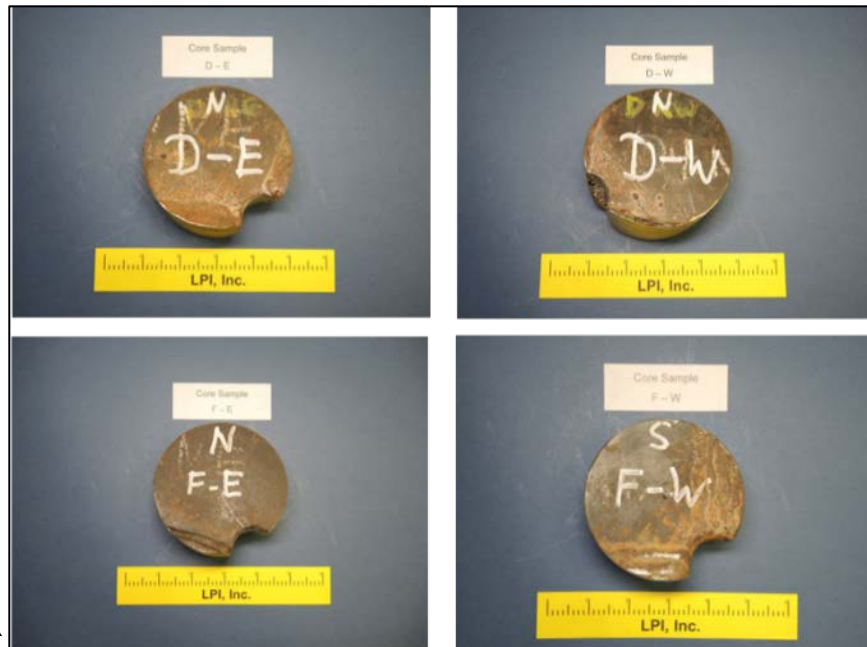
Fig. 117. Web core samples from the girders above First Street (Girders D and F) in the as-received condition.

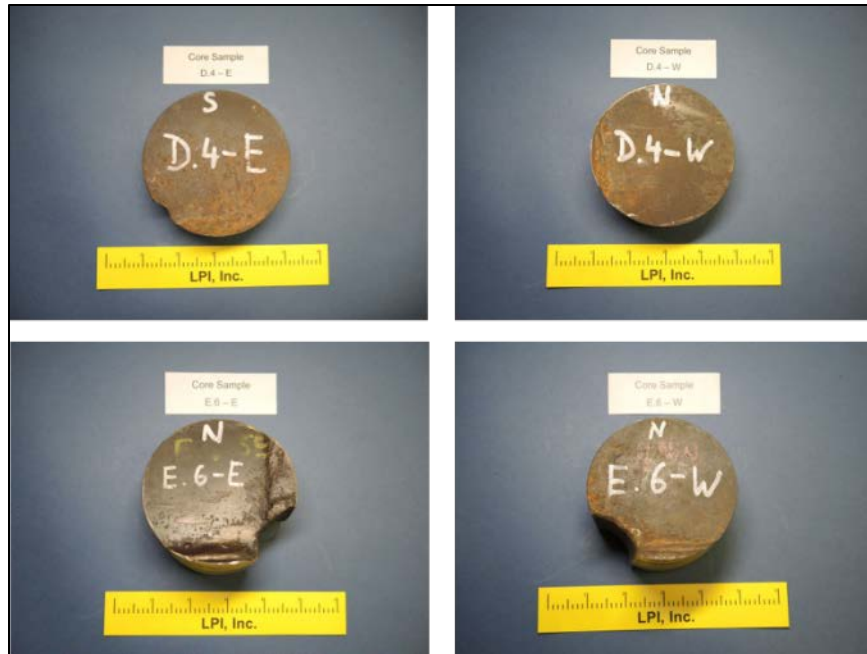
Fig. 118. Web core samples from the girders above Fremont Street (Girders D.4 and E.6) in the as-received condition.

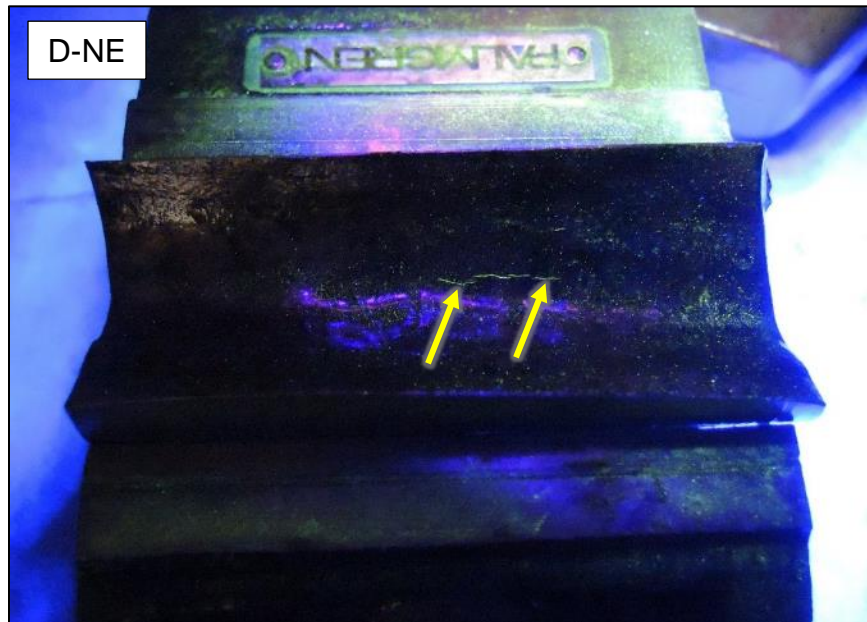
Fig. 119. Representative image of the flange weld access hole surface of core sample D-NE following wet fluorescent magnetic particle testing showing cracks (arrows).

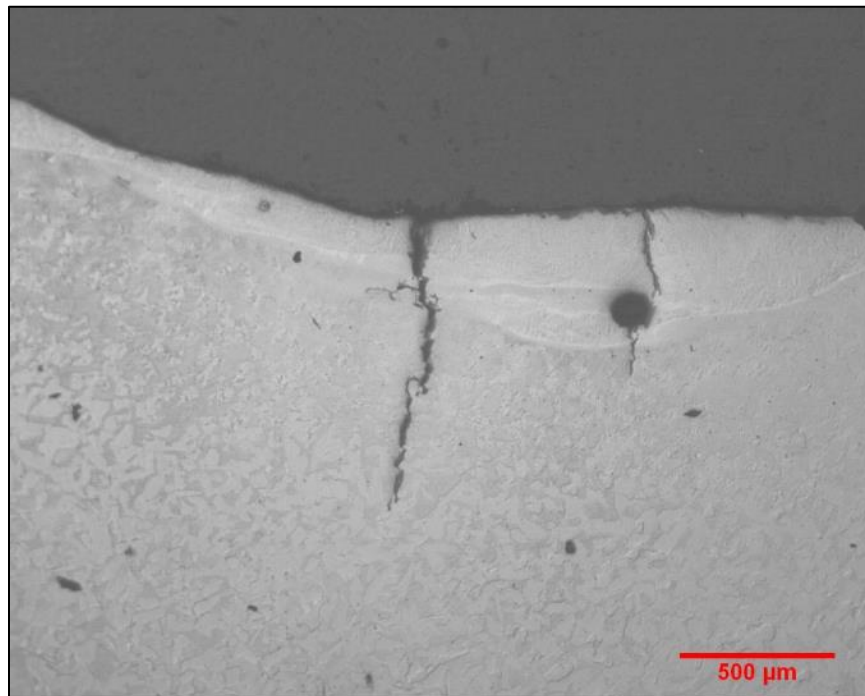
Fig. 120. Representative metallographic image of the flange weld access hole surface of core sample D-NW revealing cracks in the martensitic surface layer.

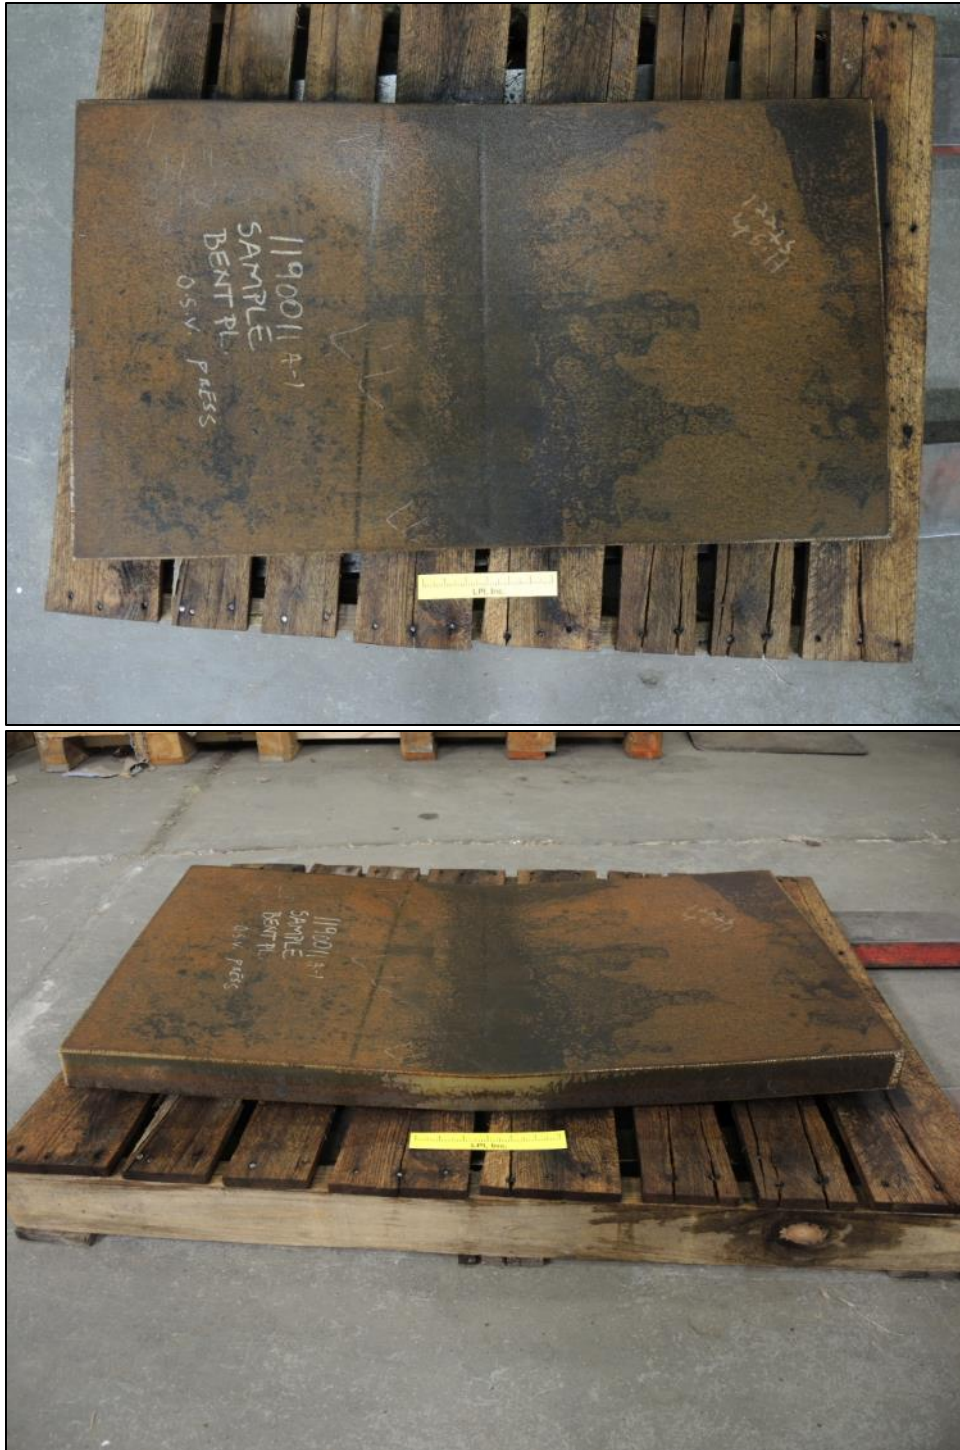
Fig. 121. Sample repair plate in the as-received condition.

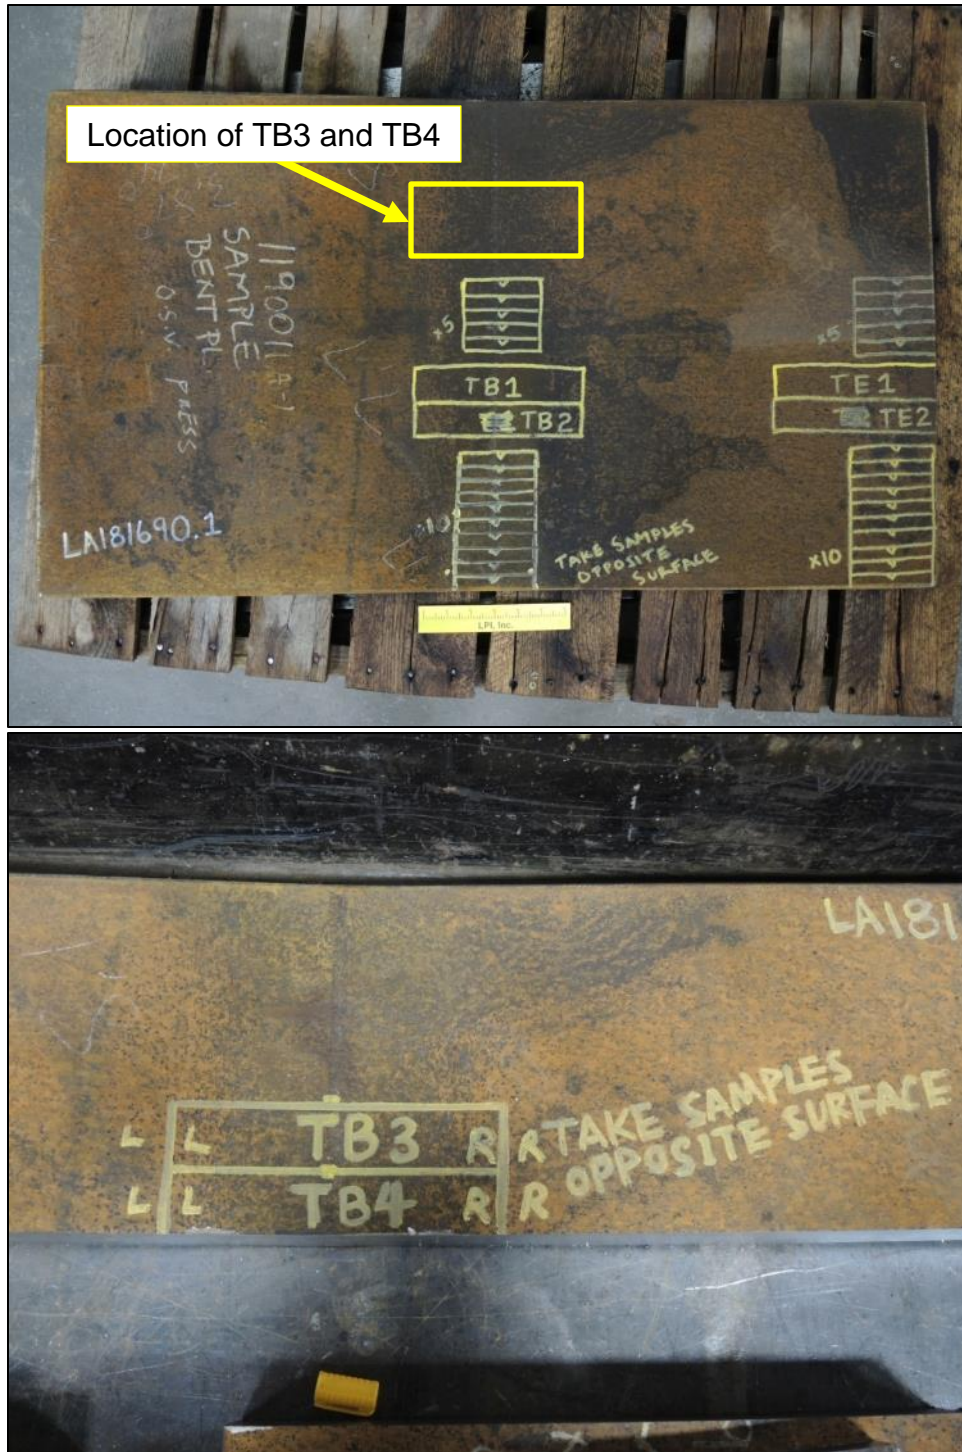
Fig. 122. Tensile and CVN specimen location mark-up prior to sectioning.

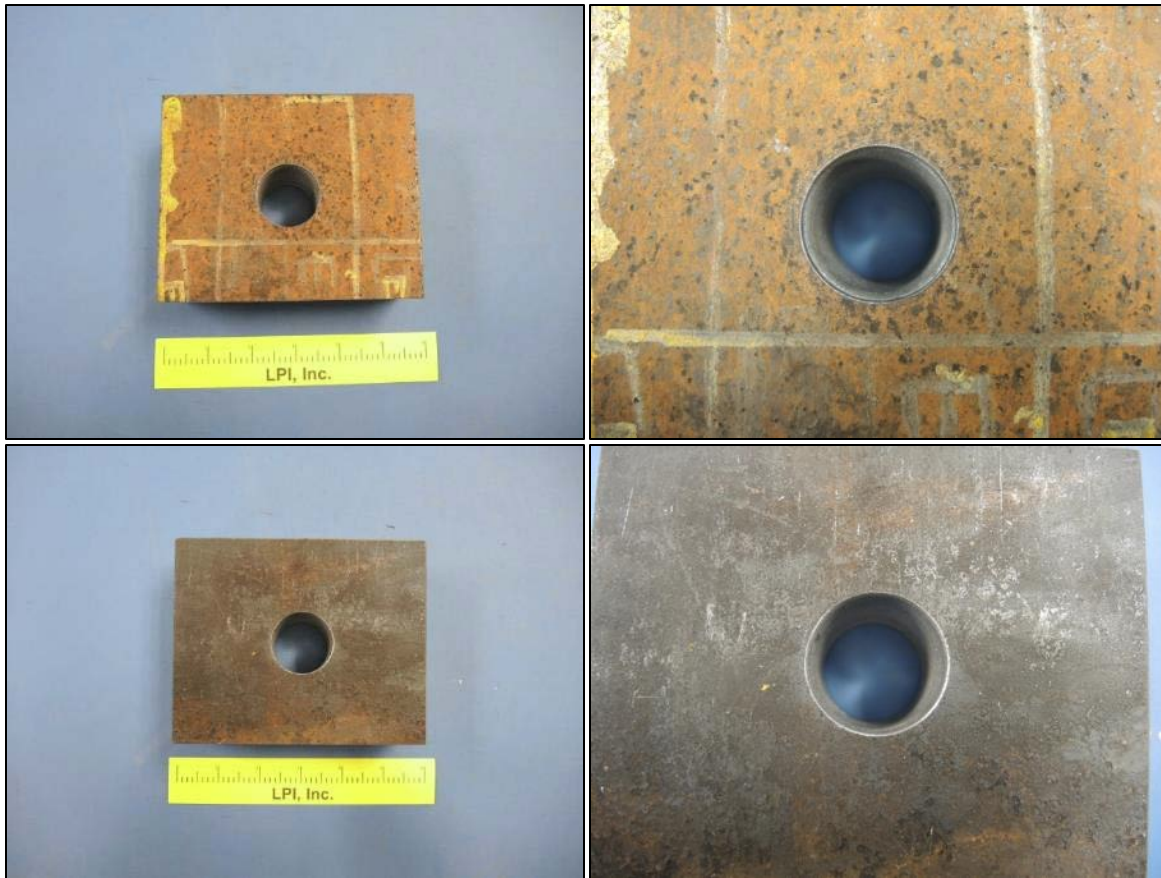
Fig. 123. Overall and close-up images of the two bolt holes drilled in the sample repair plate.

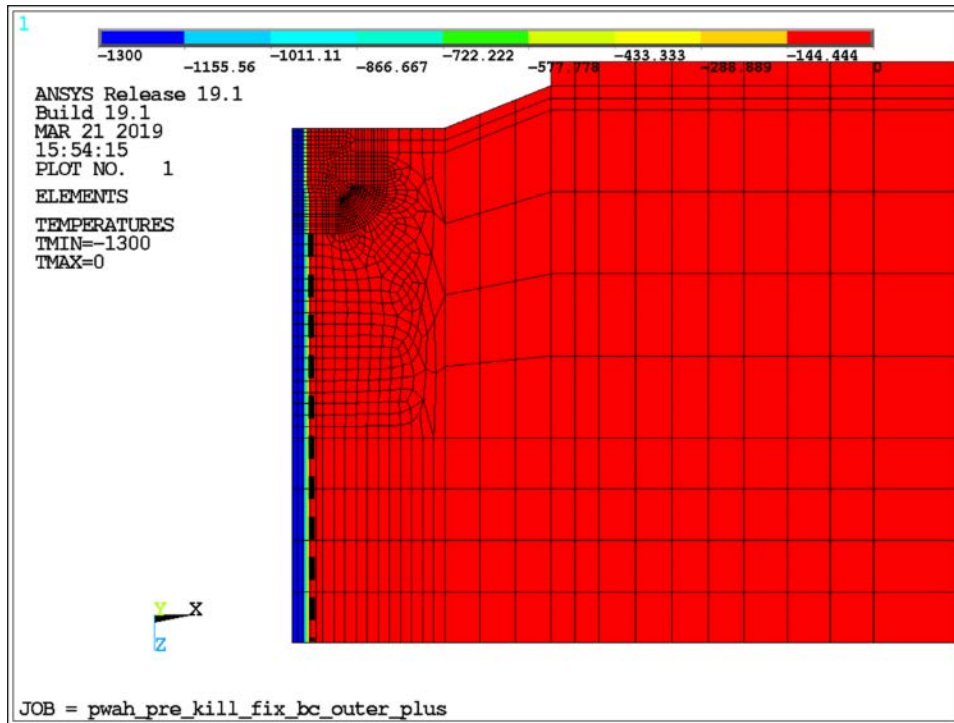
Fig. 126. Dashed line indicates section through First Street FE model on which displacements are fixed after temperature load is first applied, but before their deletion during the simulation of access-hole cutting.

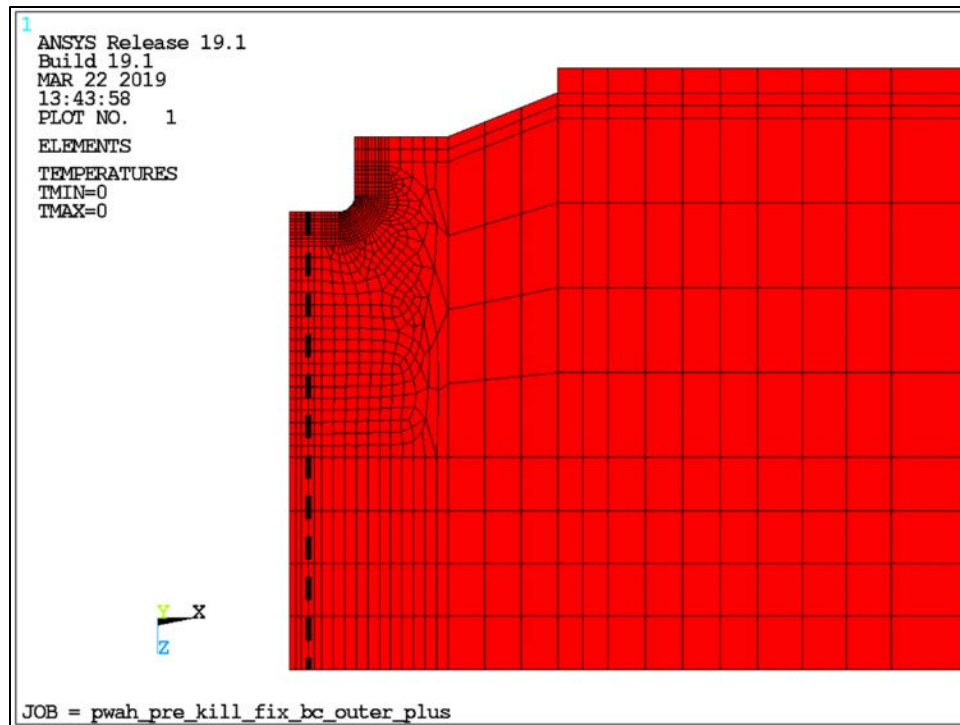
Fig. 127. First Street FE model after the access hole was created and temperature loading removed. Dotted line indicates section on which displacements caused by initial temperature loading are fixed, thereby locking in the shrinkage effect of the weld.

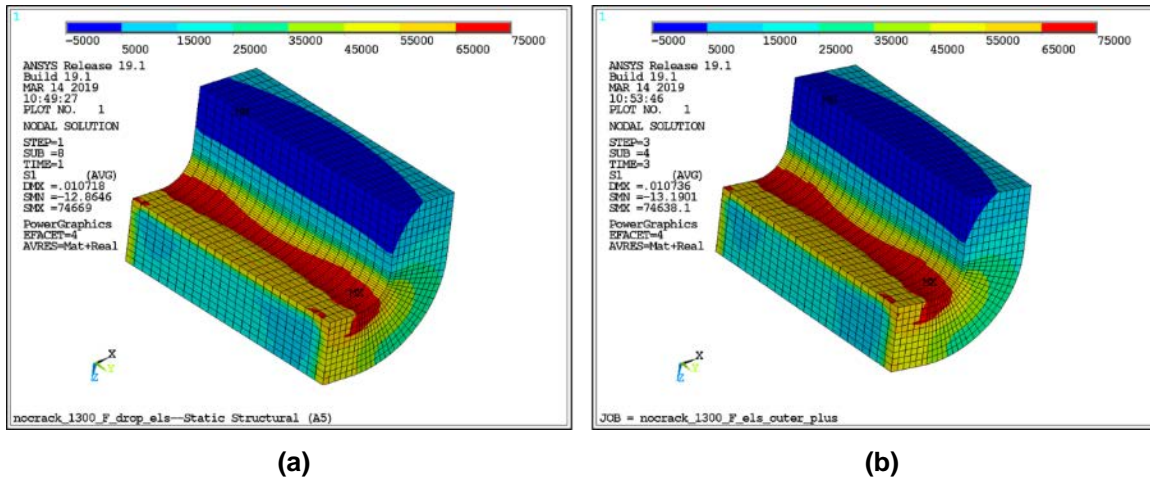
Fig. 128. Results of applying First Street FE model's displacement-locking method to Fremont Street FE model for verification. Fig. 53 results are repeated here in (a) for comparison to results using displacement-locking followed by deleted temperature loads, (b). It is clear that the calculated stress distributions are nearly identical.

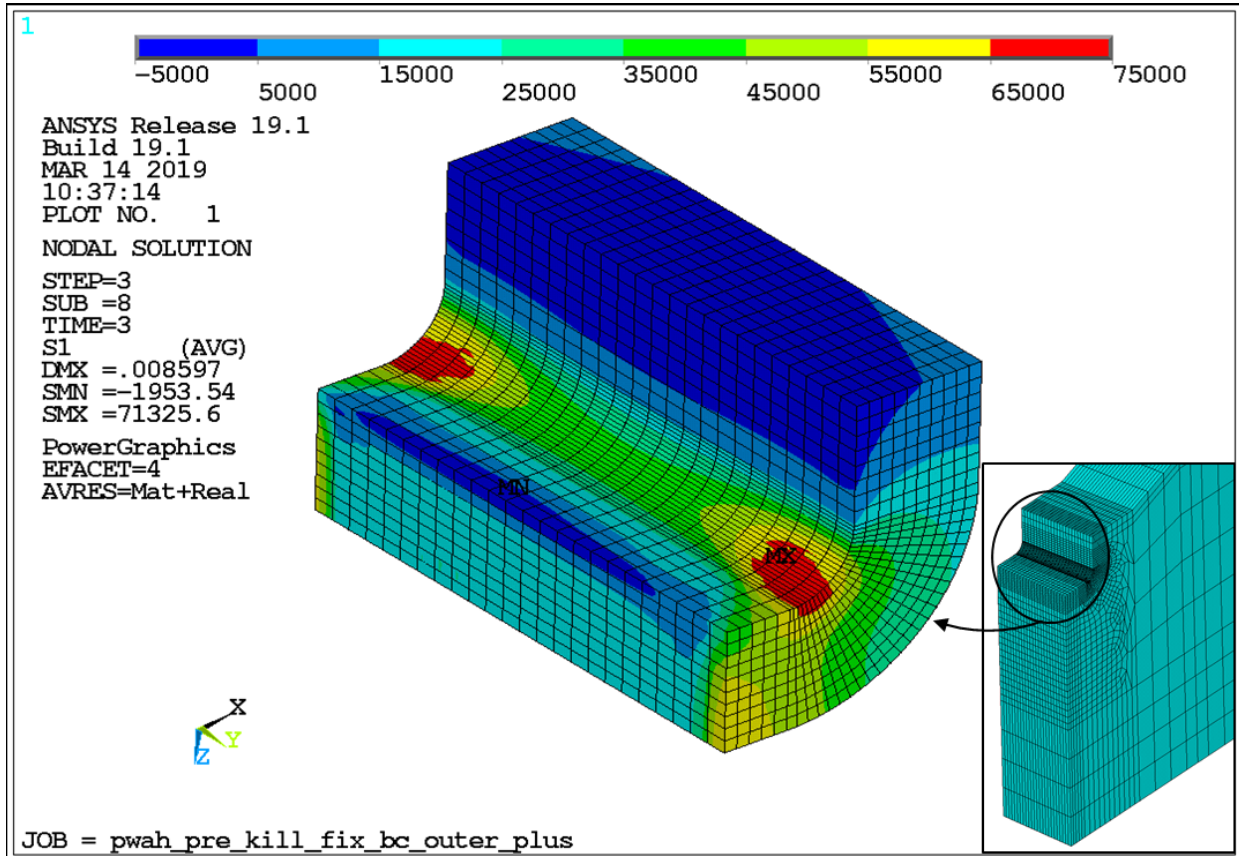
Fig. 129. Distribution of maximum principal stress local to access hole radius following cutting of the access hole in the First Street FE model. Except for the peak stress at the surfaces, the mid-thickness stresses are much lower than Fremont Street.

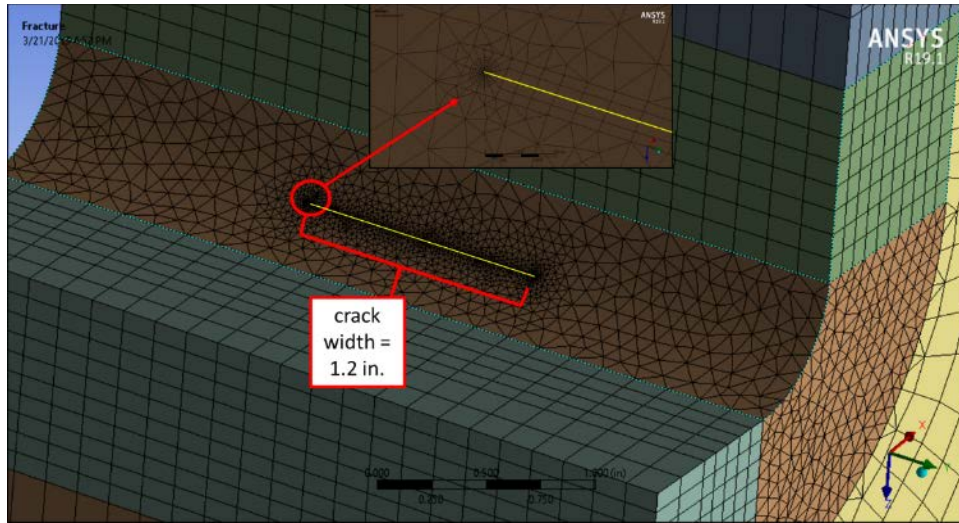
Fig. 132. Crack mesh of First Street FE model. Crack is semi-elliptical, 0.06 in. deep x 1.2-in. long, representing microcracks existing before pop-in crack initiation. Free surface of crack shown in yellow; inset shows close-up view of the structured character of the specialized mesh employed.

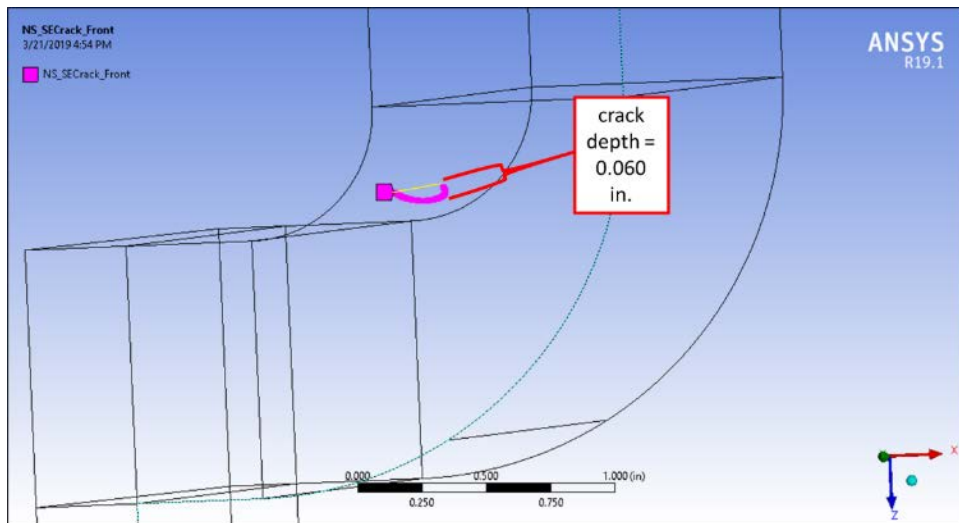
Fig. 133. Wireframe view showing depth of the microcrack of First Street FEM. Purple line shows the crack front.

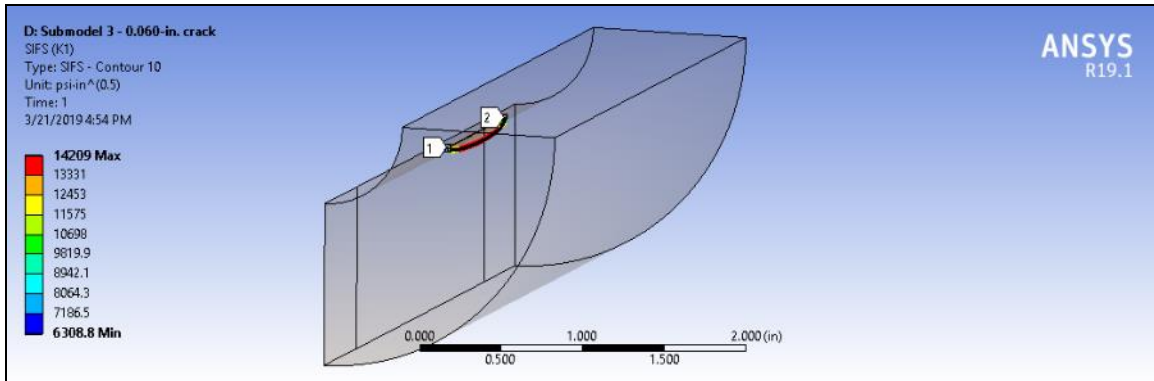
Fig. 134. Microcrack stress intensity factor for the First Street FE model subject to weld-shrinkage loading. Plot corresponds to the outermost contour around the crack front, with a peak K_I of approximately $14 \text{ ksi}\sqrt{\text{in}}$.

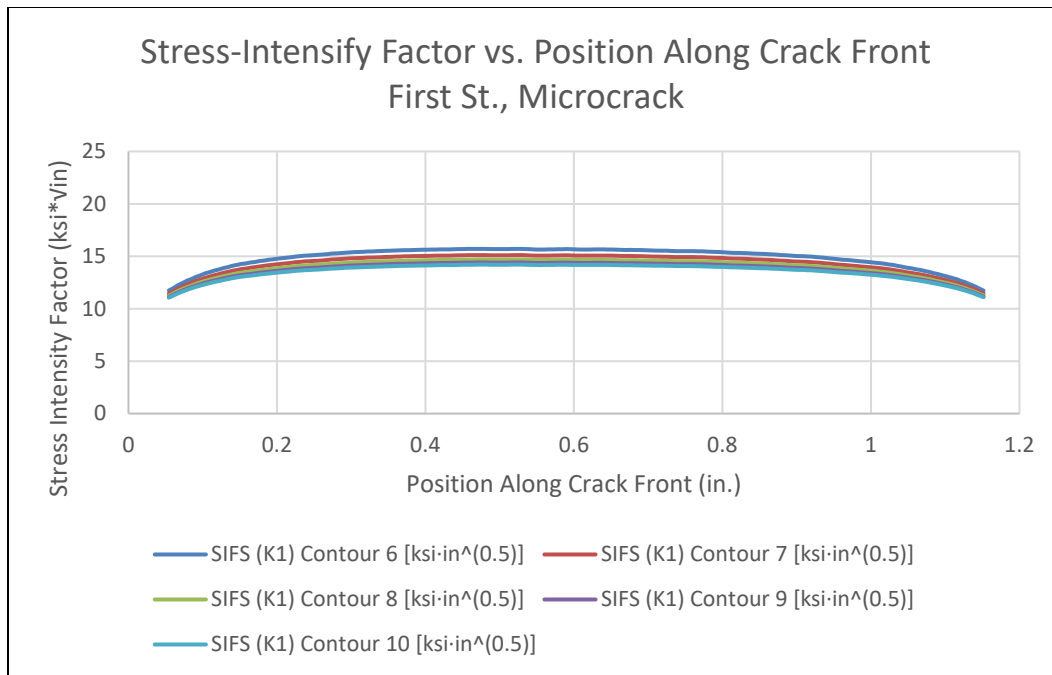
Fig. 135. Stress intensity factor (K_I) versus position along crack front for the microcrack in the First Street FE model under groove-weld-shrinkage loading. Contours 6 through 10 show a converging trend (from top curve to bottom curve) toward a K_I of approximately $14 \text{ ksi}\sqrt{\text{in}}$.
