LPI, Inc. Consulting Engineers

*Advanced Analysis & Fitness for Service
Failure & Materials Evaluation
Nondestructive Engineering*

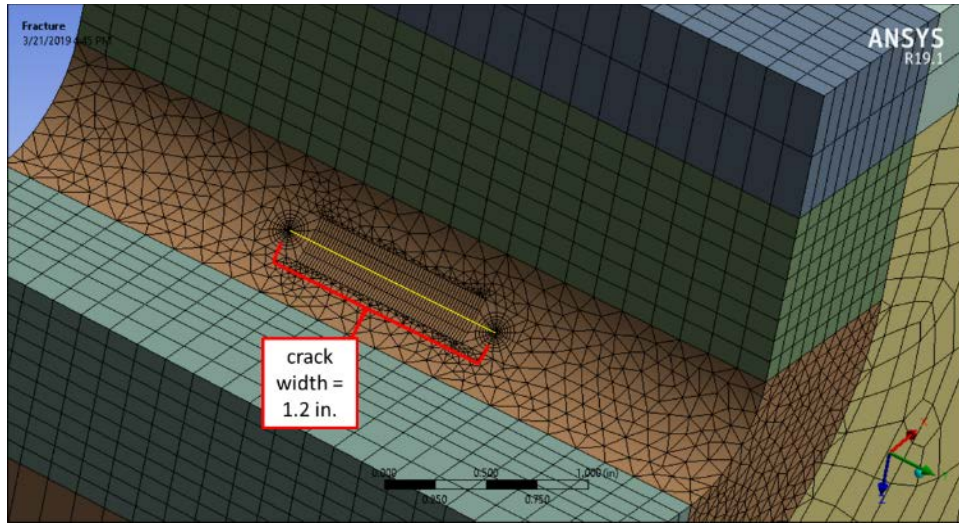
Fig. 136. Crack mesh of First Street FE model. Crack is semi-elliptical, 0.38 in. deep x 1.2-in. wide, 0.38-in. representing the pop-in crack. Free surface of crack shown in yellow. Structured character of specialized mesh local to crack is evident.

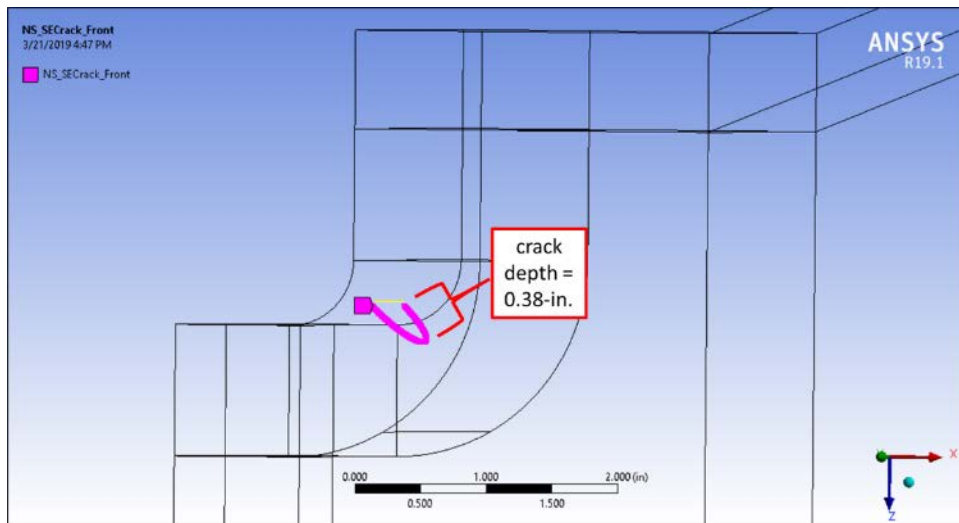
Fig. 137. Wireframe view showing depth of the pop-in crack of First Street FEM. Purple line shows the crack front.

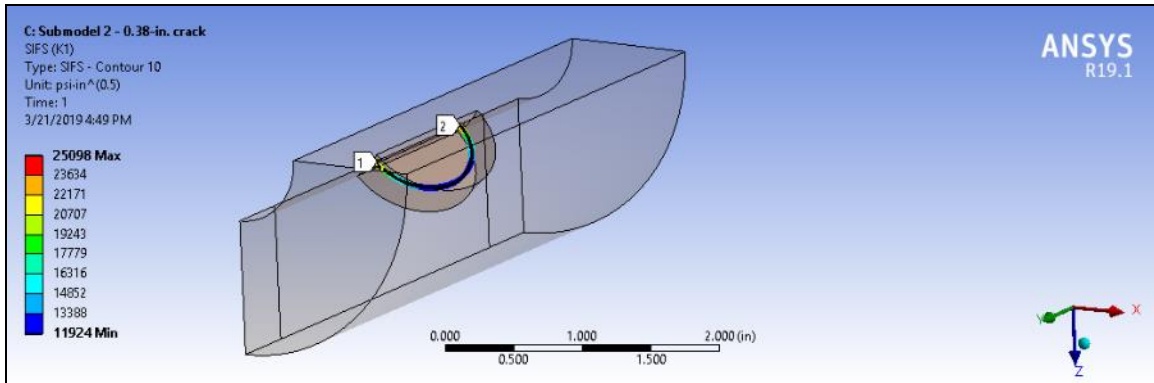
Fig. 138. Pop-in crack stress intensity factor for the First Street FE model subject to weld-shrinkage loading. Plot corresponds to the outermost contour around the crack front, with a peak K_1 of approximately 12 $\text{ksi}\sqrt{\text{in}}$. (blue) stress-intensity-factor (SIF) plot for First Street FEM under groove-weld-shrinkage loading.

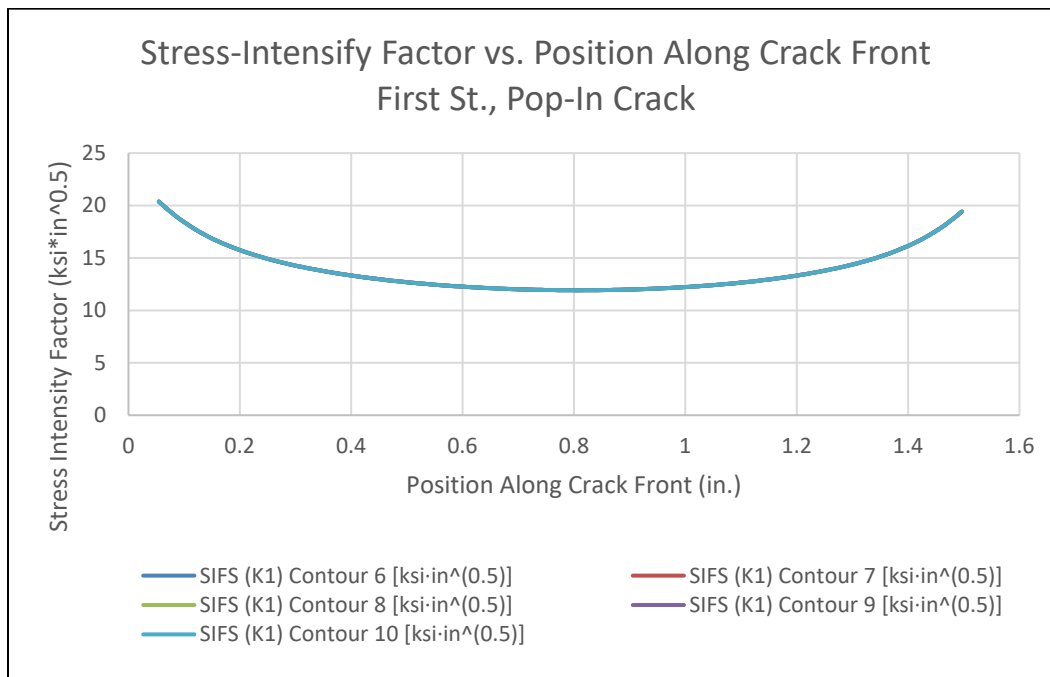
Fig. 139. Stress intensity factor (K_1) versus position along crack front for the microcrack in the First Street FE model under groove-weld-shrinkage loading. Contours 6 through 10 show a converging trend (from top curve to bottom curve) toward a K_1 of approximately 12 $\text{ksi}\sqrt{\text{in}}$.

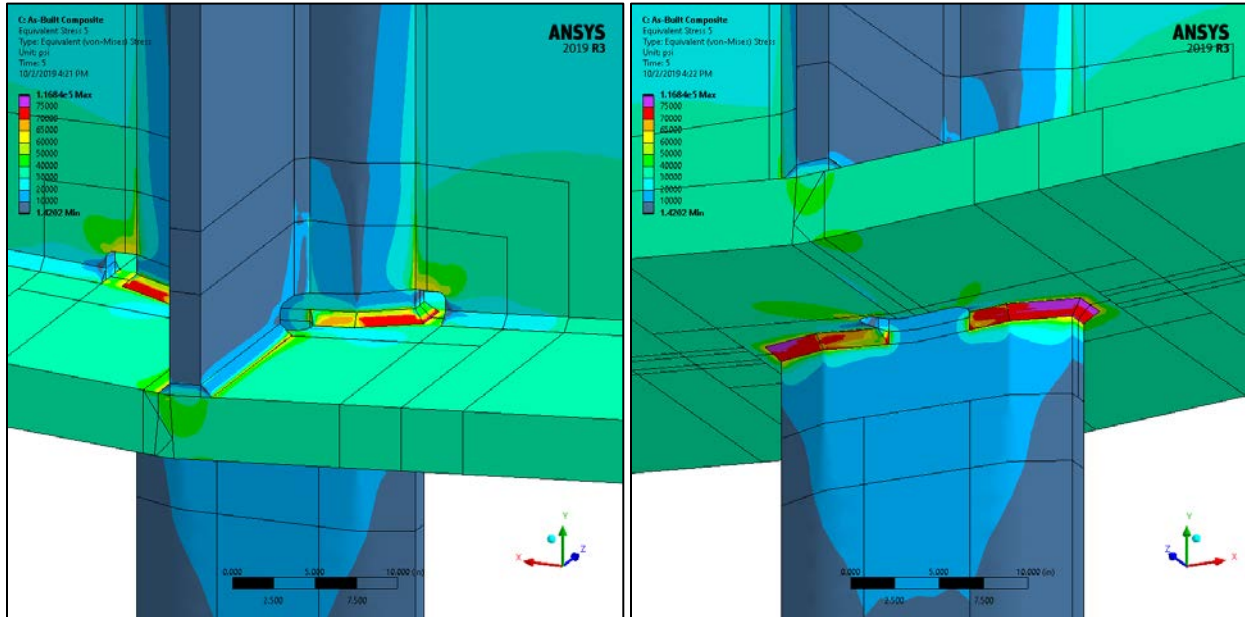
Fig. 149. Equivalent (von Mises) stress plots, view from Southeast looking Northwest.

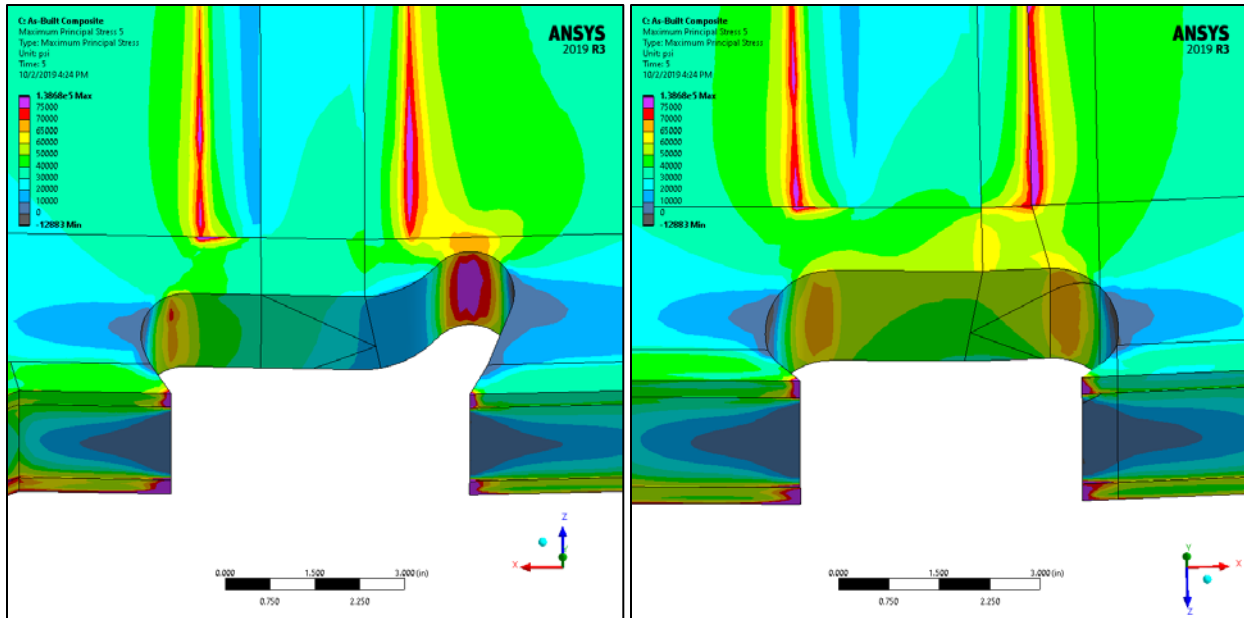
Fig. 150. Maximum principal stress plots of north-side (left) and south-side (right) weld access holes.

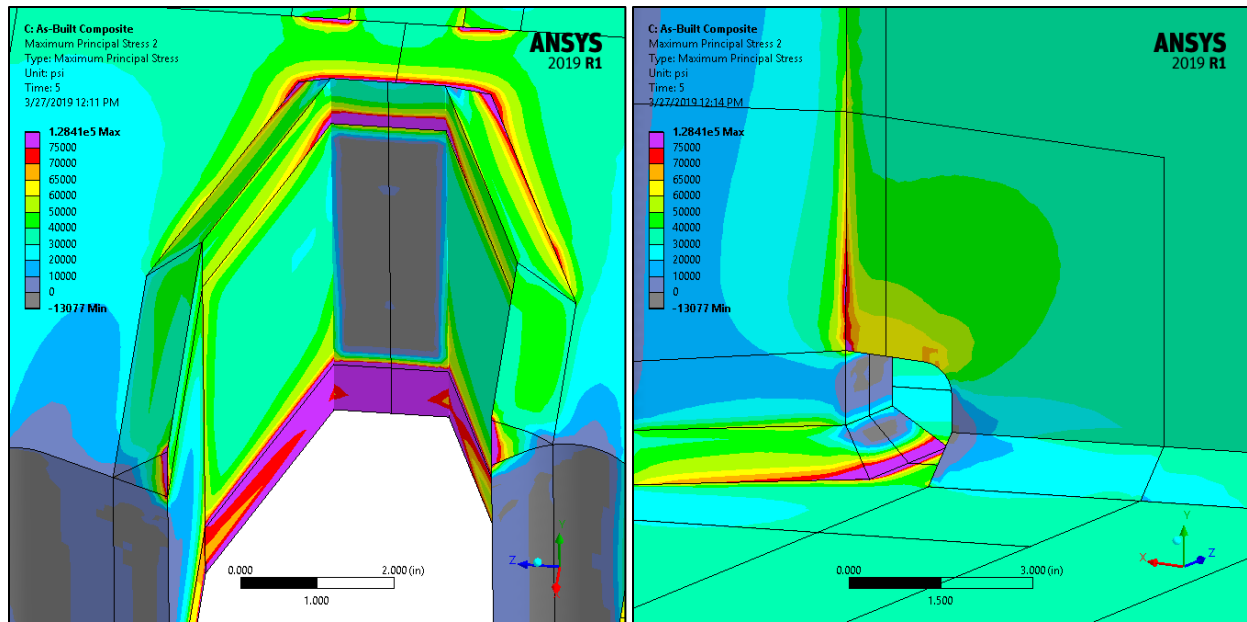
Fig. 151. Maximum principal stress plots of bottom flange hanger slot (left) and web access hole (right).

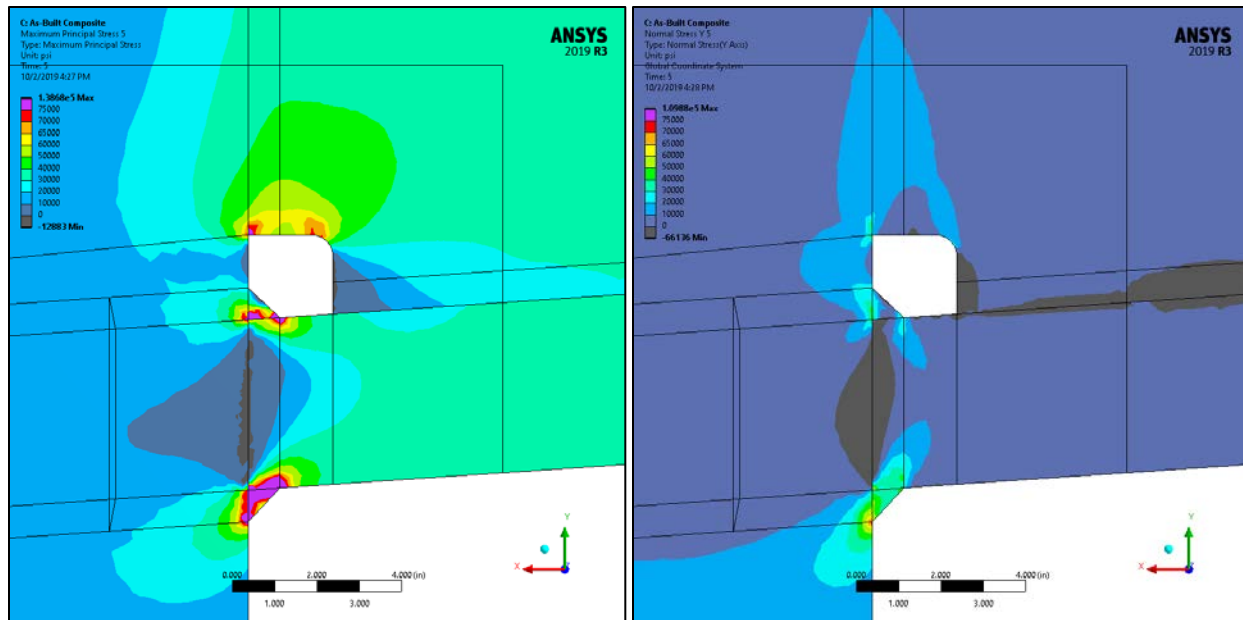
Fig. 152. Web access hole centerline section view of maximum principal stress (left) and vertical stress component (right).

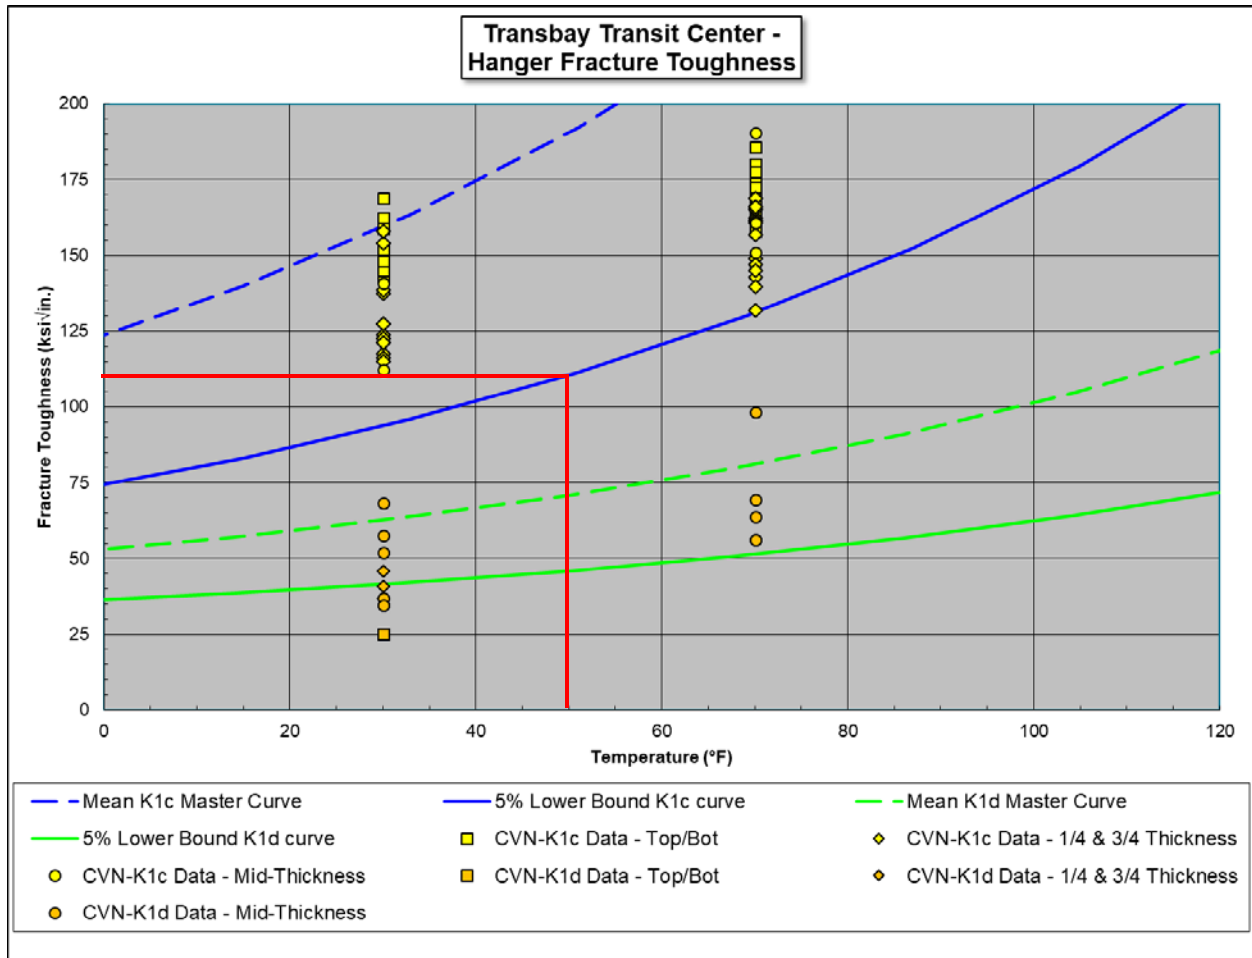
Fig. 153. Hanger fracture toughness data.

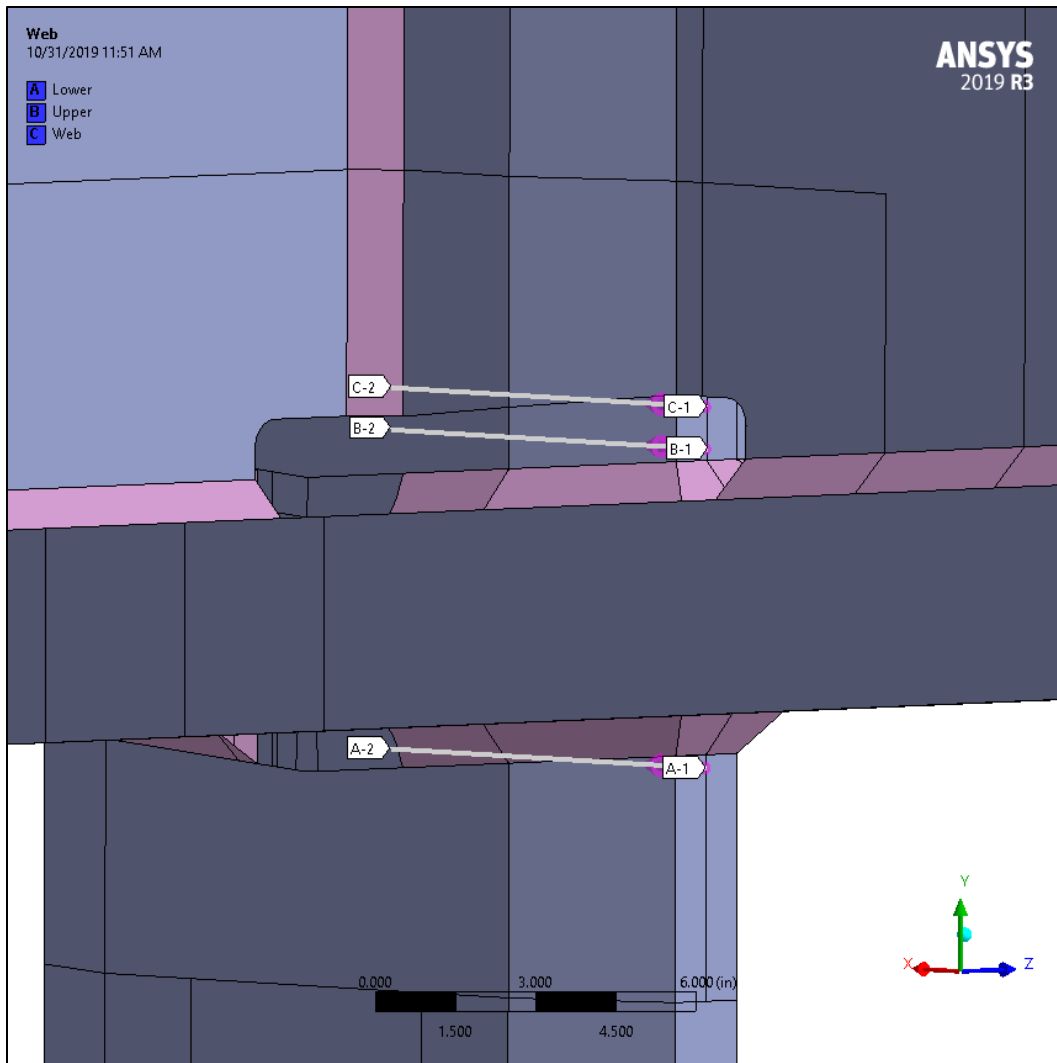
Fig. 154. Paths for hanger stress output.

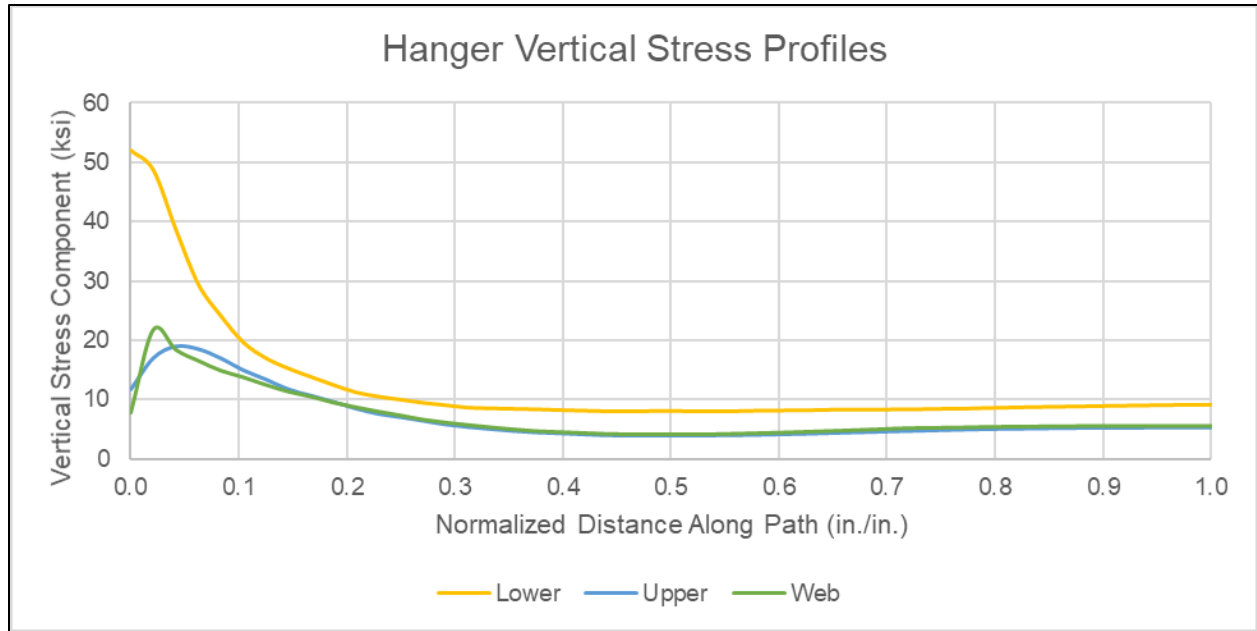
Fig. 155. Vertical stress component profiles in the hanger when subjected to the factored design loads.

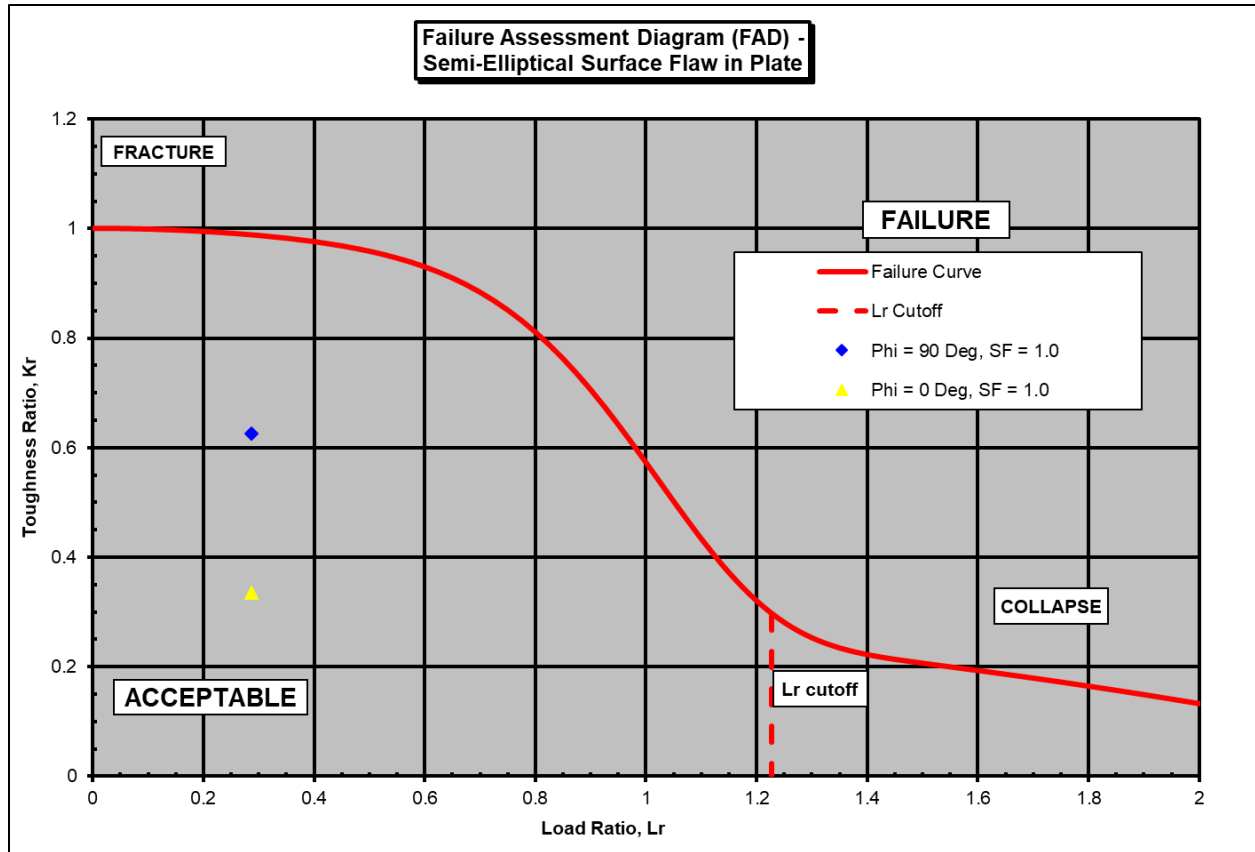
Fig. 156. FAD calculation results for an assumed 1.2 x 0.125-in. semi-elliptical surface flaw on the hanger in the as-built condition when subjected to the factored design loads.

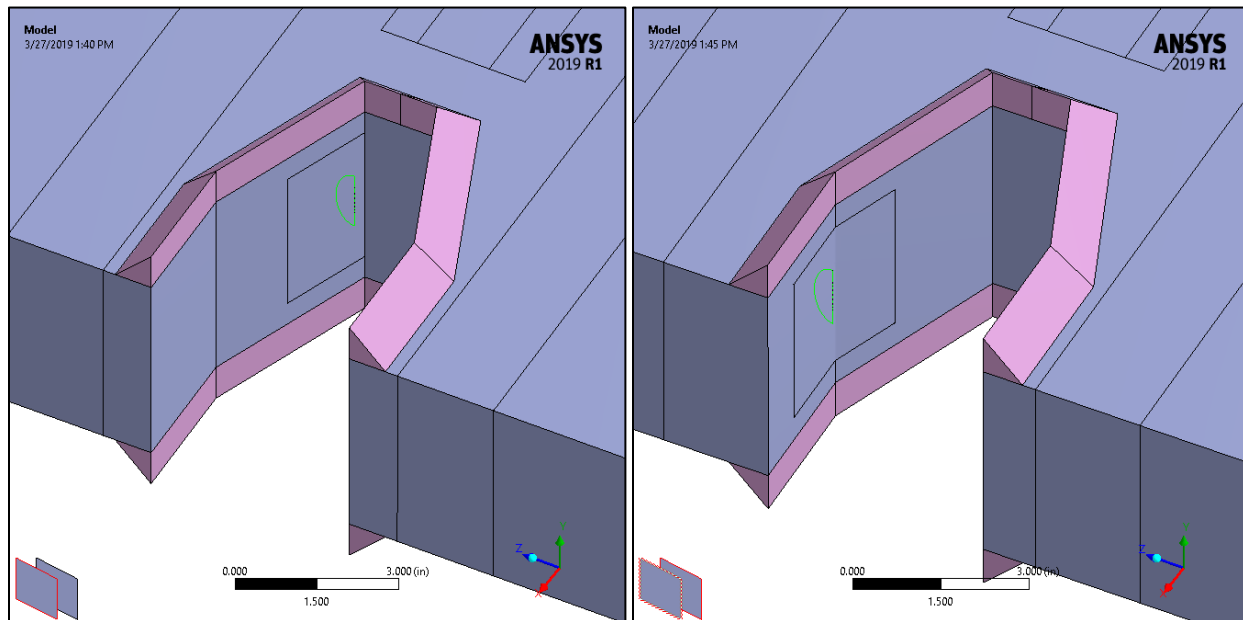
Fig. 157. Bottom flange hanger slot end corner crack (left) and transition corner crack (right). Hanger, stiffener, and web plates are hidden from view.

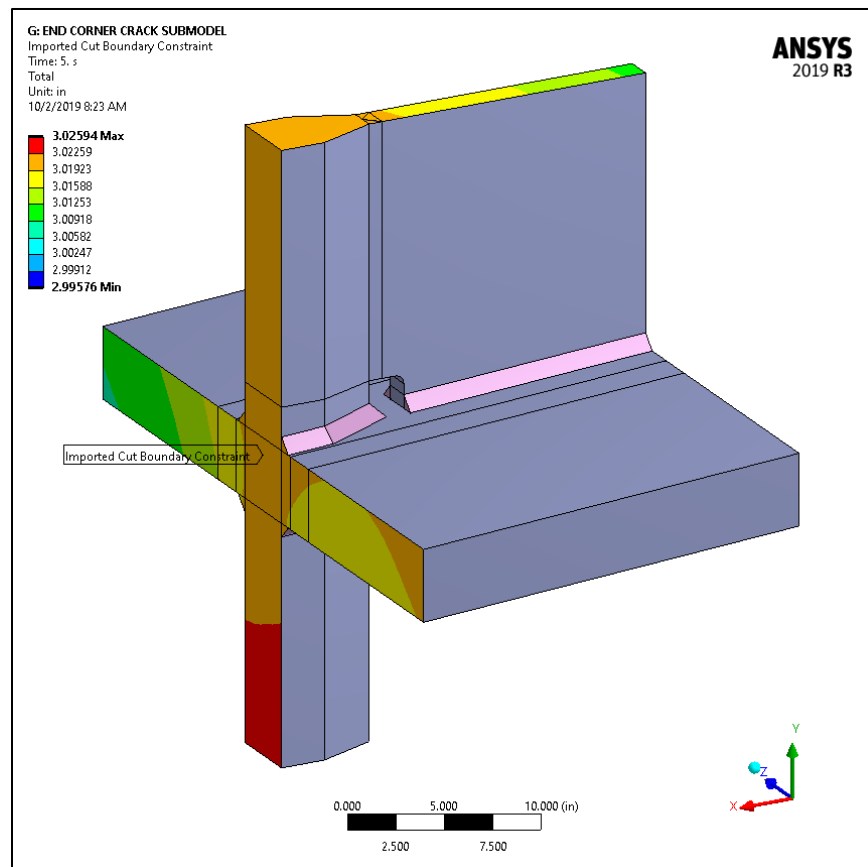
Fig. 158. Submodel with representative cut boundary displacement constraints.

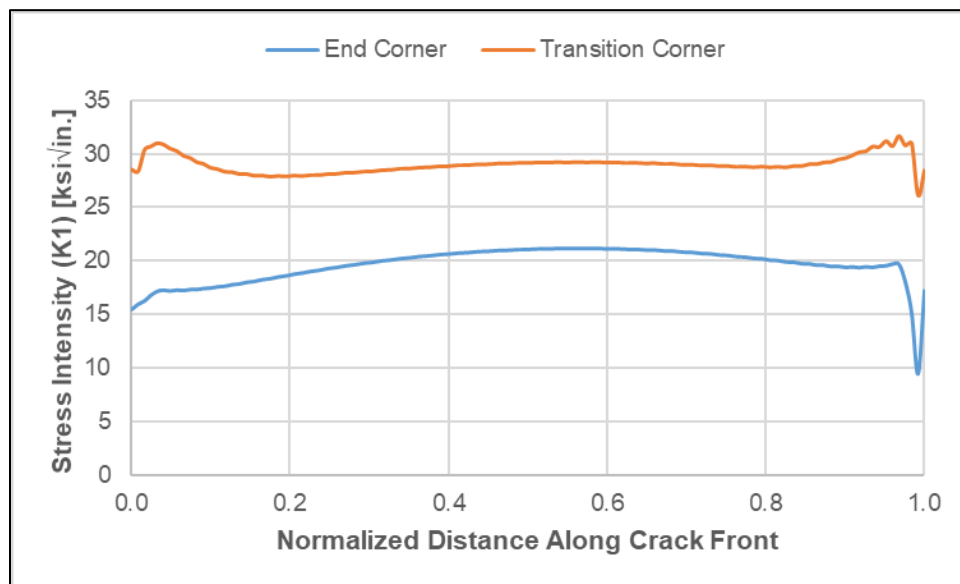
Fig. 159. Stress intensity factors along the end corner and transition corner semi-elliptical crack fronts.

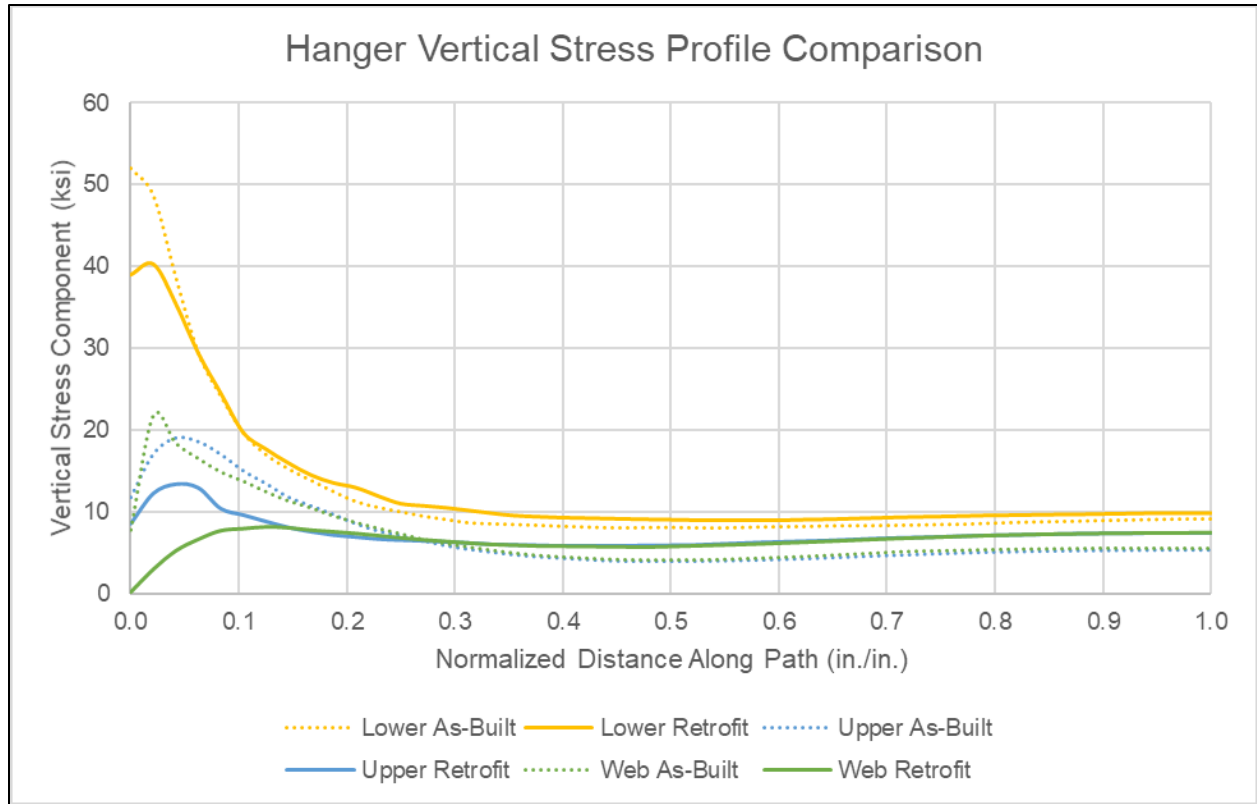
Fig. 173. Comparison of hanger vertical stress profiles.

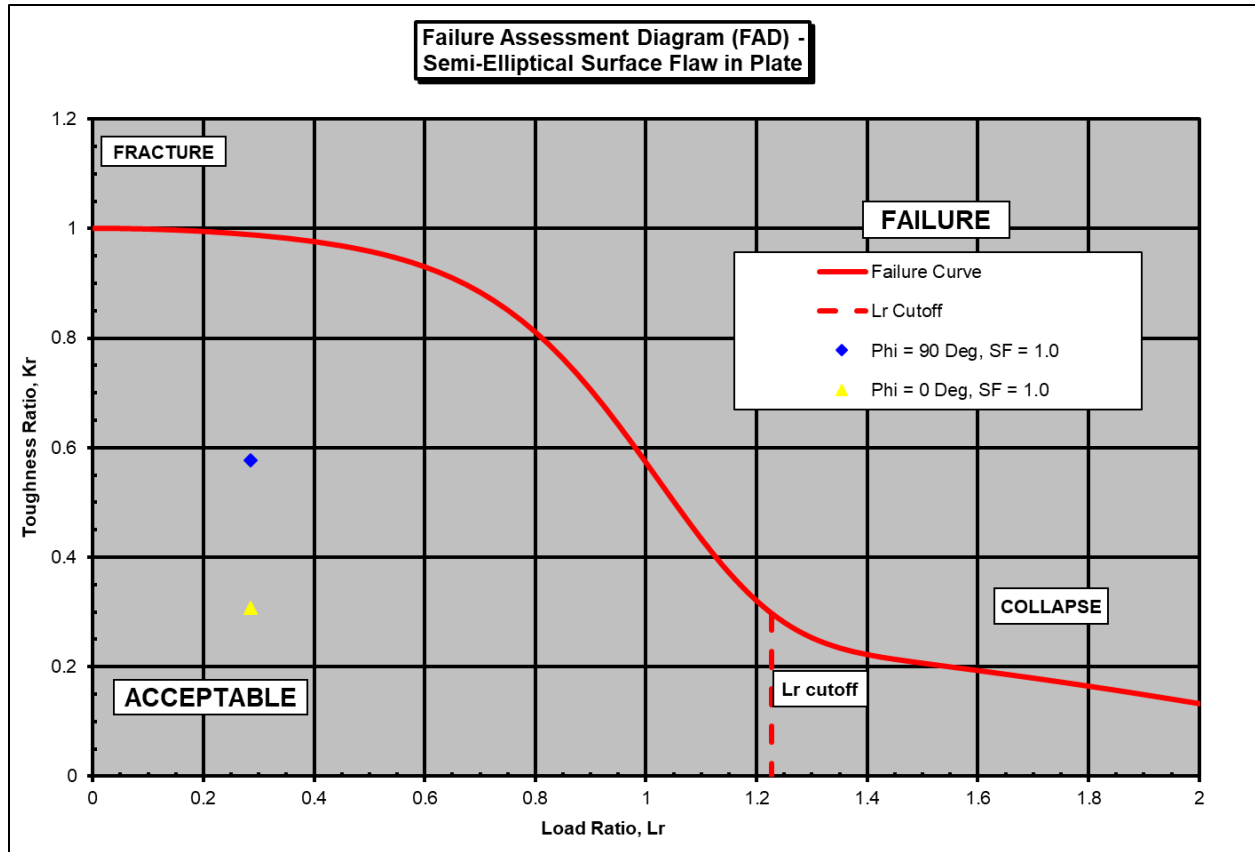
Fig. 174. FAD calculation results for an assumed 1.2 x 0.125-in. semi-elliptical surface flaw on the hanger in the as-built condition when subjected to the factored design loads.

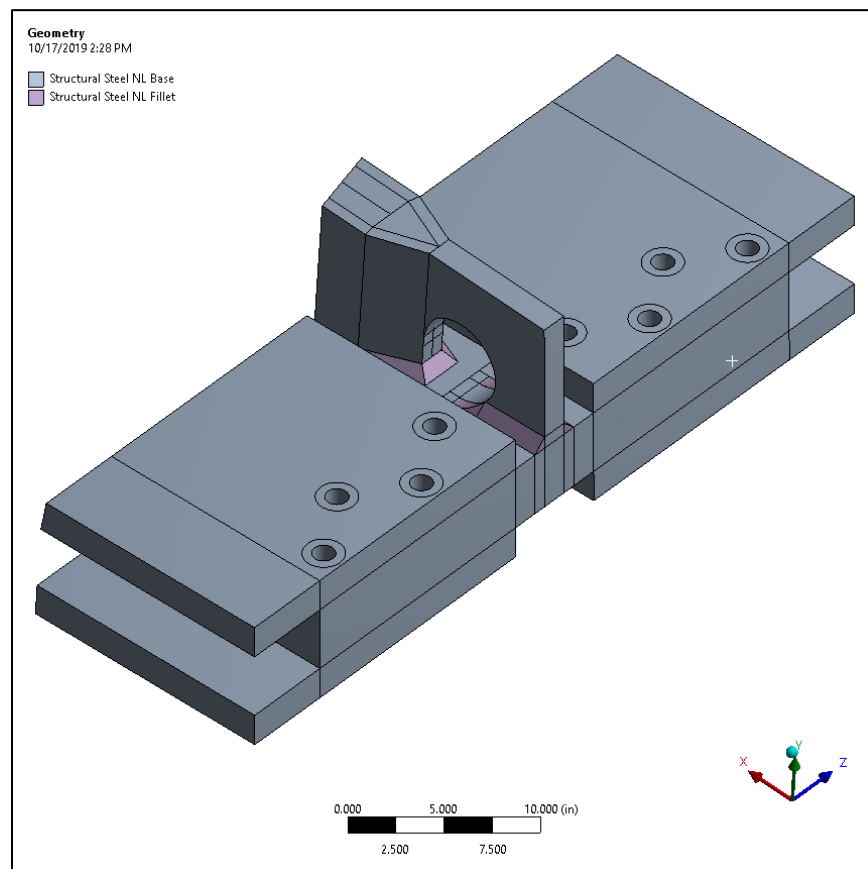
Fig. 175. Retrofit reinforcement submodel.

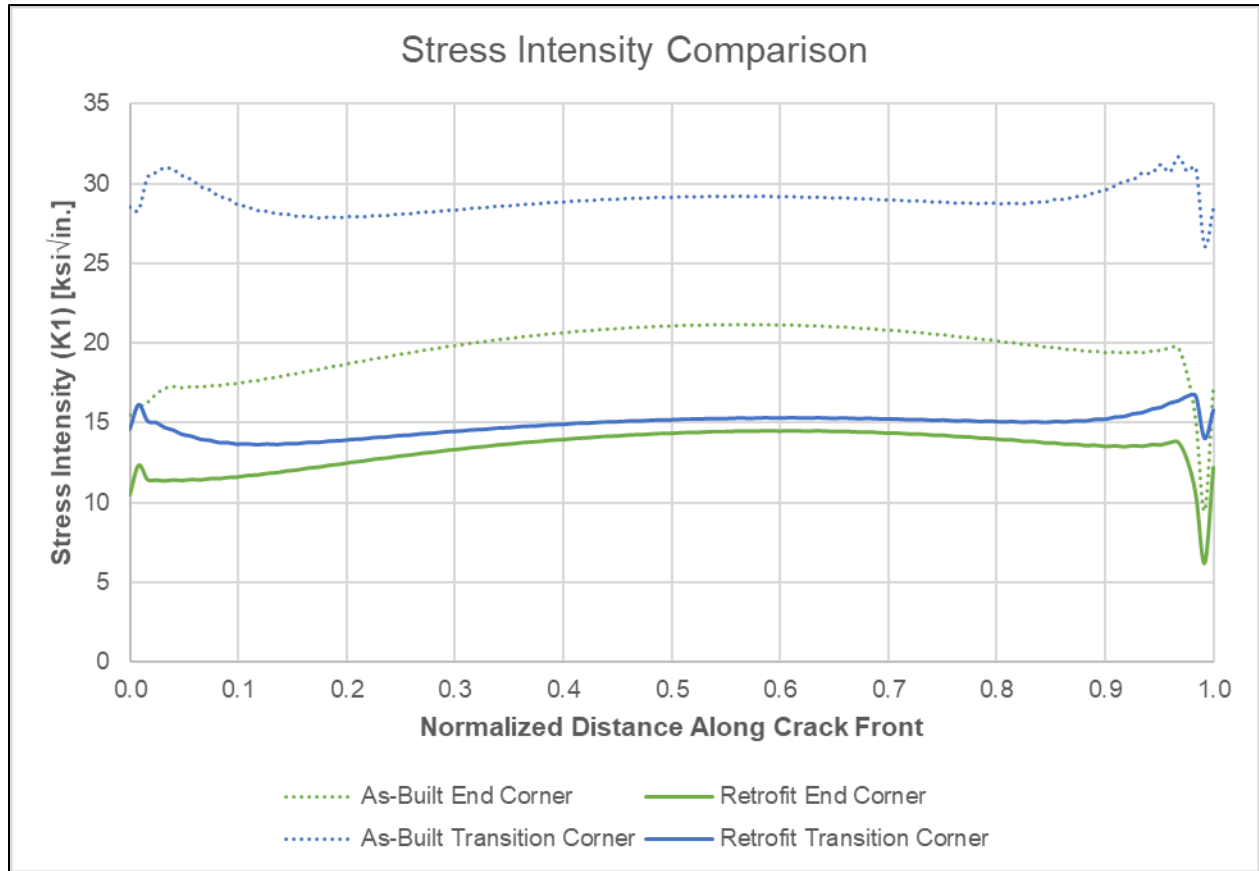
Fig. 176. Comparison of stress intensities between the retrofit and as-built configurations.

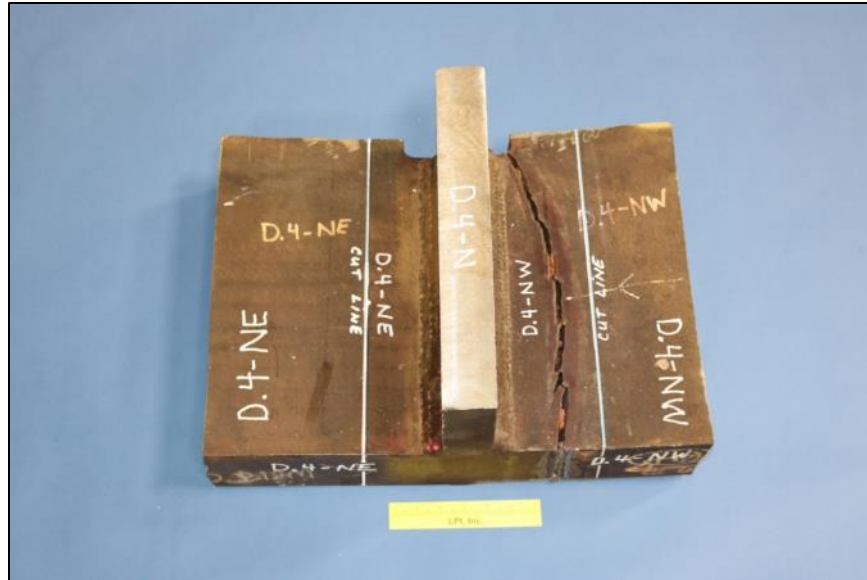
Fig. 181. Girder sample D.4-N in as-received condition upon receipt at LPI.

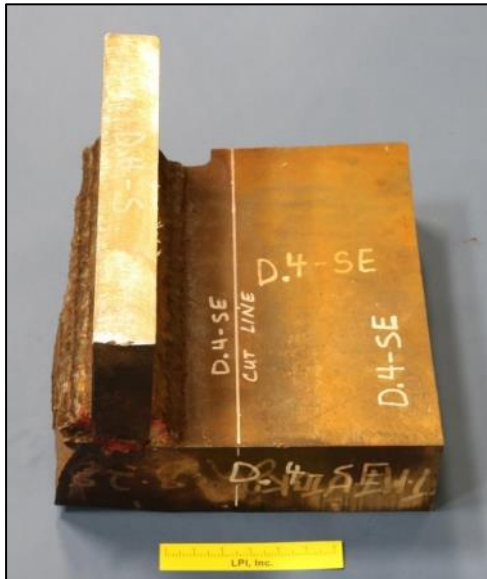
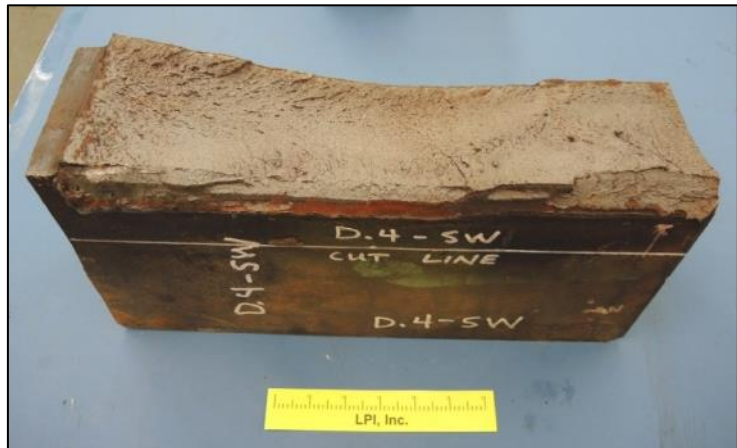
Fig. 182. Girder sample D.4-S in as-received condition upon receipt at LPI.

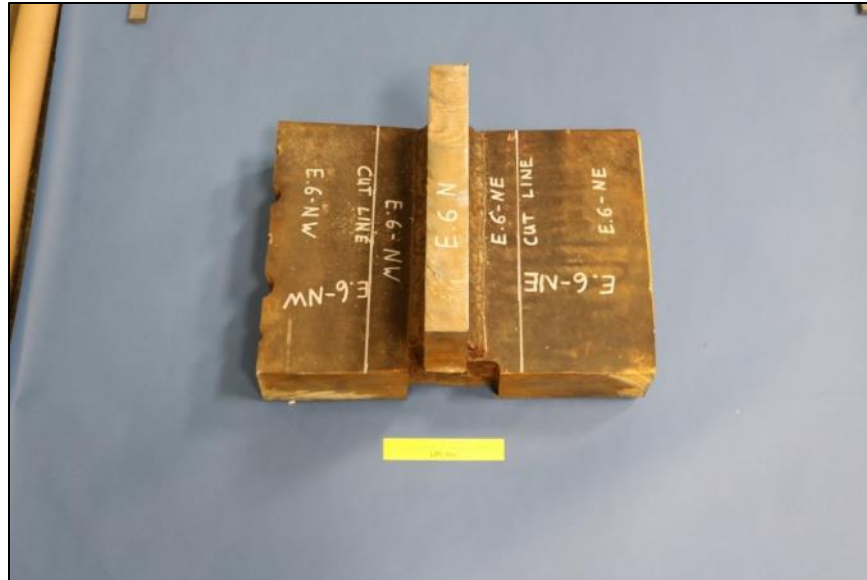
Fig. 183. Girder sample E.6-N in as-received condition upon receipt at LPI.

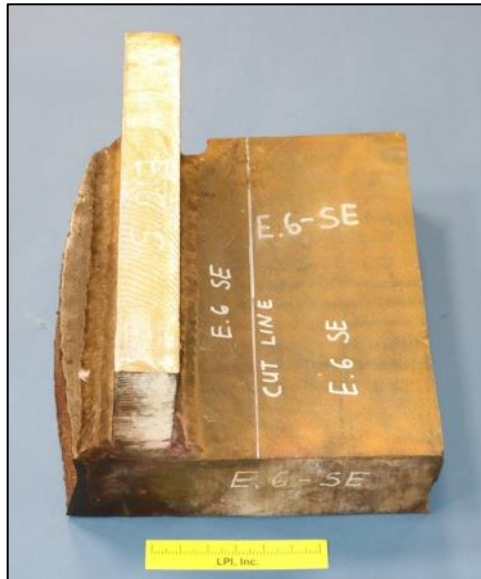
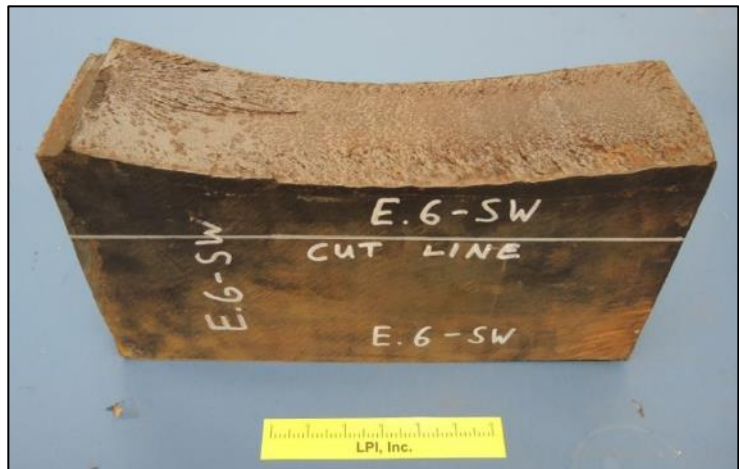
Fig. 184. Girder sample E.6-S in as-received condition upon receipt at LPI.

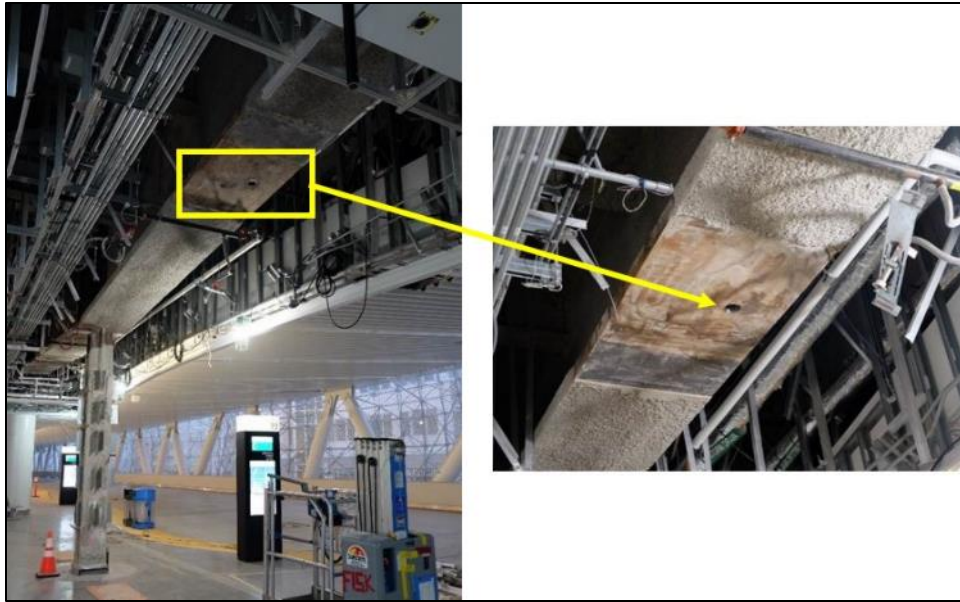
Fig. 185. Typical removal location for the 3-in. diameter core samples removed from girder flanges above First Street.

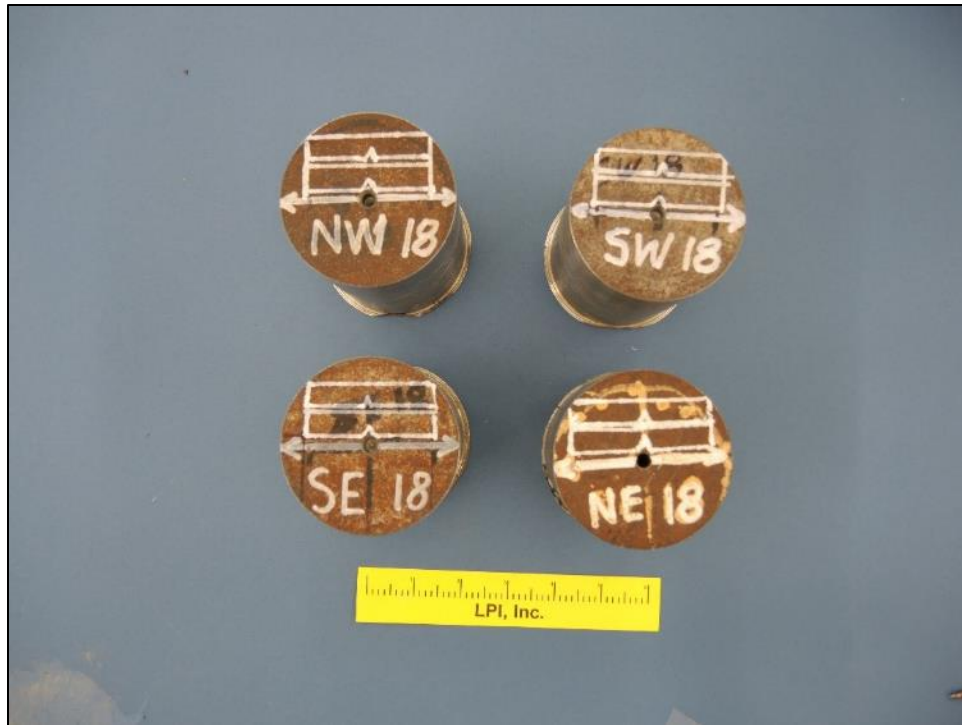
Fig. 187. 3-in. diameter core samples removed from girder flanges above First Street in the as-received condition upon receipt by LPI.

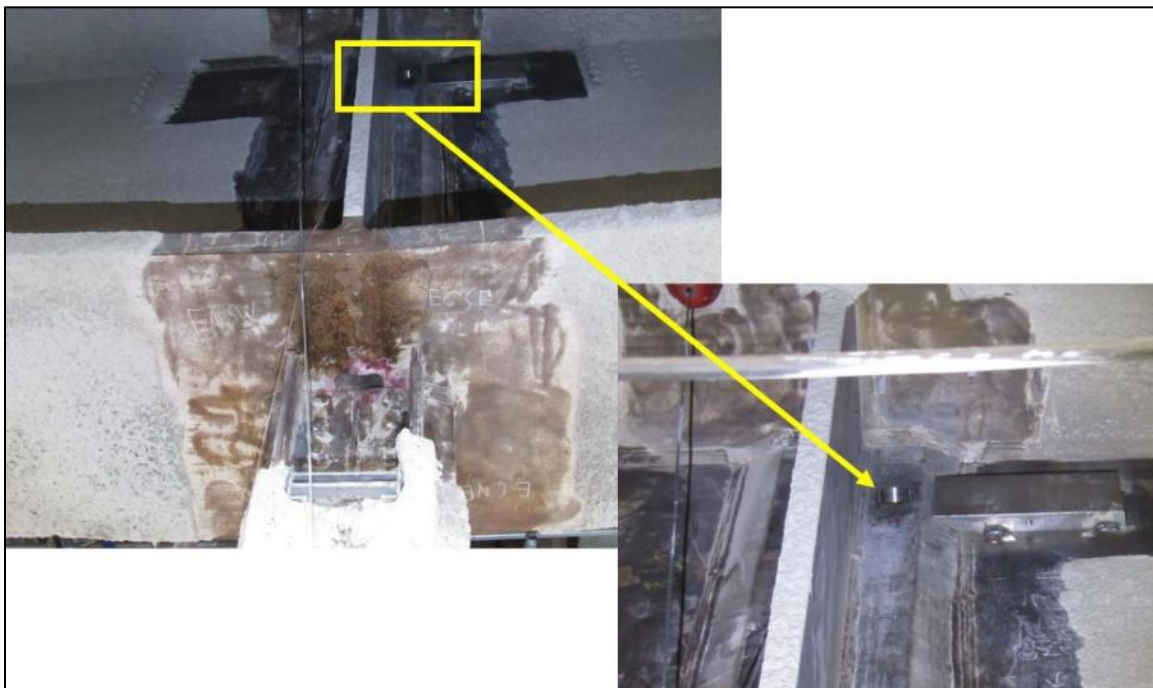
Fig. 188. Typical removal location for the 3-in. diameter core samples removed from girder hangers above Fremont Street and First Street.

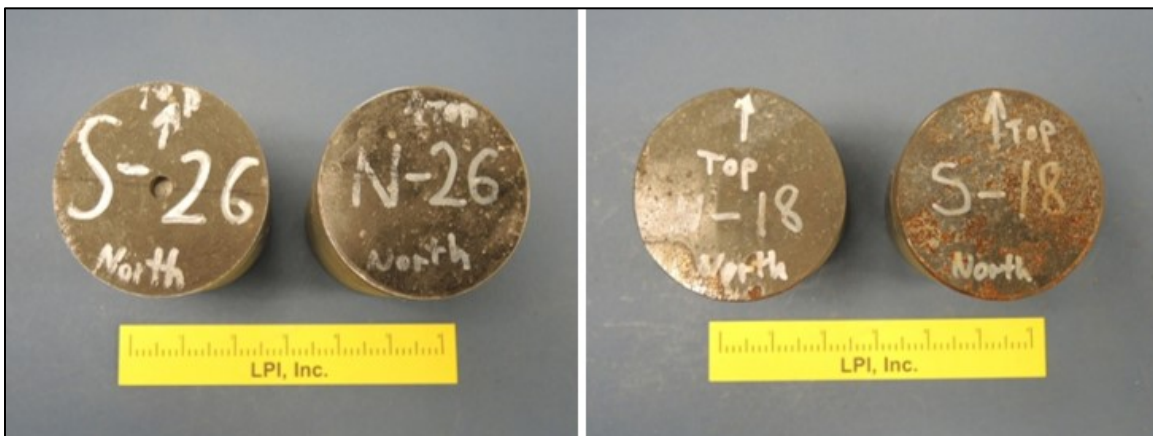
Fig. 190. 3-in. diameter core samples removed from girder hangers above Fremont Street and First Street in the as-received condition upon receipt by LPI.

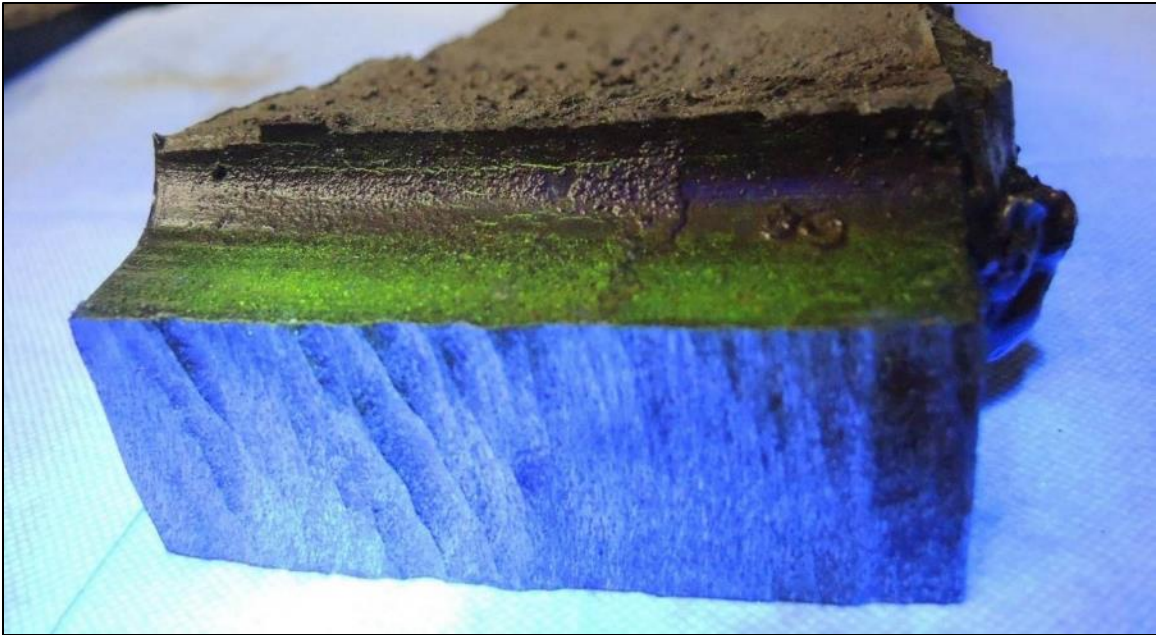
Fig. 191. Secondary cracking in the radius of the weld access hole of sample D.4-SW as identified by fluorescent magnetic particle testing.

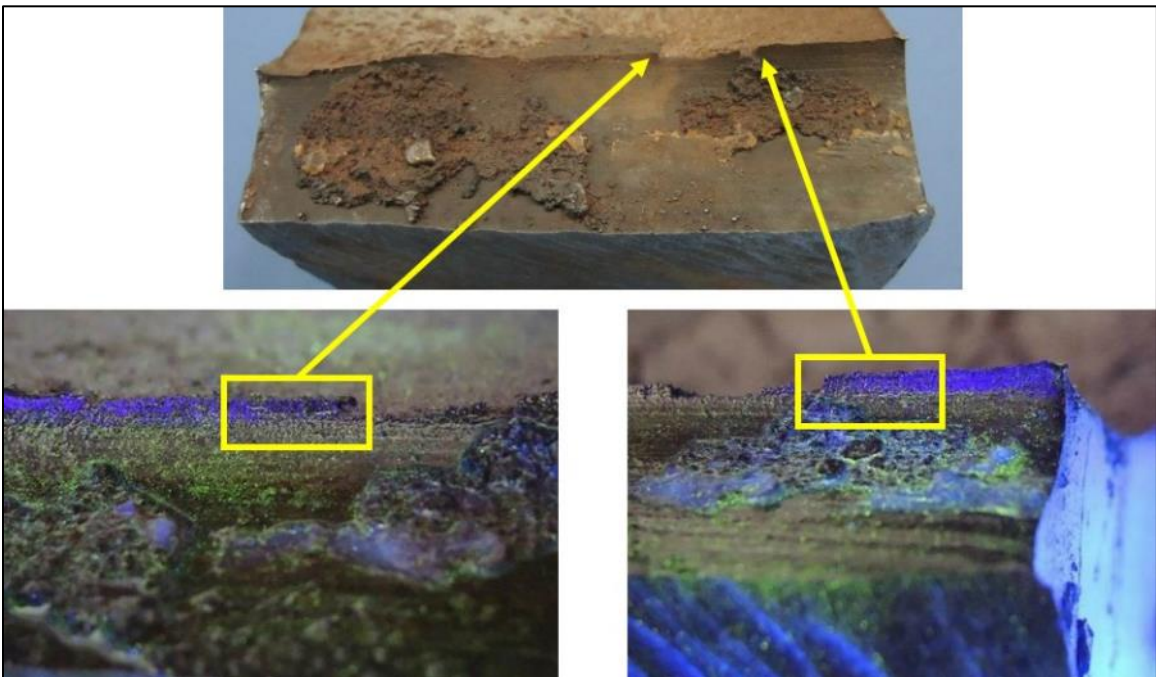
Fig. 192. Secondary cracking in the radius of the weld access hole of sample D.4-NW as identified by fluorescent magnetic particle testing.
