LPI, Inc. Consulting Engineers

*Advanced Analysis & Fitness for Service
Failure & Materials Evaluation
Nondestructive Engineering*

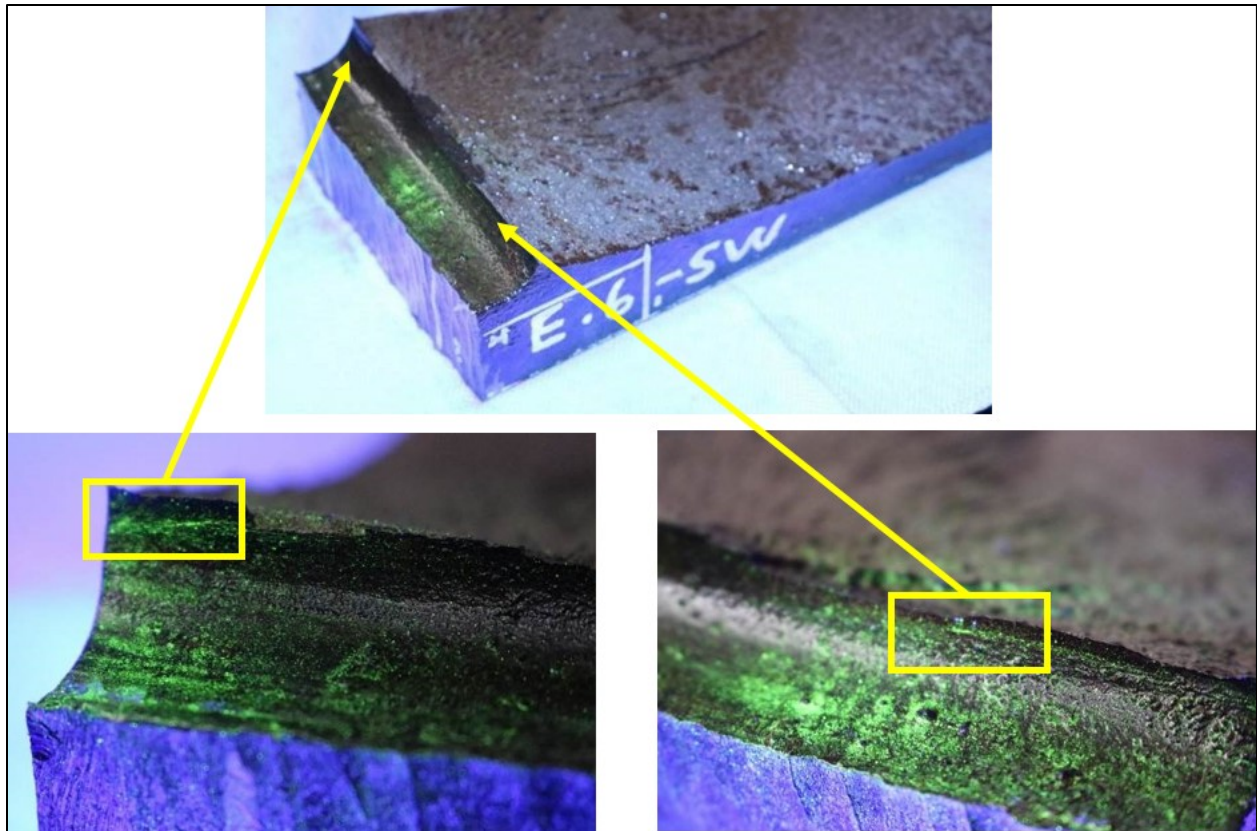
Fig. 193. Secondary cracking in the radius of the weld access hole of sample E.6-SW as identified by fluorescent magnetic particle testing.

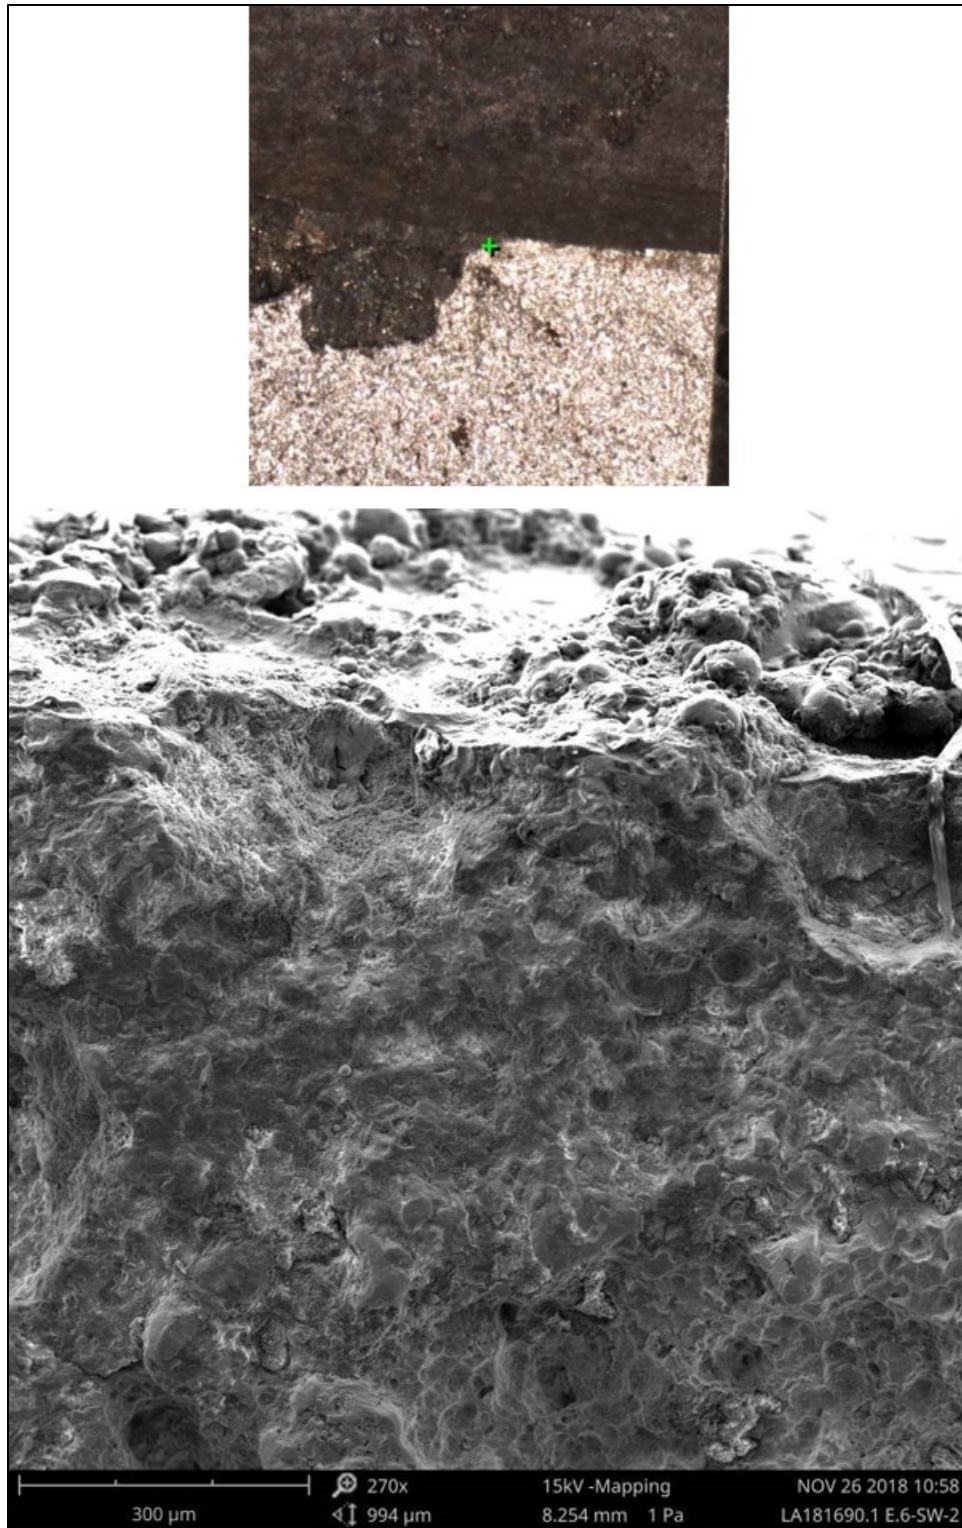
Fig. 194. SEM of oxide covered fracture origin after cleaning of sample E.6-SW.

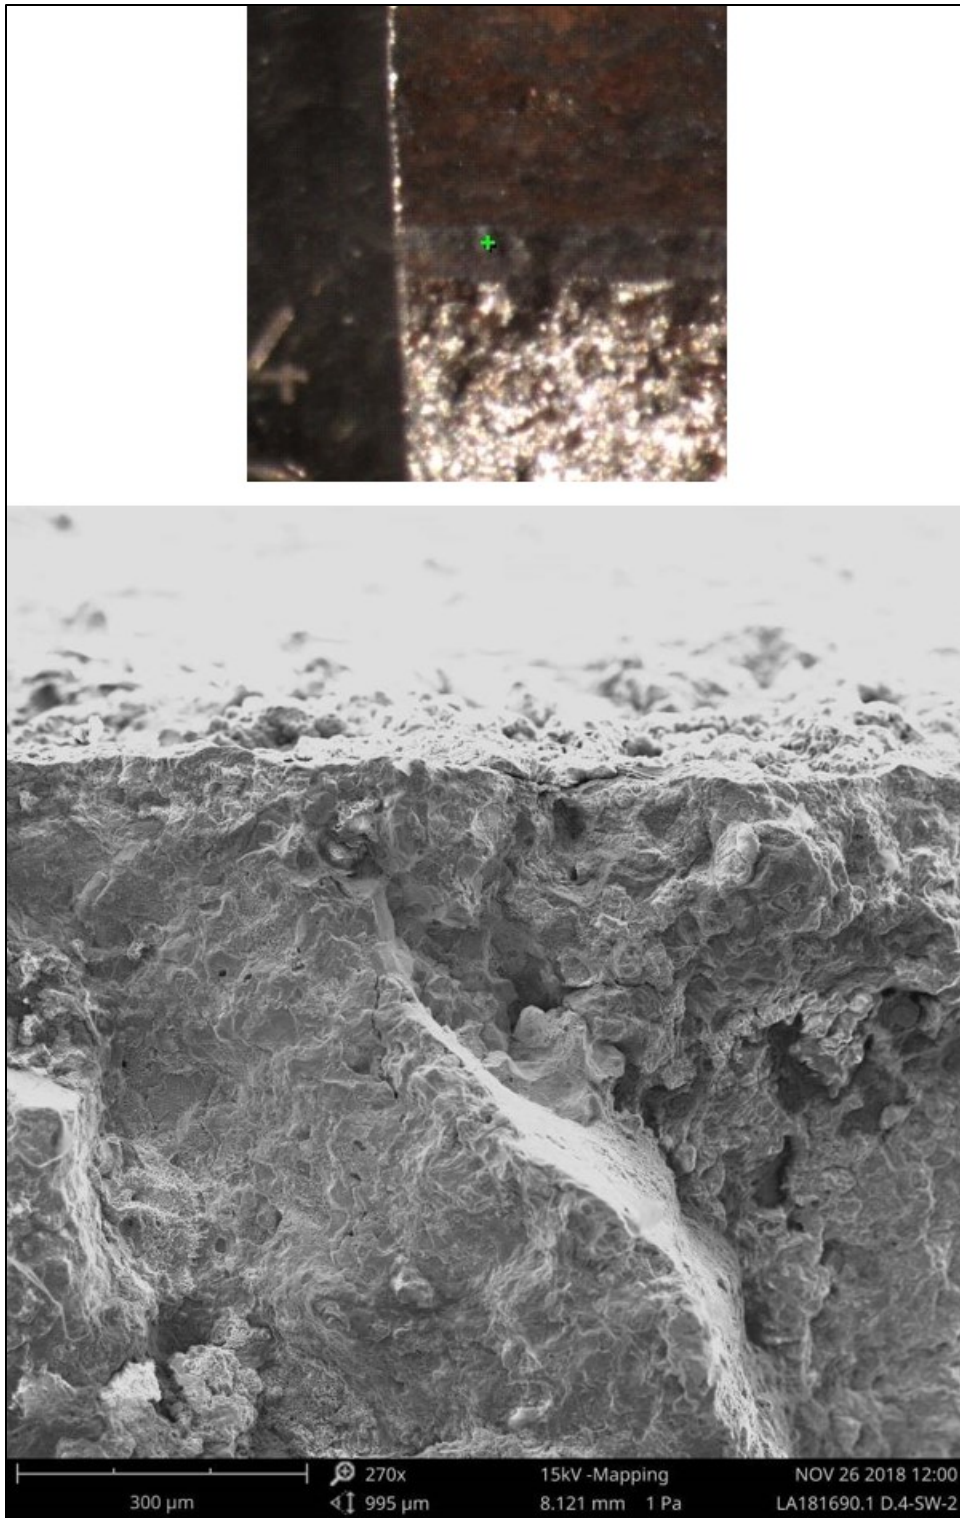
Fig. 195. SEM of oxide covered microcrack fracture origin after cleaning of sample D.4-SW.

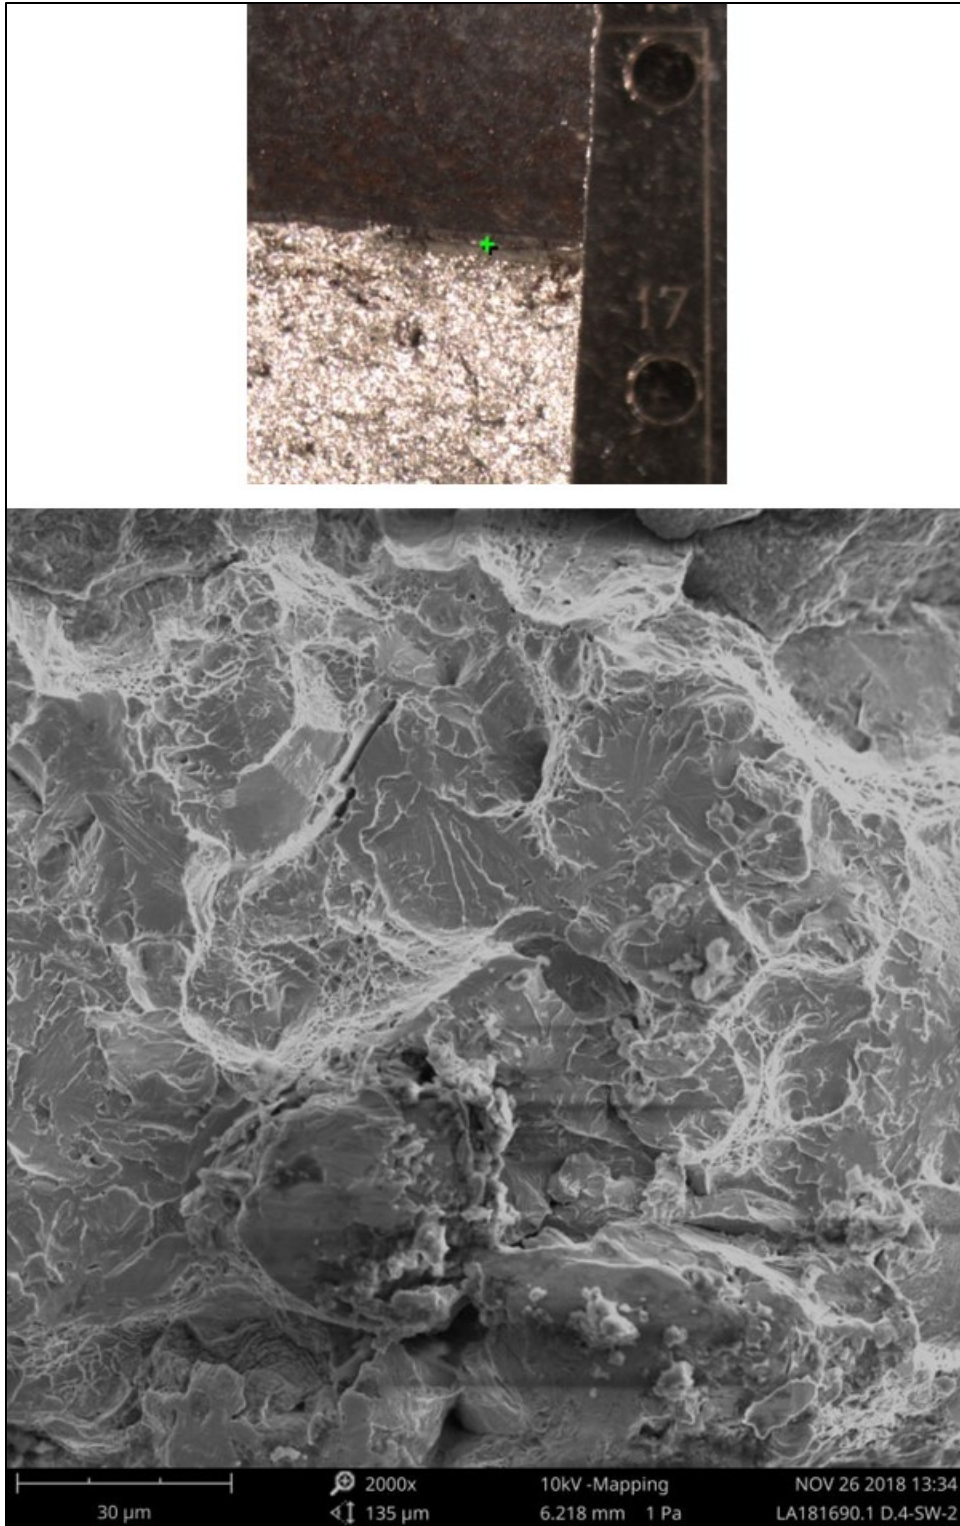
Fig. 196. SEM of microcrack origin showing low-energy (brittle) cleavage fracture morphology in sample D.4-SW.

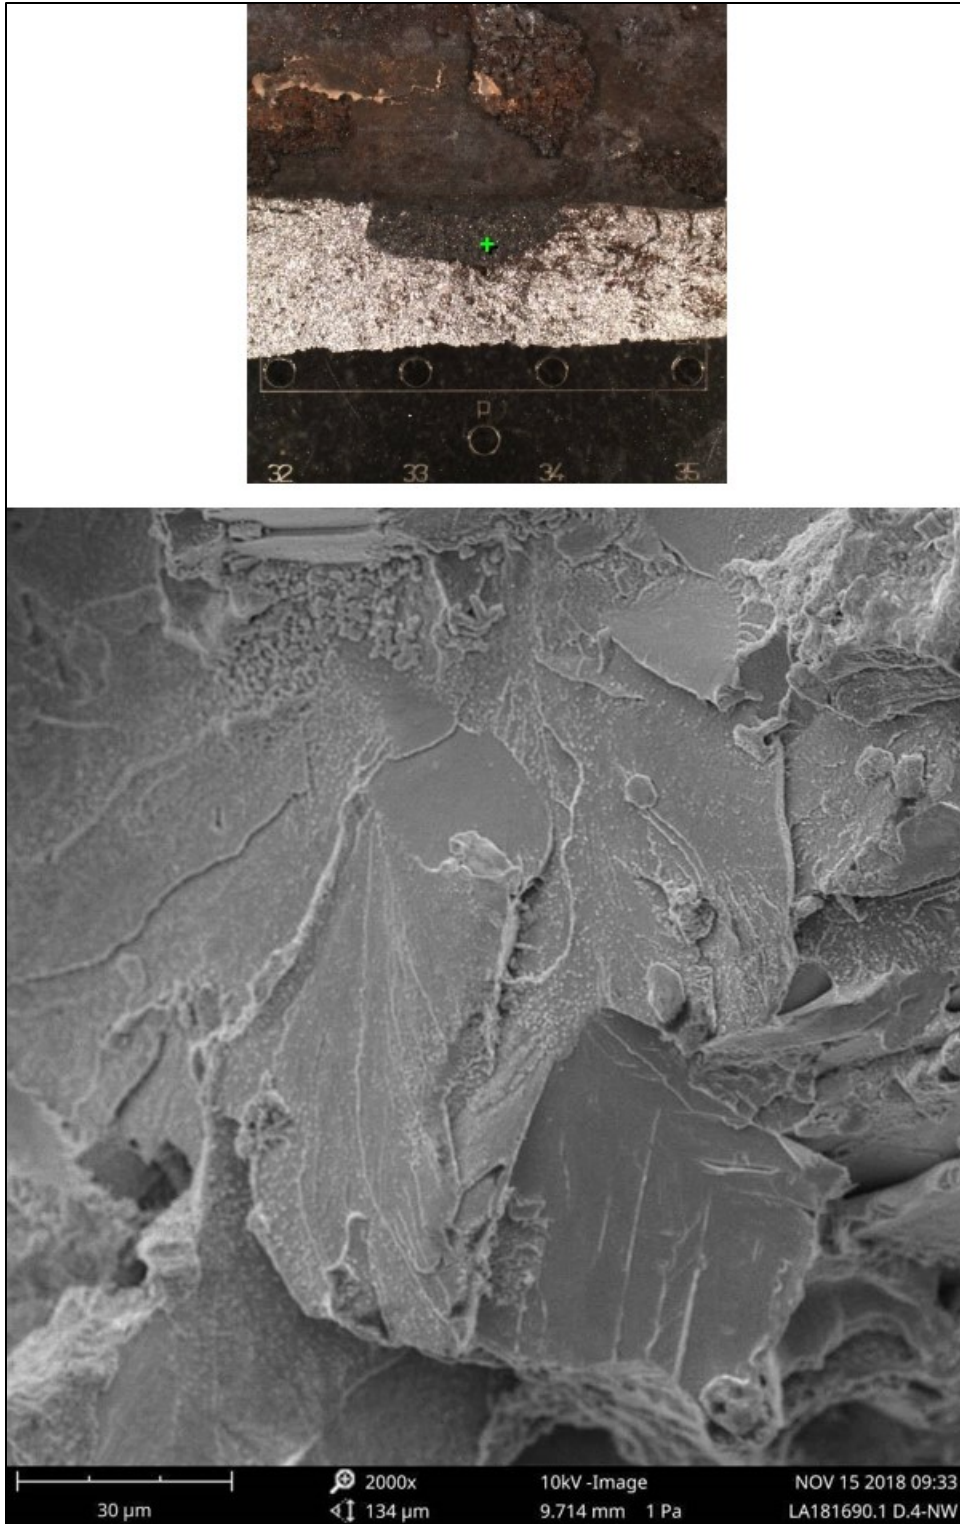
Fig. 197. SEM of elliptical pop-in crack origin showing low-energy (brittle) cleavage fracture morphology in sample D.4-NW.

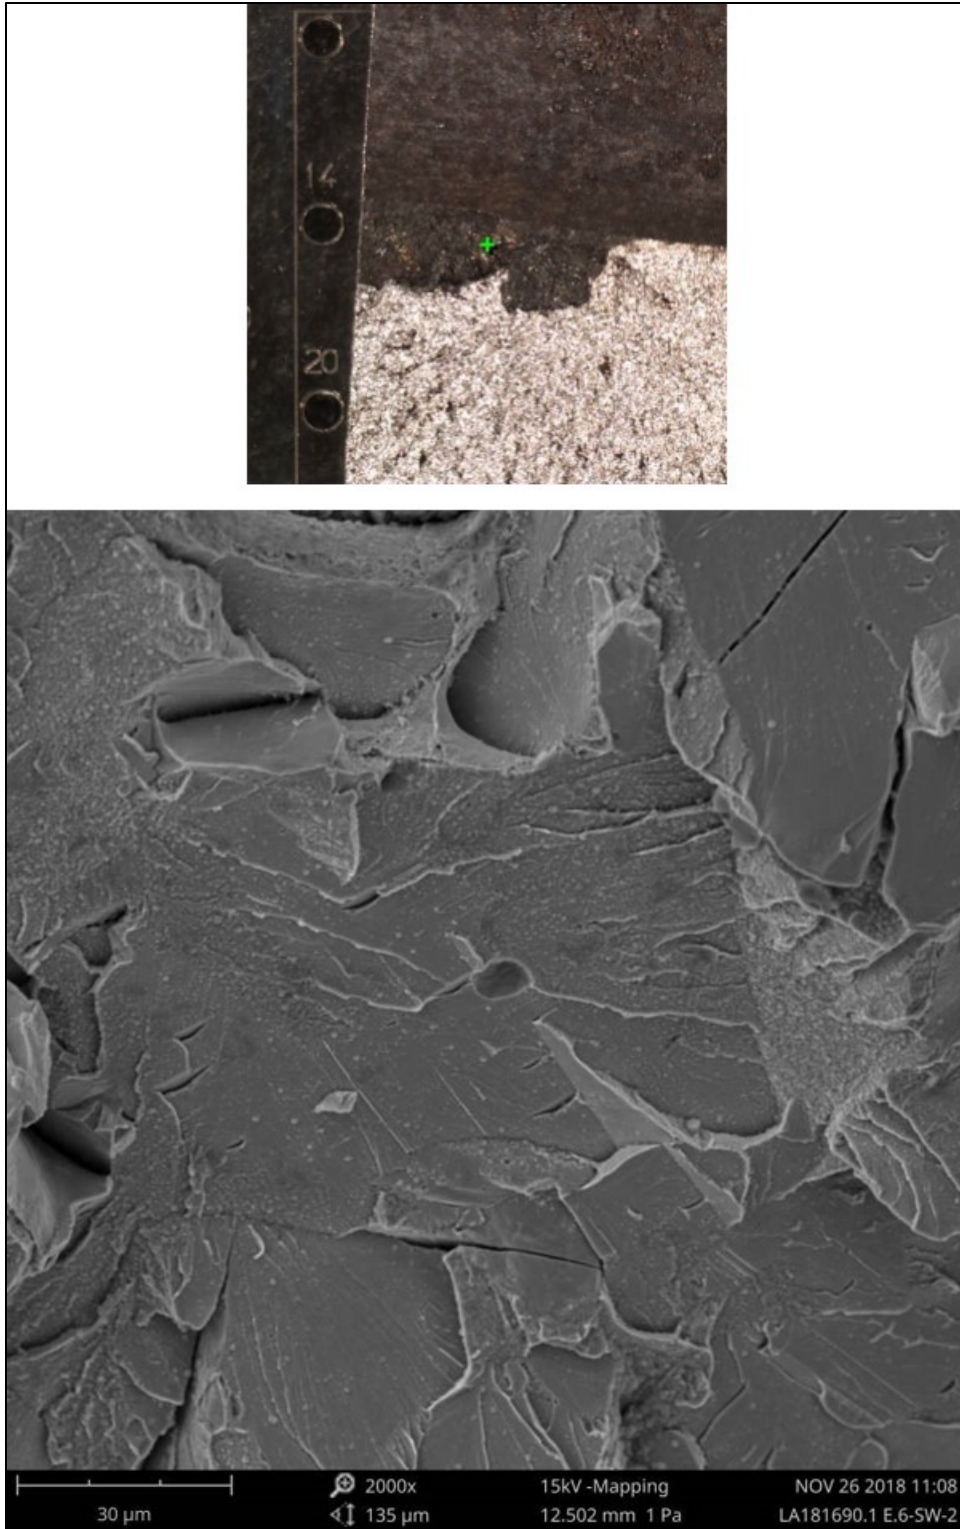
Fig. 198. SEM of elliptical pop-in crack origin showing low-energy (brittle) cleavage fracture morphology in Sample E.6-SW.

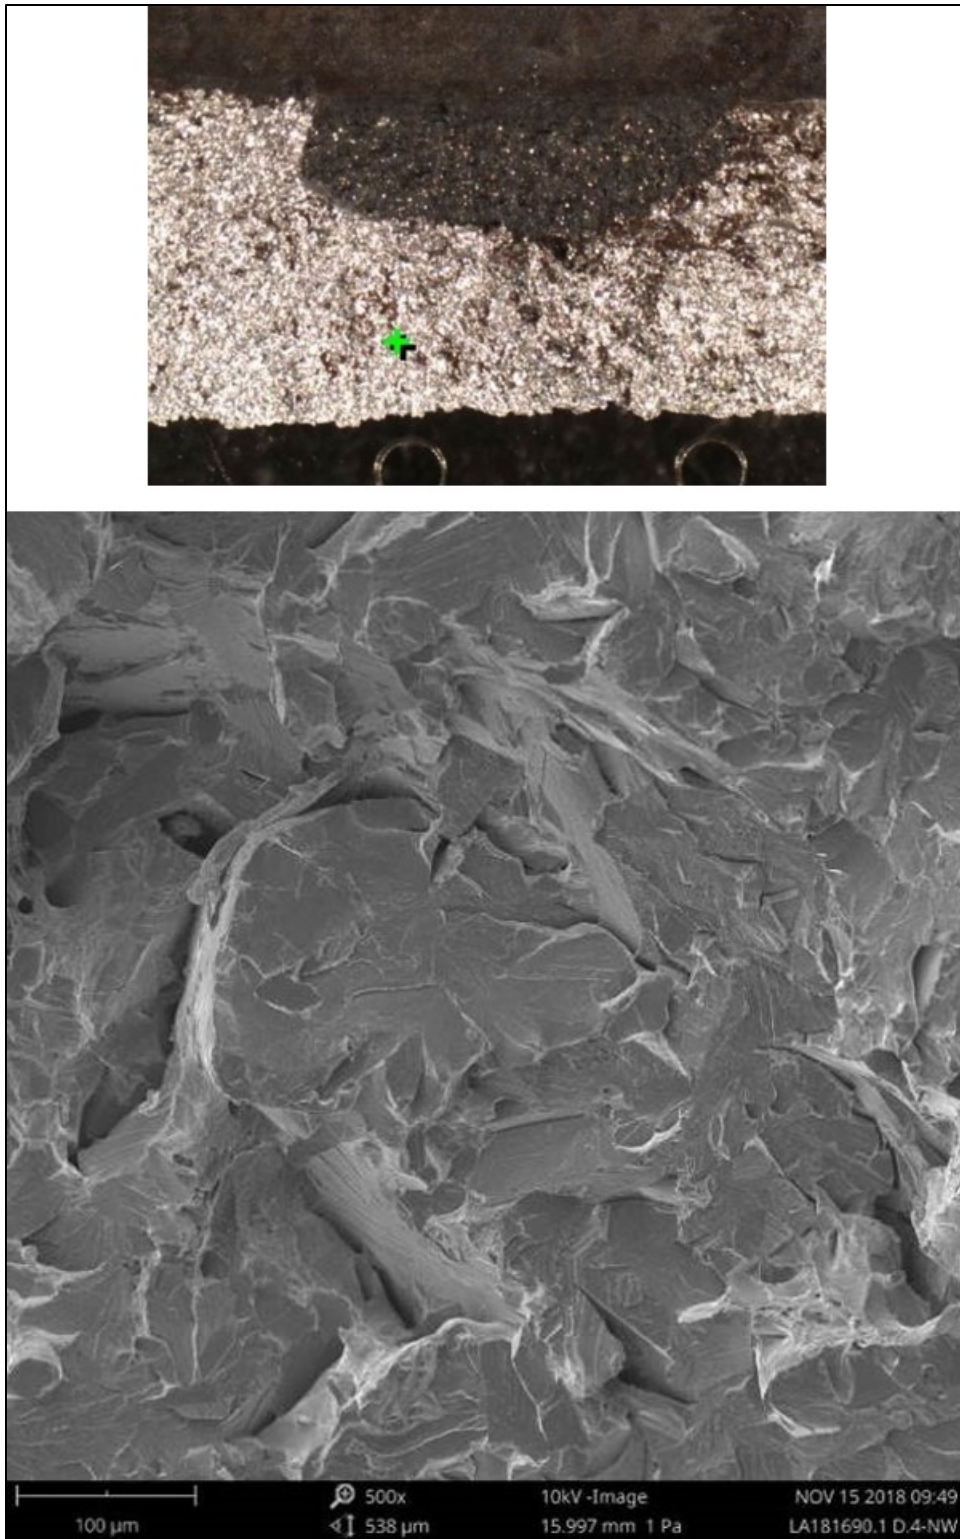
Fig. 199. SEM of sample D.4-NW showing low-energy (brittle) cleavage fracture morphology remote from the origin.

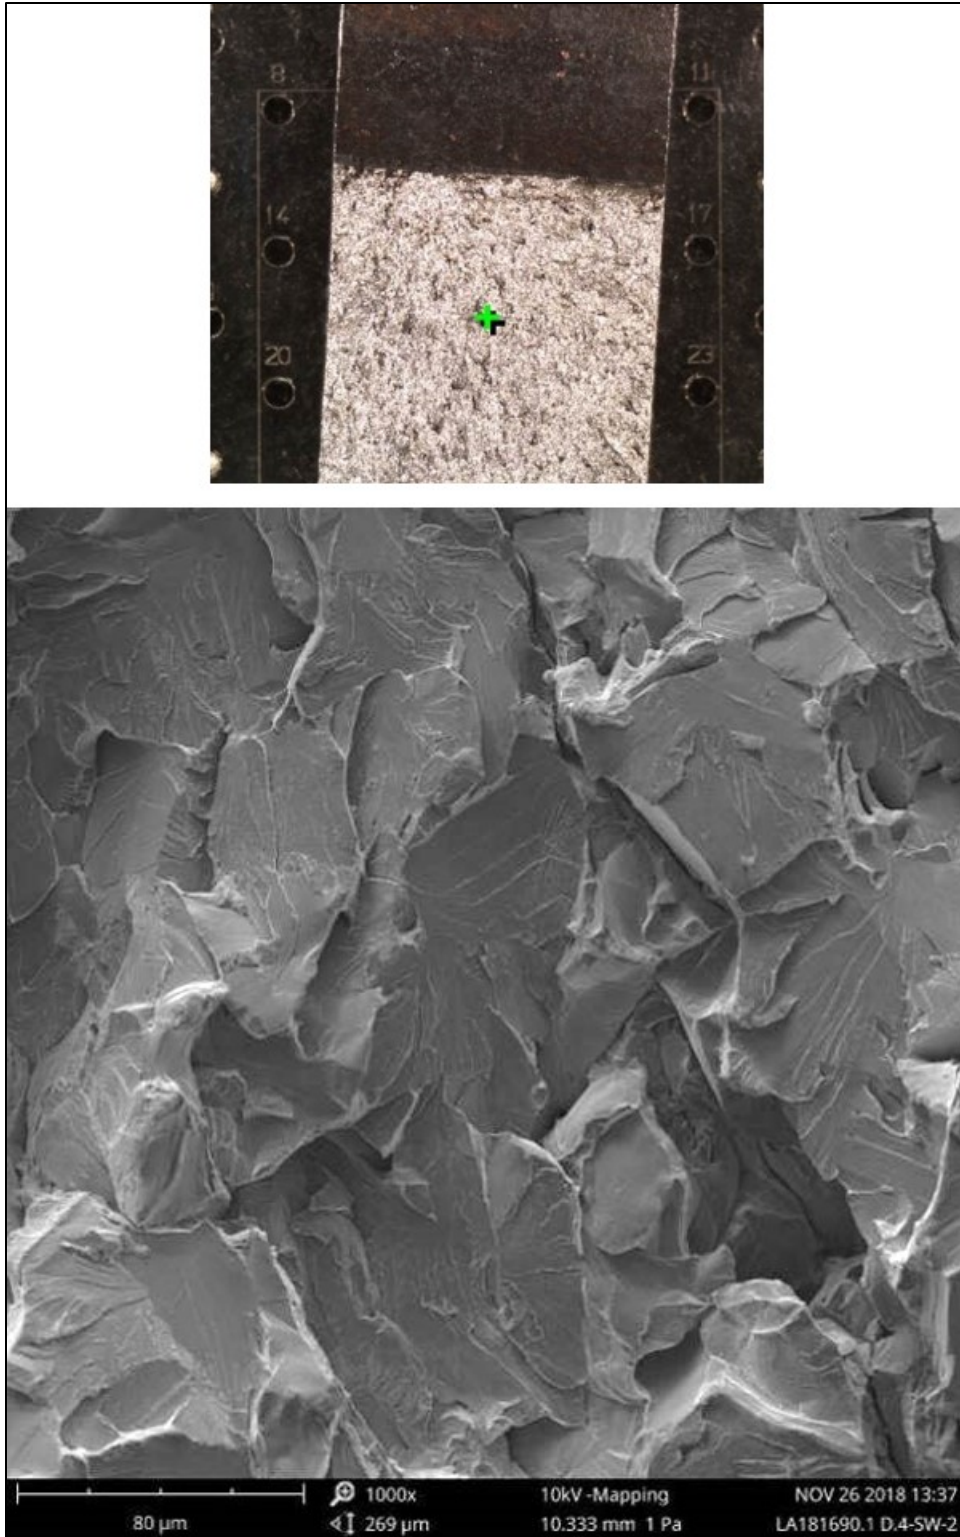
Fig. 200. SEM of sample D.4-SW showing low-energy (brittle) cleavage fracture morphology remote from the origin.

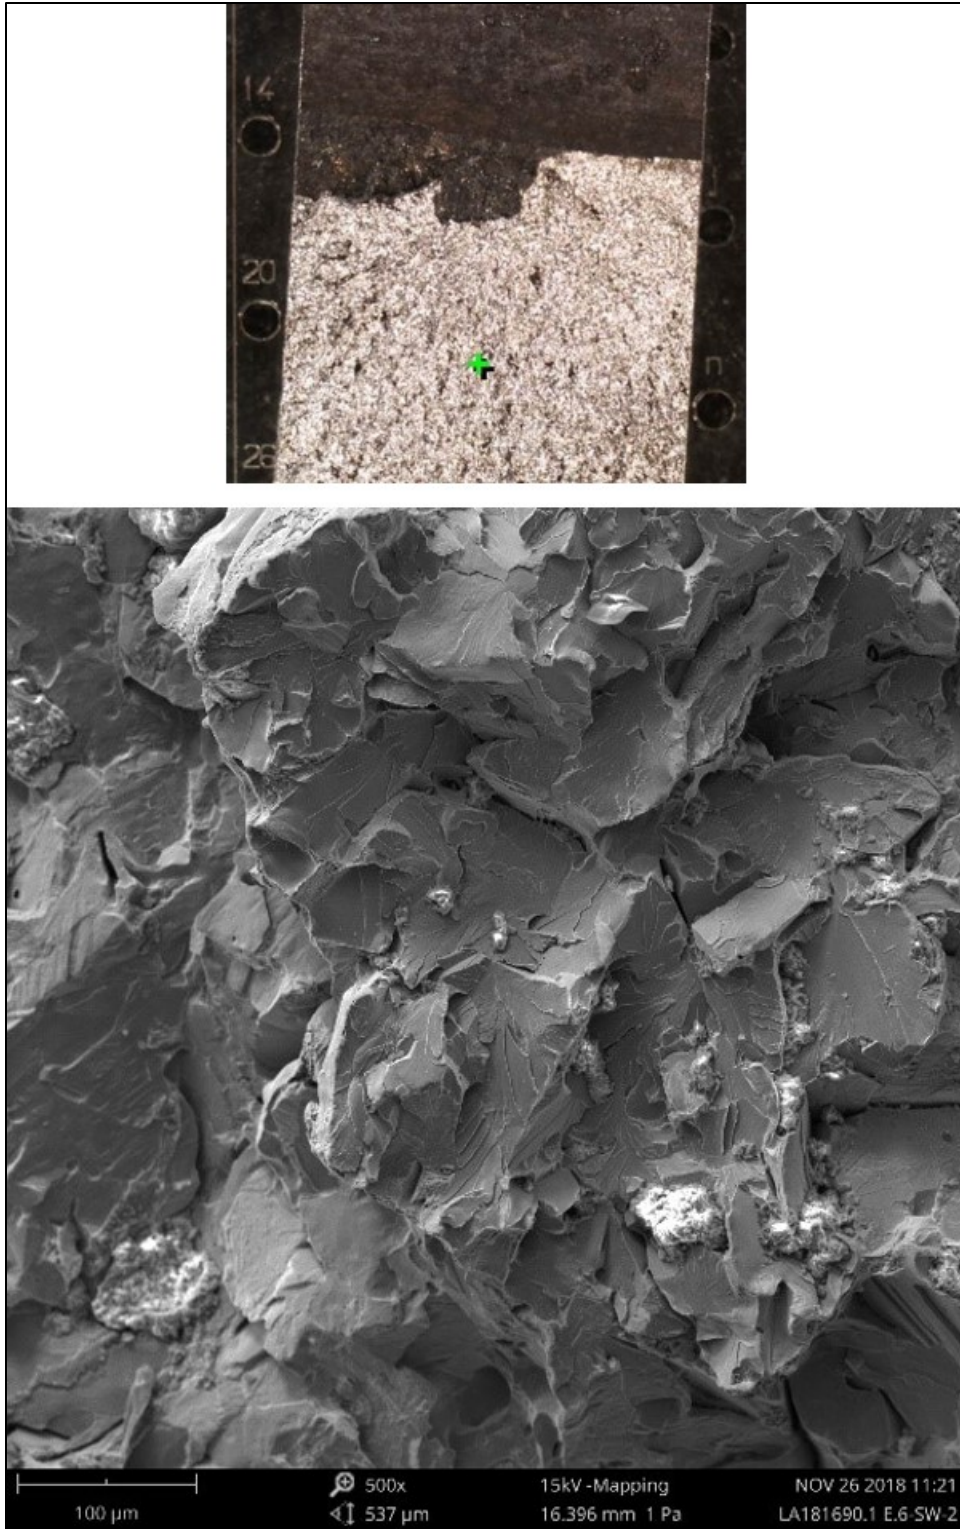
Fig. 201. SEM of sample E.6-SW showing low-energy (brittle) cleavage fracture morphology remote from the origin.

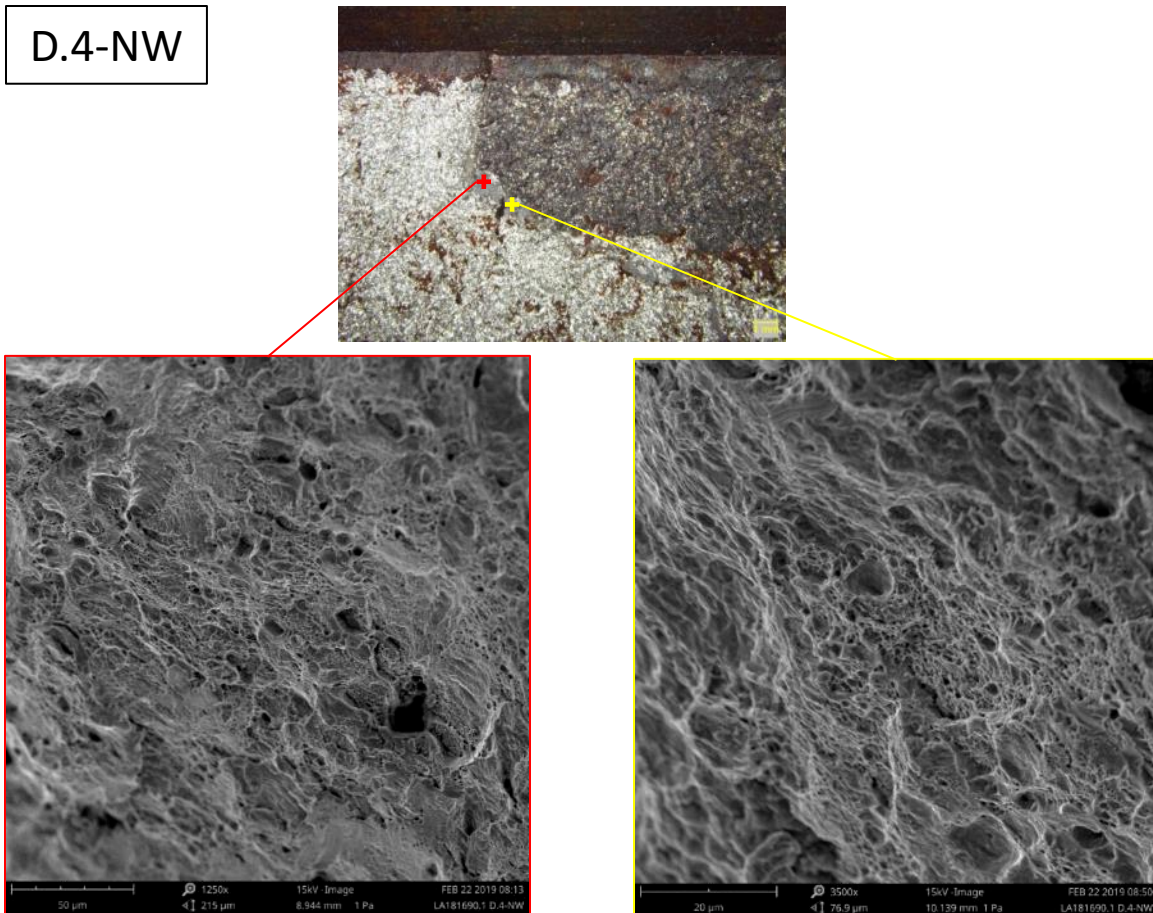
Fig. 202. Representative SEM images of the narrow band of microvoid coalescence between the oxidized elliptical pop-in crack and final fracture on girder sample D.4-NW.

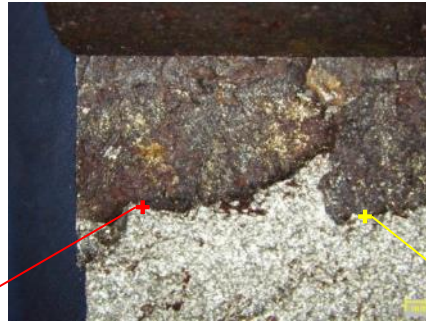
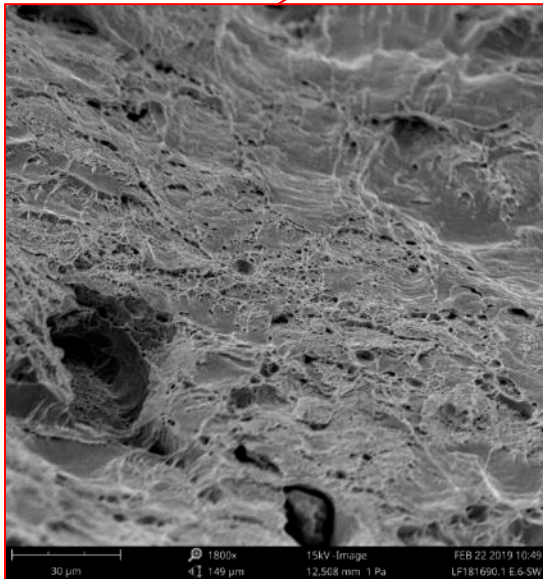
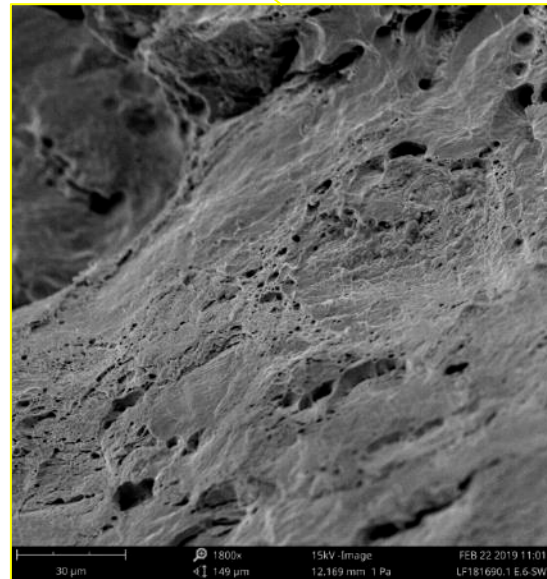
Fig. 203. Representative SEM images of the narrow band of microvoid coalescence between the oxidized elliptical pop-in crack and final fracture on girder sample E.6-SW.

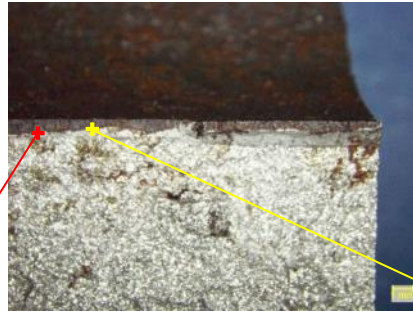
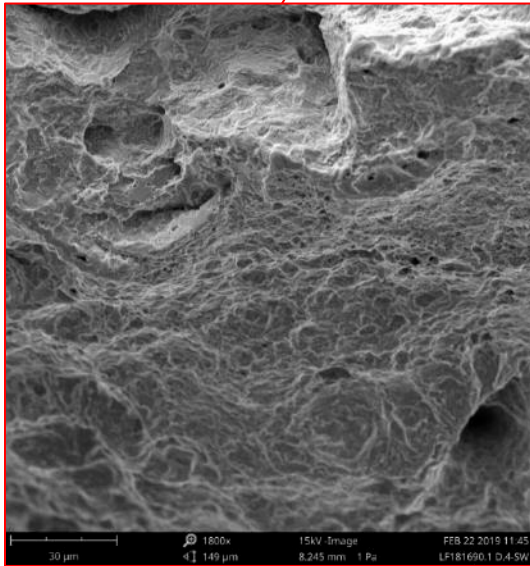
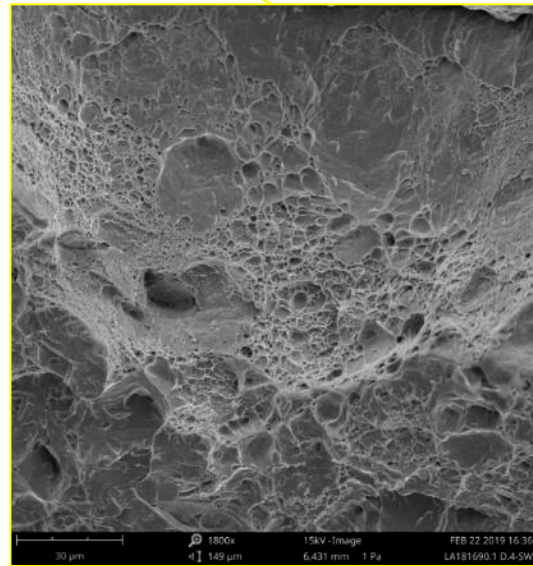
Fig. 204. Representative SEM images of the narrow band of microvoid coalescence between the oxidized microcrack region and final fracture on girder sample D.4-SW.

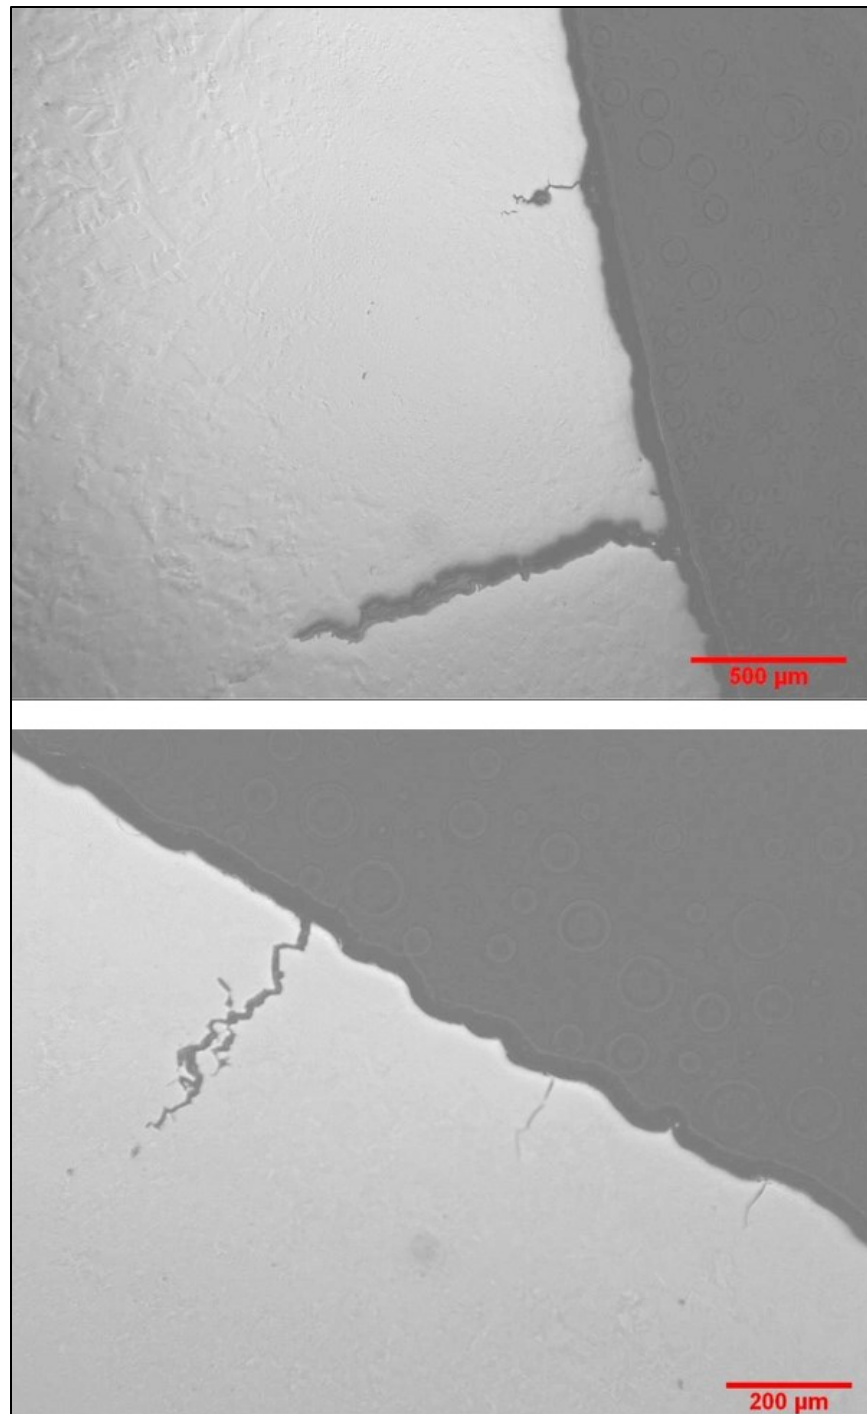
Fig. 205. Multiple secondary cracks in the weld access radius of sample D.4-SW.

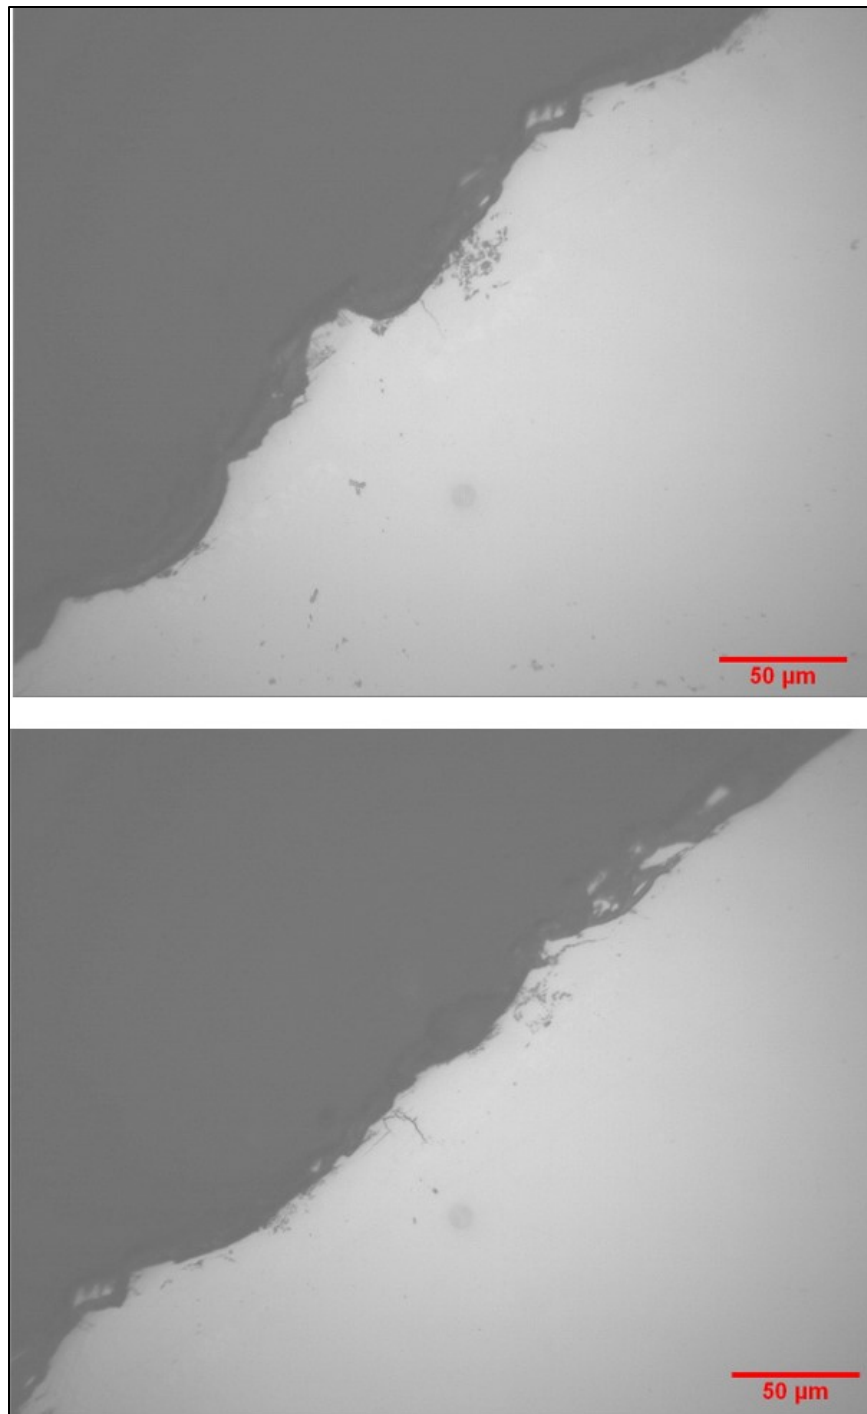
Fig. 206. Multiple secondary cracks in the weld access radius of sample D.4-NW.

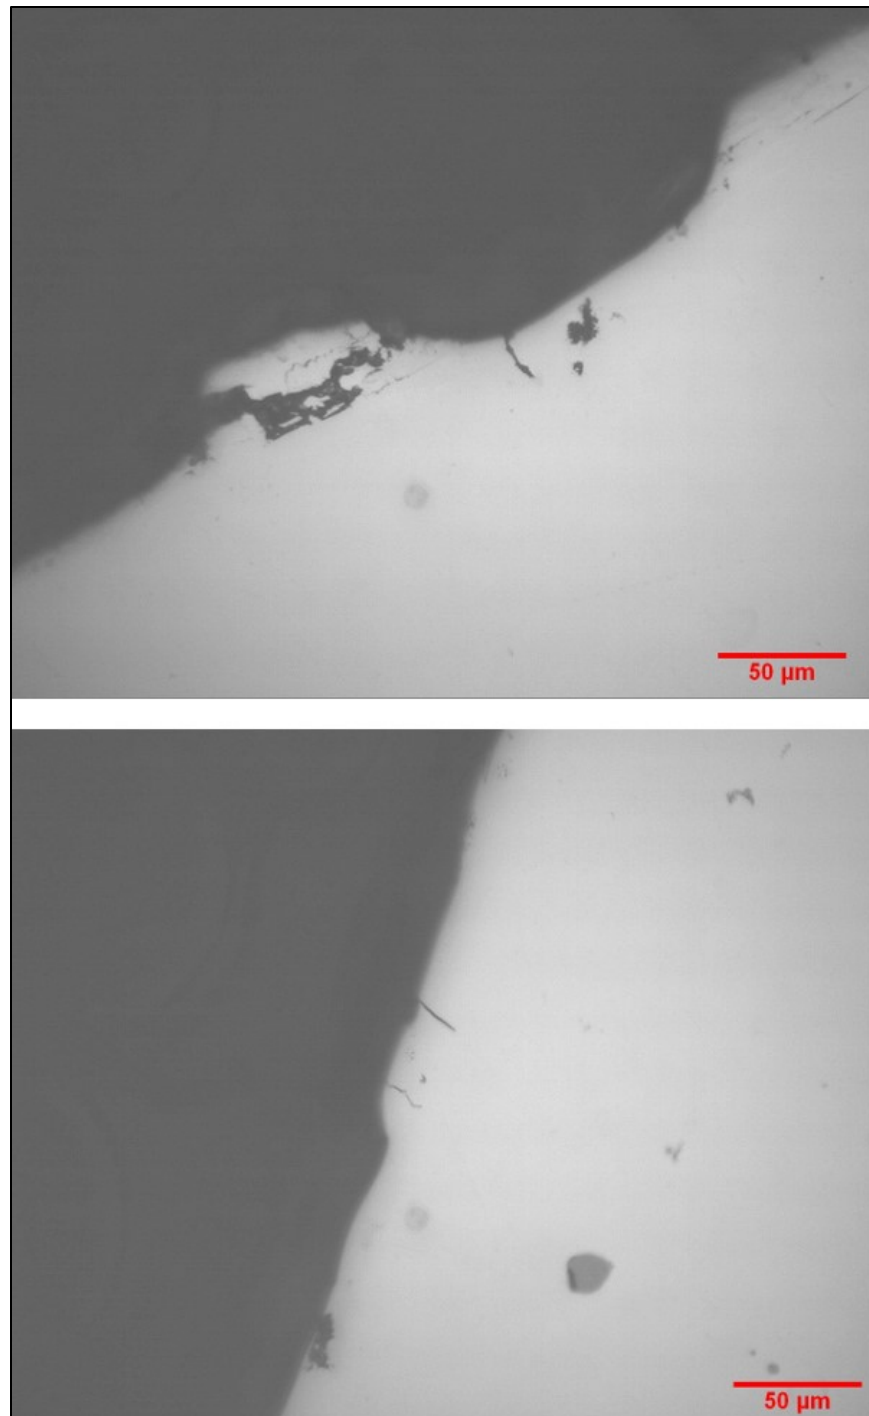
Fig. 207. Multiple secondary cracks in the weld access radius of sample E.6-NE.

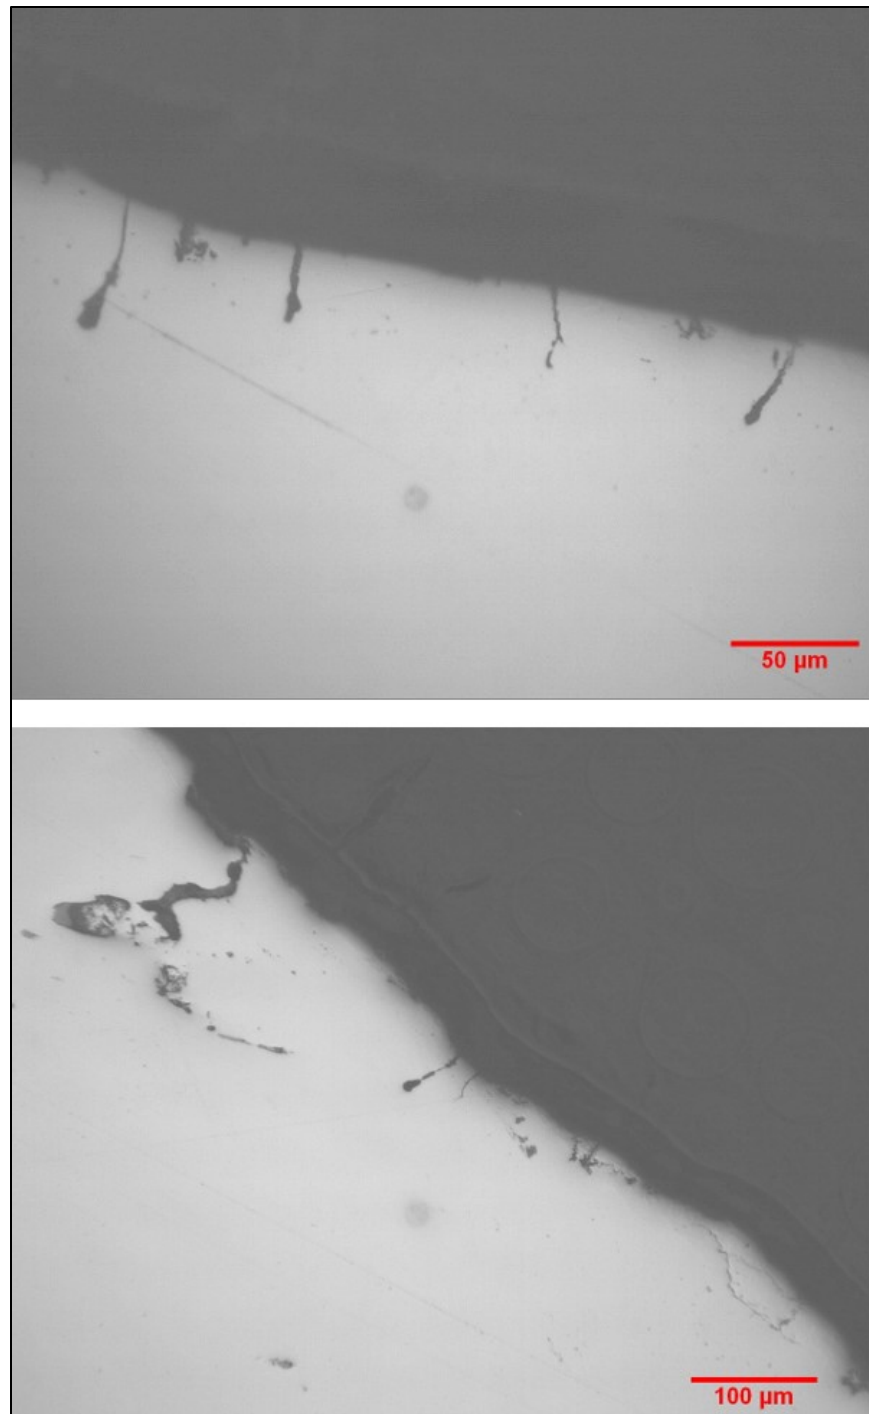
Fig. 208. Multiple secondary cracks in the weld access radius of sample E.6-NW.

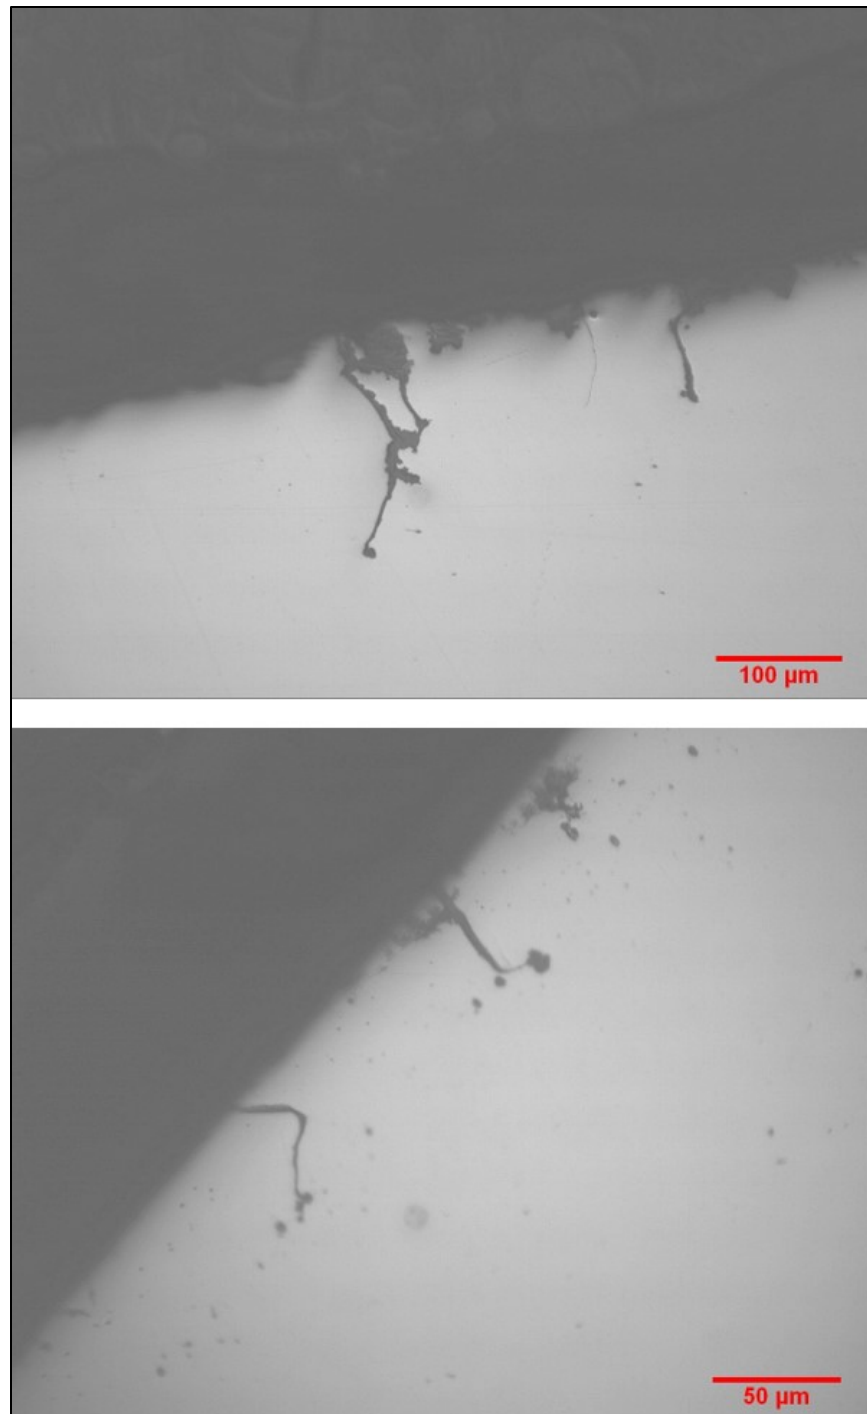
Fig. 209. Multiple secondary cracks in the weld access radius at the top surface of sample E.6-SE.

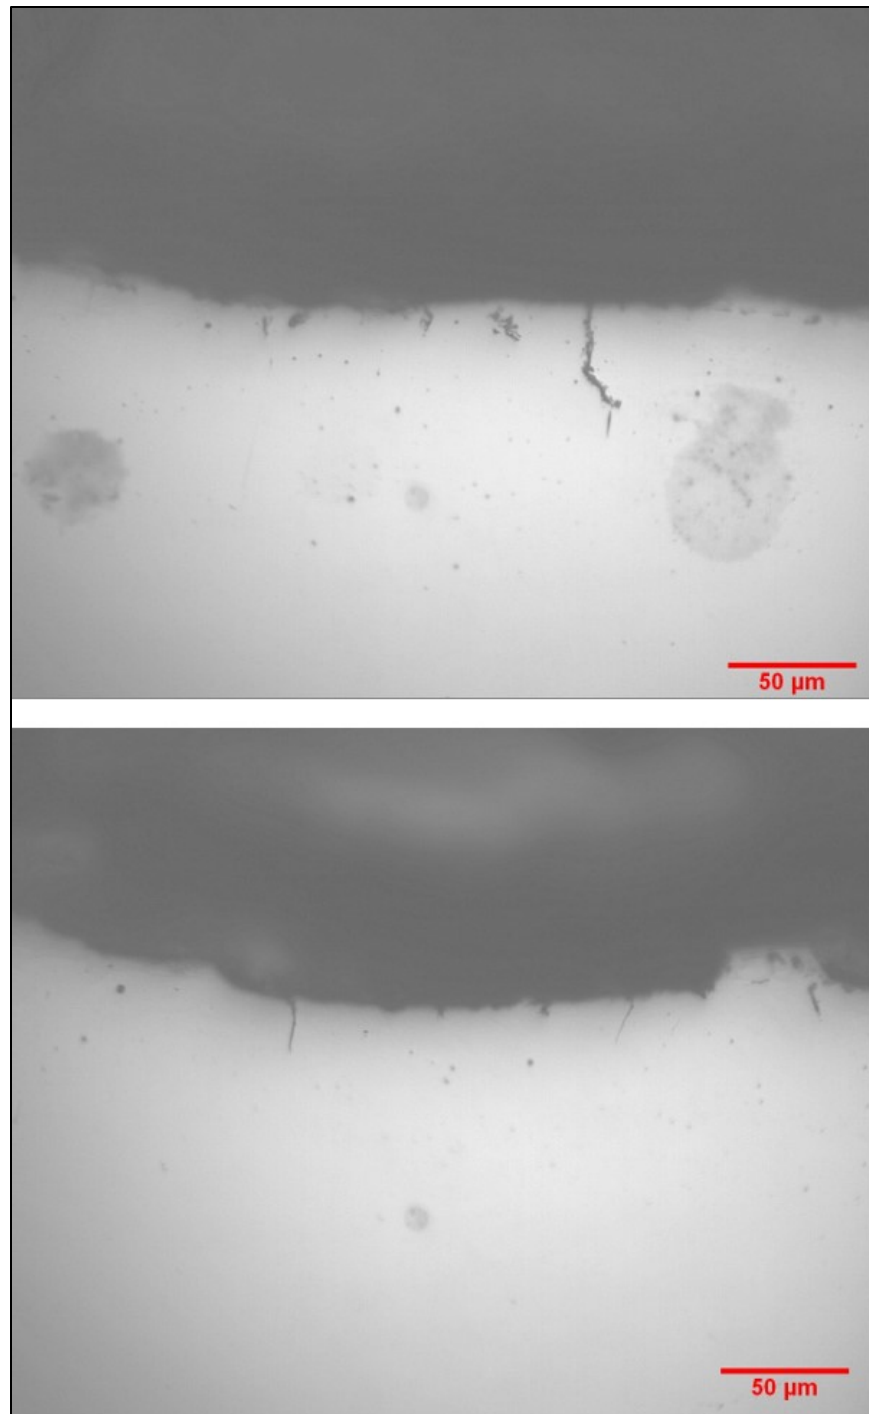
Fig. 210. Multiple secondary cracks in the weld access radius at mid-thickness of sample E.6-SE.
