LPI, Inc. Consulting Engineers

*Advanced Analysis & Fitness for Service
Failure & Materials Evaluation
Nondestructive Engineering*

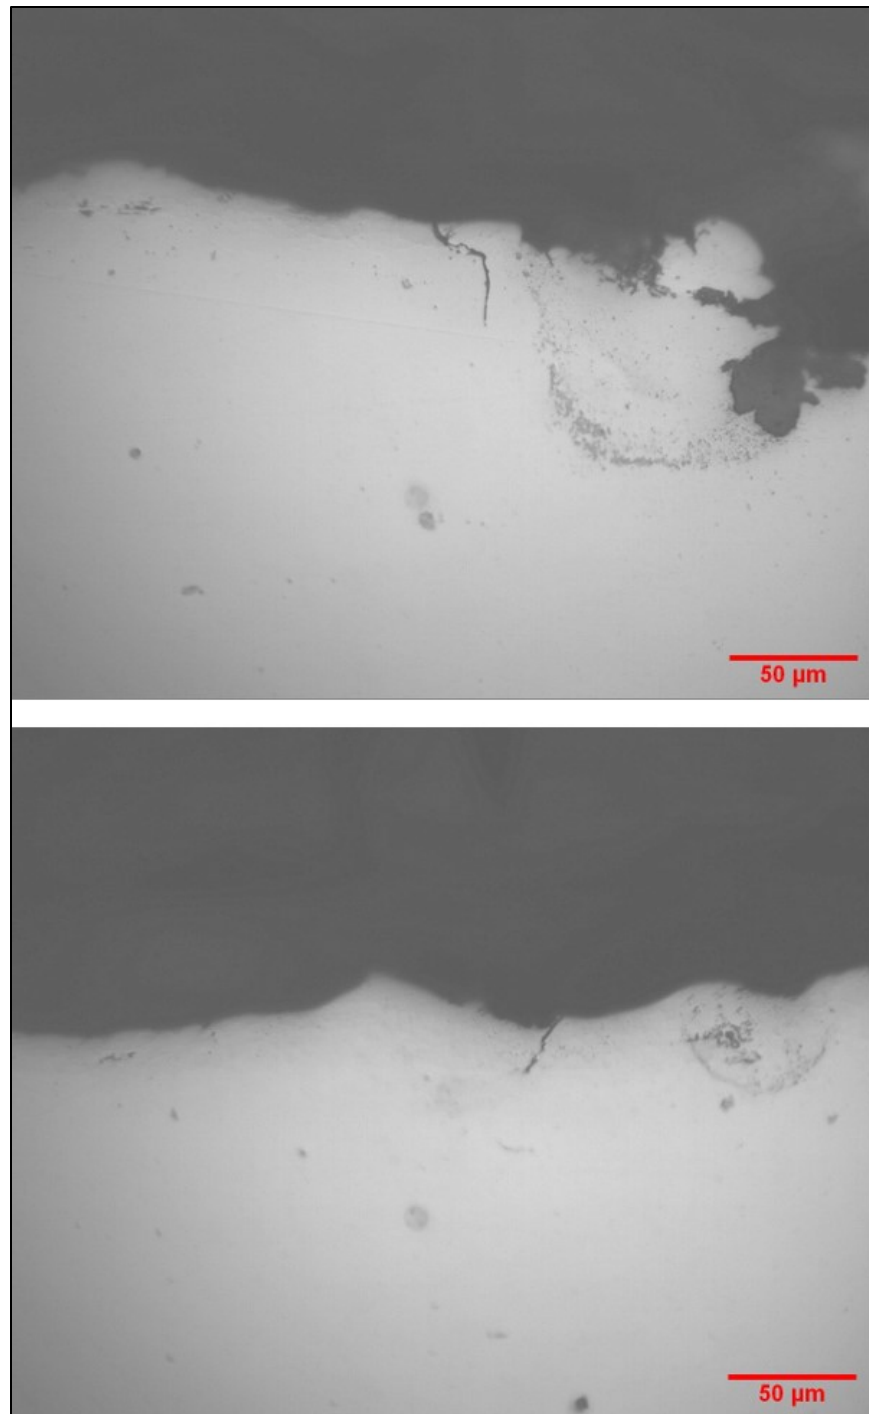
Fig. 211. Multiple secondary cracks in the weld access radius at the top surface of sample D.4-NE.

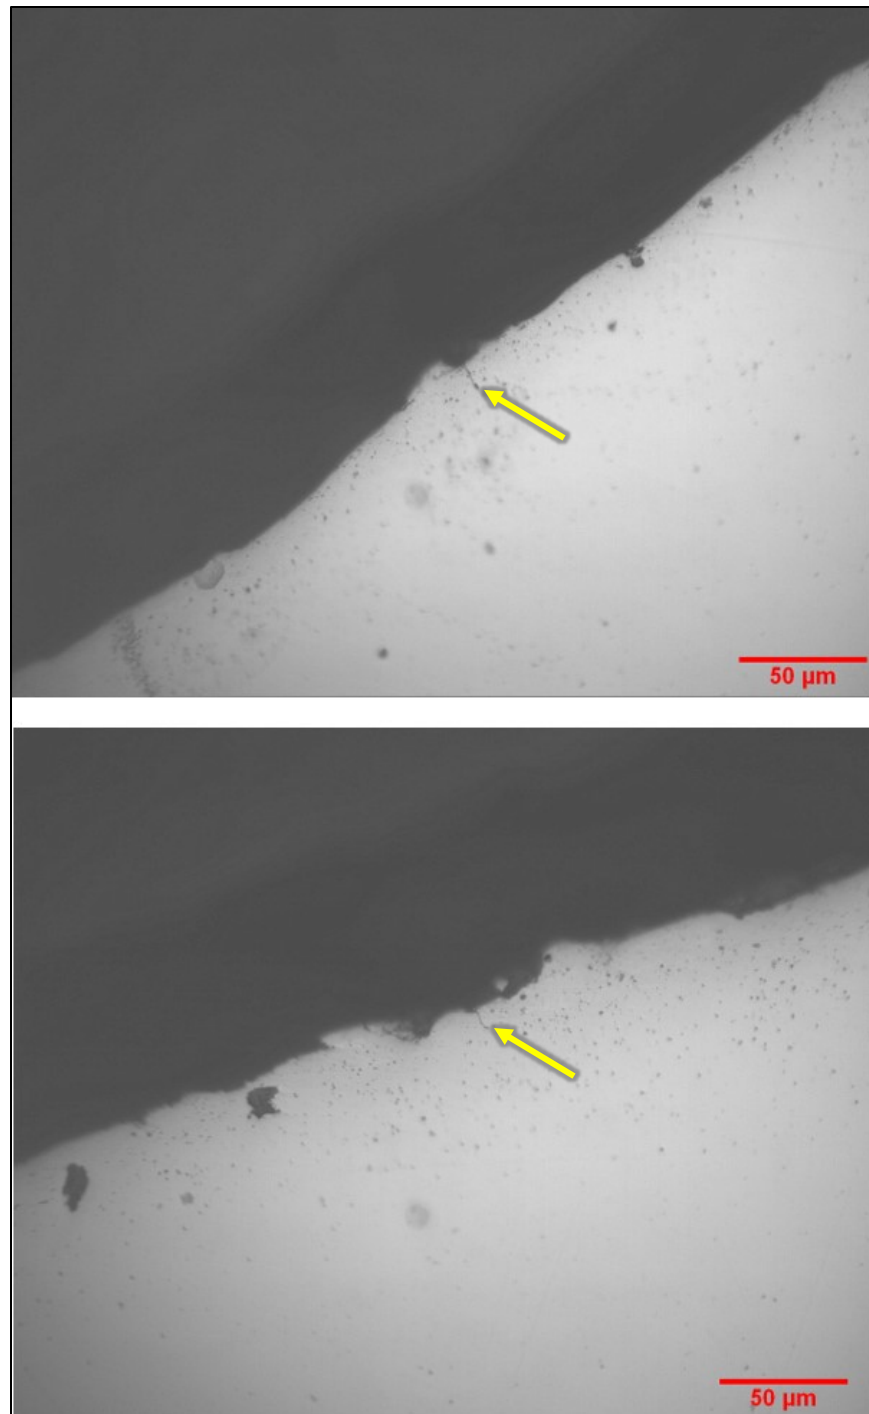
Fig. 212. Multiple secondary cracks in the weld access radius at mid-thickness of sample D.4-NE.

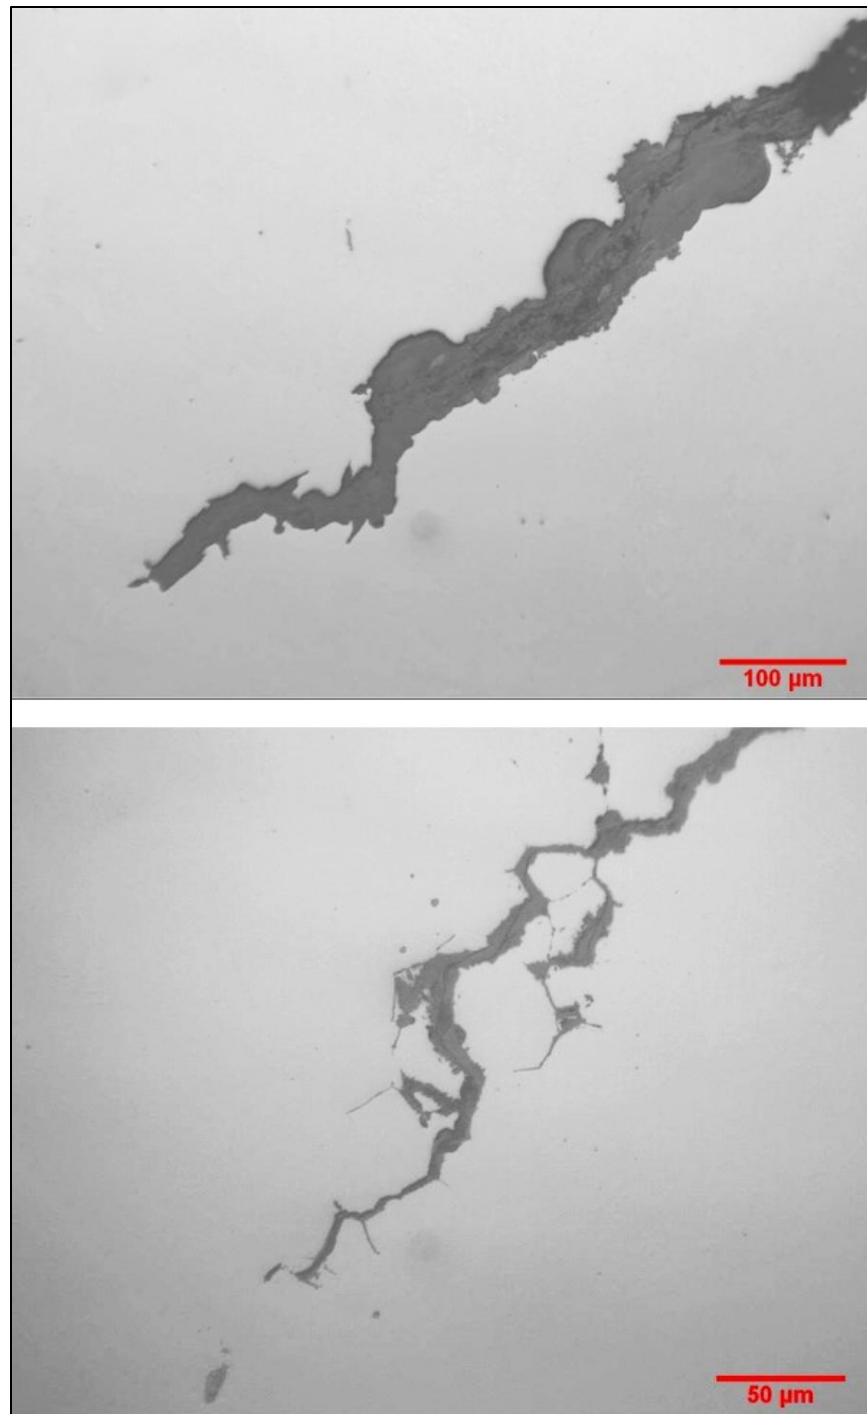
Fig. 213. Cracks filled with dark, high temperature oxide in the weld access hole of sample D.4-SW.

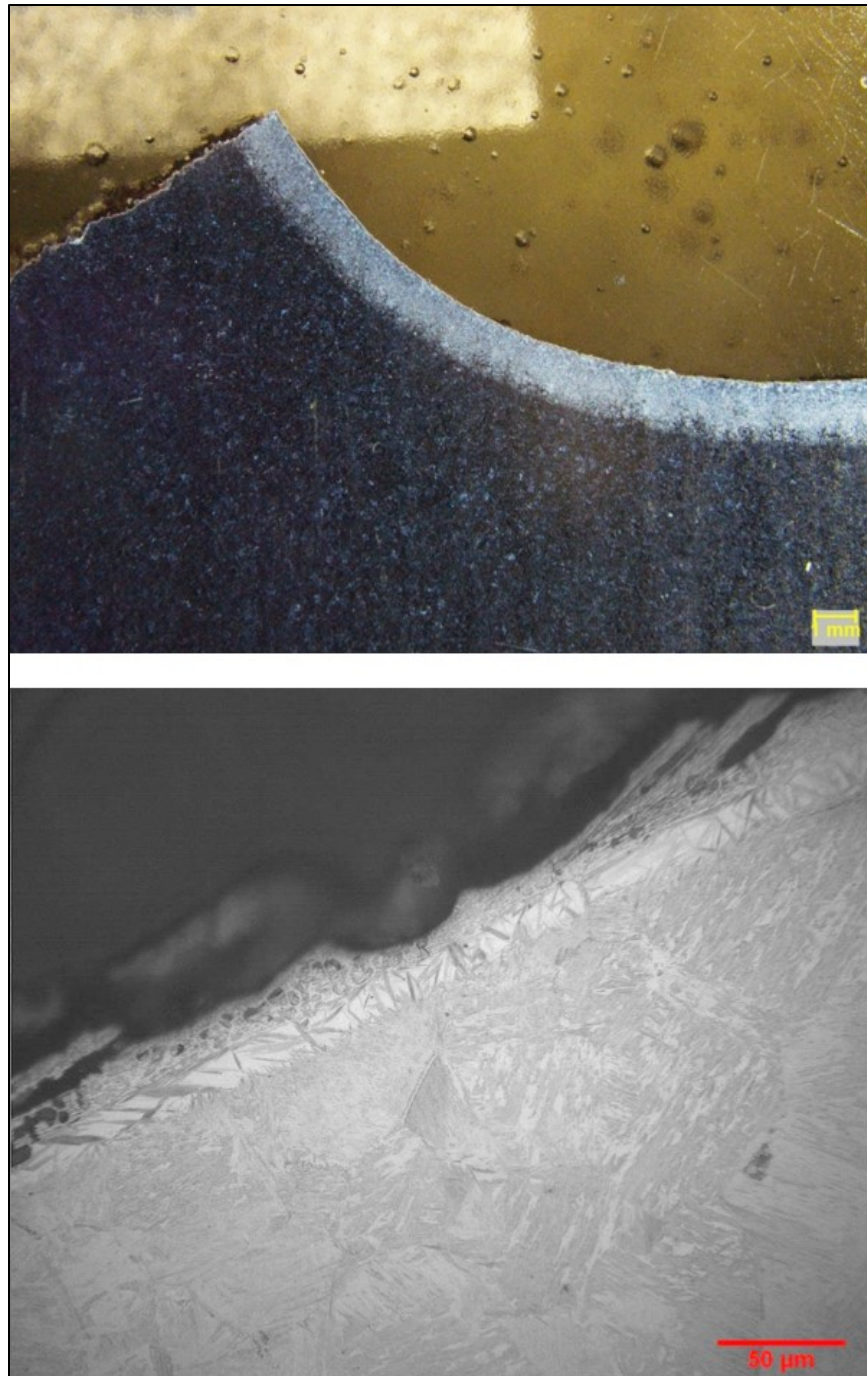
Fig. 214. Martensitic surface structure at the weld access hole radius of sample E.6-SW (fractured side). The martensitic layer appears as the lighter-etching band in the stereomicroscopic image at top. The bottom metallographic image shows the martensitic structure within the band.

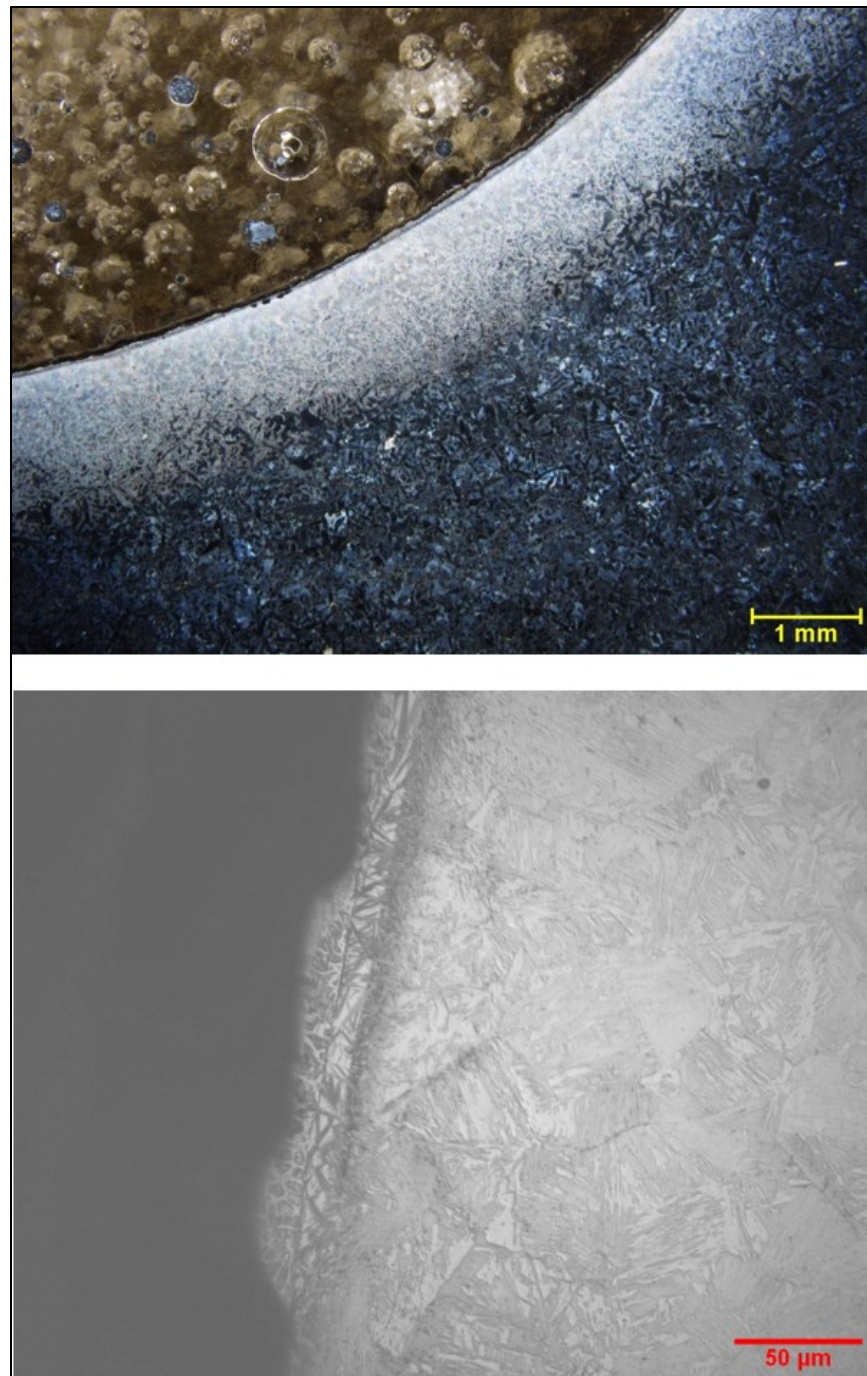
Fig. 215. Martensitic surface structure at the weld access hole radius of sample E.6-SE (intact side). The martensitic layer appears as the lighter-etching band in the stereomicroscopic image at top. The bottom metallographic image shows the martensitic structure within the band.

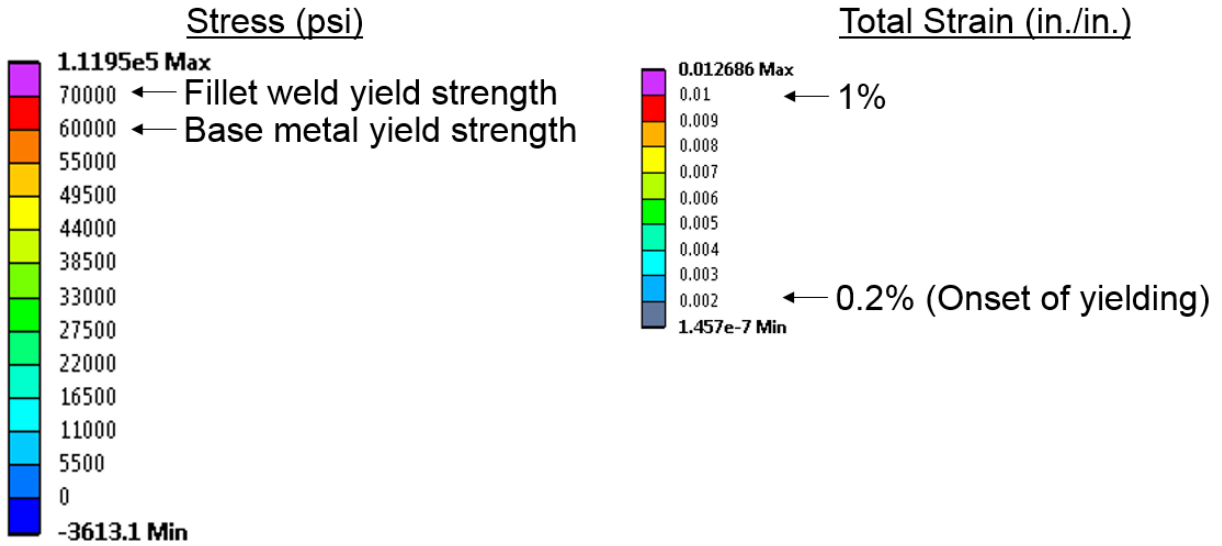
Fig. 244. Stress and strain contour bands for all preceding FE result plots. Yield strengths shown are the assumed values at the time of fracture.

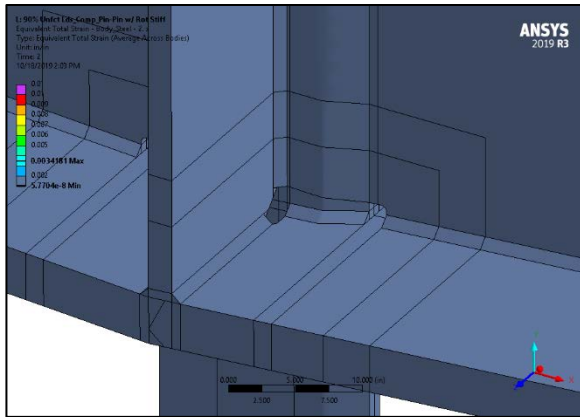
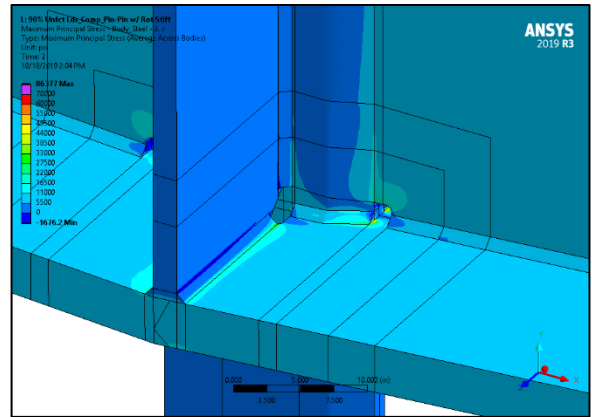
Fig. 245. Region of interest (top) total strain (in./in.) and maximum principal stress (psi) at 1.0xDL.

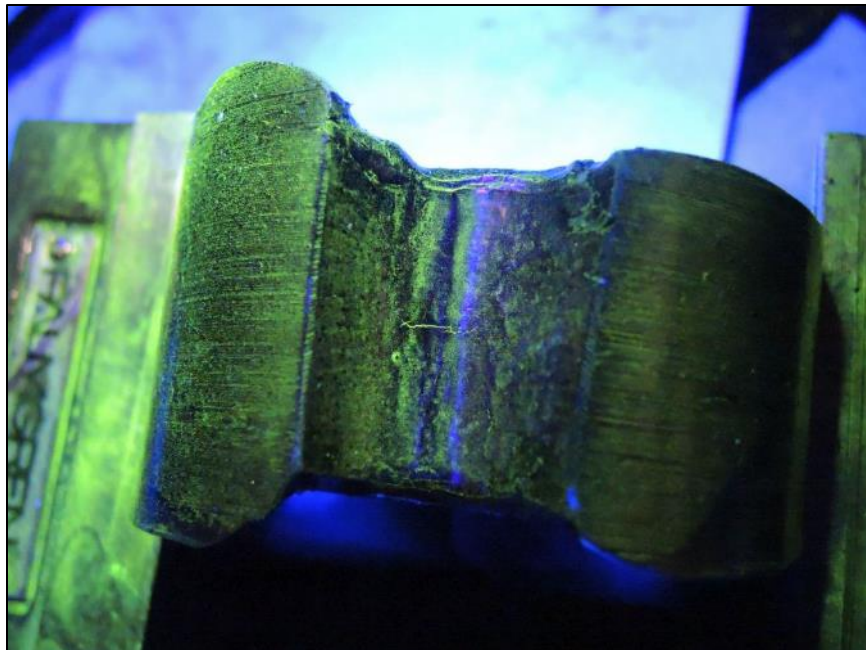
Fig. 266 Representative image of core sample F-W, which was removed to create the new web stress relief hole, following wet fluorescent magnetic particle testing showing a crack.

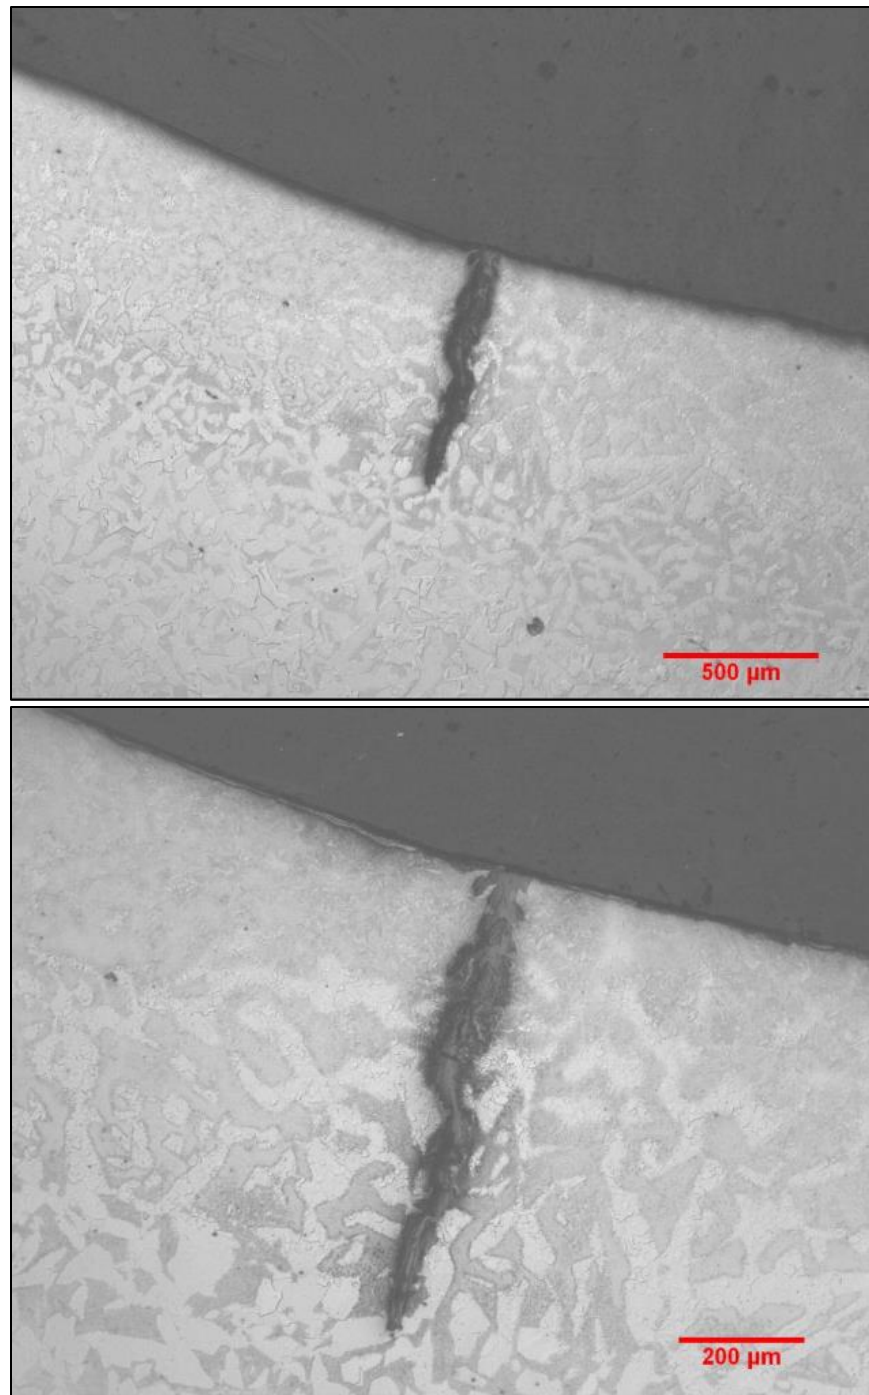
Fig. 267 Representative image of the flange weld access hole surface of core sample D-NE revealing a microcrack.

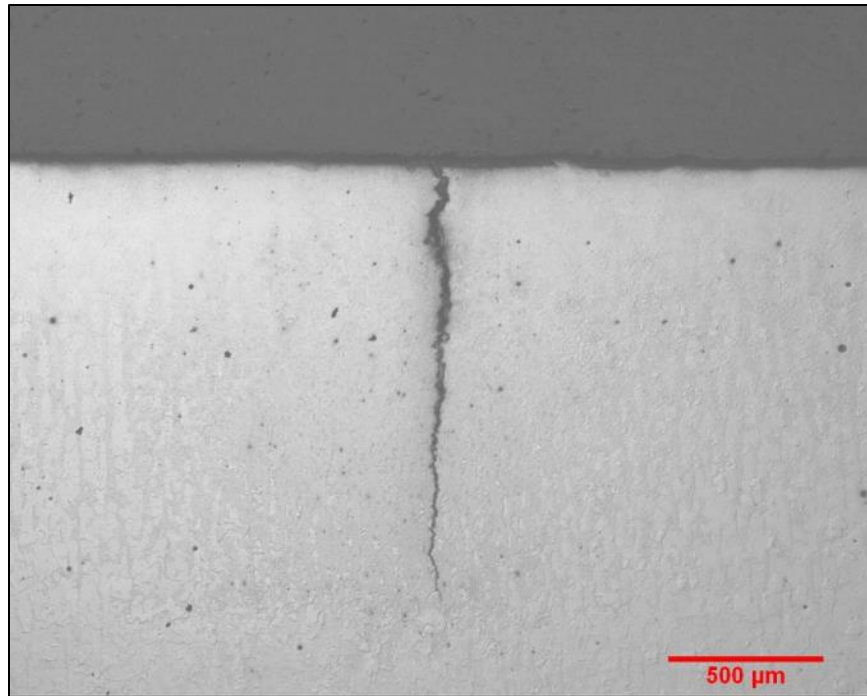
Fig. 270 Representative image of the original web access hole surface contained in core sample F-W revealing a crack (see Fig. 266).
