Recommendations to Industry Arising from Investigation of Fractured Plate Girders and Associated Studies at the Transbay Transit Center, San Francisco

February 14, 2020

Introduction

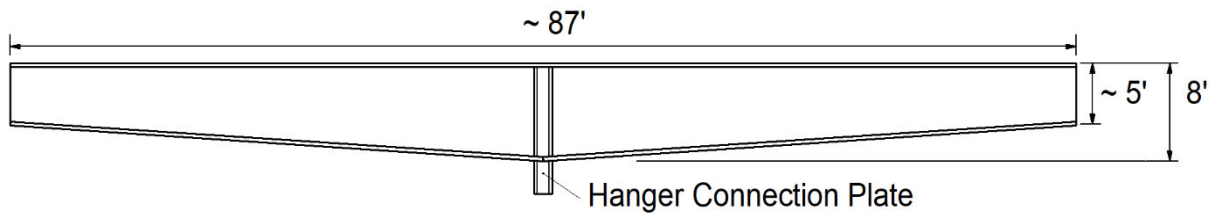
Figure 1 – Overall Dimensions of TPG3 Girder

Each TPG3 girder, approximately 87-ft. in length, is a single span. The girder cross-section is a welded I-shape, with an overall depth of 8-ft. at midspan and with a linear reduction in depth to approximately 5-ft. at each end. The top flange is horizontal whereas the bottom flange on each half of the girder is inclined to provide for the tapered depth. Both the top and bottom flanges are 36-in. wide and 4-in. thick along the entire length of the girder. The web plate is 1.5-in. thick with a varying depth. The web is connected to the flanges using fillet welds. Figure 1 shows a sketch of the TPG3 girder in elevation, and Figure 2 shows a typical cross-section.

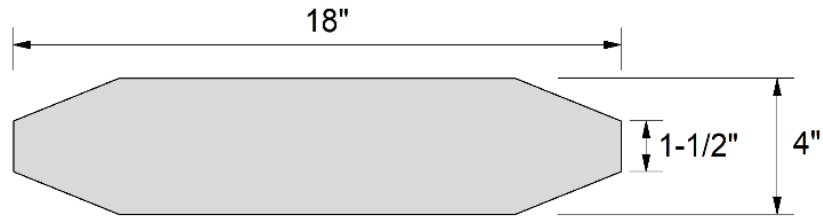
Figure 3 – Hanger Connection Plate Cross-Section

The hanger assembly includes an integral hanger connection plate, angles, and a wide flange member. The hanger connection plate is 18-in. wide by 4-in. thick and approximately 10-ft. 3-in. in length. The 4-in. plate thickness is tapered to 1.5-in. at each side of the 18-in. width to match the 1.5-in. TPG3 web plate thickness. Figure 3 shows the hanger connection plate cross-section. The hanger connection plate also serves as the web of TPG3 at midspan and is welded to the adjoining 1.5-in. web plates by complete joint penetration (CJP) groove welds. The hanger connection plate starts at the bottom side of the top flange, extends downward over the full depth of the girder, passes through a slot cut in the bottom flange, and extends below the girder approximately 31-in. Fillet welds were provided between the hanger connection plate and the bottom side of the top flange, and between the hanger connection plate and the top and bottom sides of the bottom flange. Angles are bolted to the protruding portion of the hanger connection plate that then connect to a wide-flange member that extends down to the bus level.

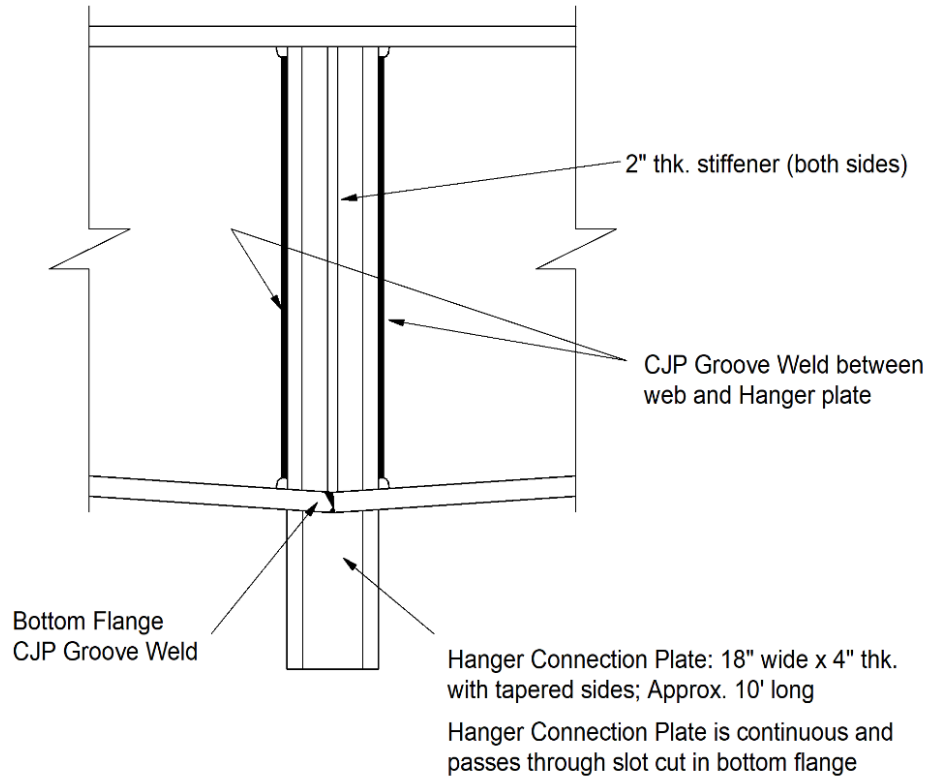
Figure 4 – TPG3 Girder at Mid-Span

At midspan of the girder, at the location where the hanger connection plate protrudes from the bottom of the girder, the 4-in. thick bottom flange plates on either side of midspan were connected by a CJP groove weld. The CJP groove weld was not continuous over the 36-in. width of the flange, as the weld was interrupted by the hanger connection plate. In addition, at midspan, 2-in. thick full-depth stiffeners were provided in the girder. The stiffeners were attached to the top flange, to the hanger connection plate, and to the bottom flange by fillet welds. The bottom of the stiffener was located approximately over the CJP groove weld in the bottom flange.

Figure 4 is a sketch of the TPG3 girder at midspan showing the hanger connection plate. This figure also shows the location of the CJP groove weld in the bottom flange and the CJP groove welds connecting the 1.5-in. thick girder web to the 1.5-in. thick edges of the hanger connection plate. Fillet welds connecting the girder flanges to the girder web, fillet welds connecting the stiffener to the girder flanges and to the hanger, and fillet welds between the hanger connection plate and top and bottom side of the bottom flange and the bottom side of the top flange are not shown. Figure 5 is a photo of a TPG3 girder that was taken during construction of the TTC. Figure 6 is a similar photo with labels identifying several features.

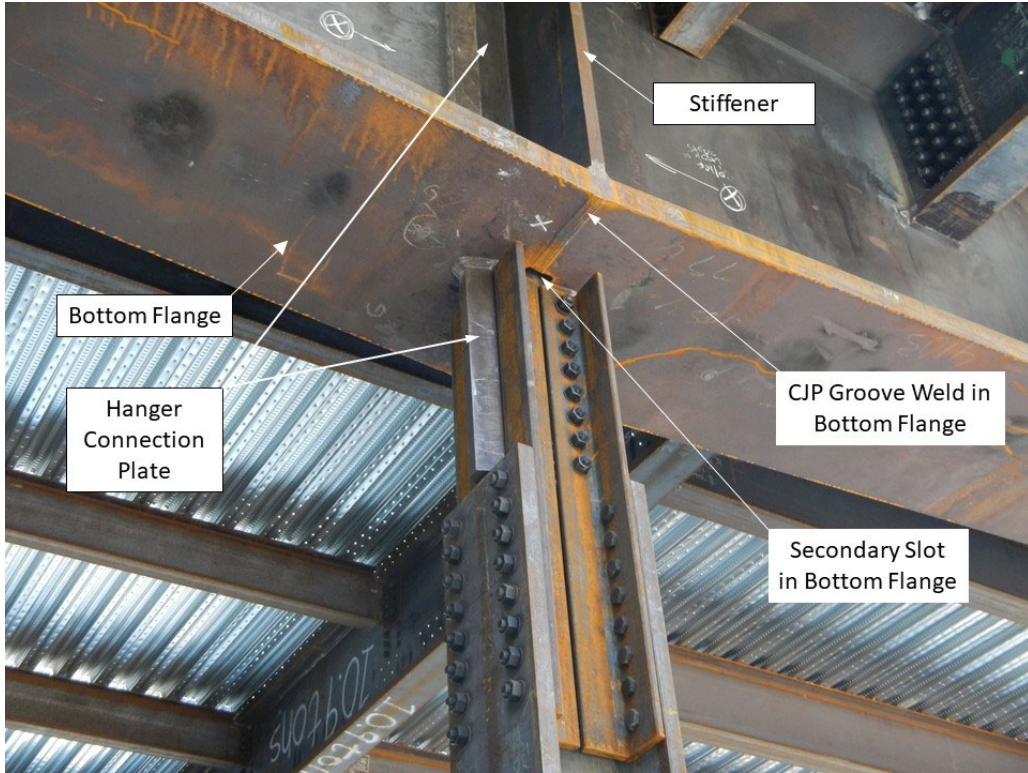
Figure 6 – Photo of a TPG3 Girder with Labeled Features (Photo: TJPA)

One of the slots in the bottom flange conforms to the shape of the hanger connection plate and allows the hanger connection plate to pass through the bottom flange. In this report, this slot is referred to as the “primary slot.” Two additional slots were cut into the bottom flange in the region where the CJP groove weld approaches the hanger connection plate. These slots, which are approximately rectangular in shape, are referred to in this report as “secondary slots.” Each secondary slot was approximately 5-in. in length and 2-in. in width. There is a secondary slot on either side of the primary slot. A secondary slot is visible in the photo of the TPG3 girder in Figure 6.
